CK-2478

NAHATLATCH 42.6km

2016 Inspection

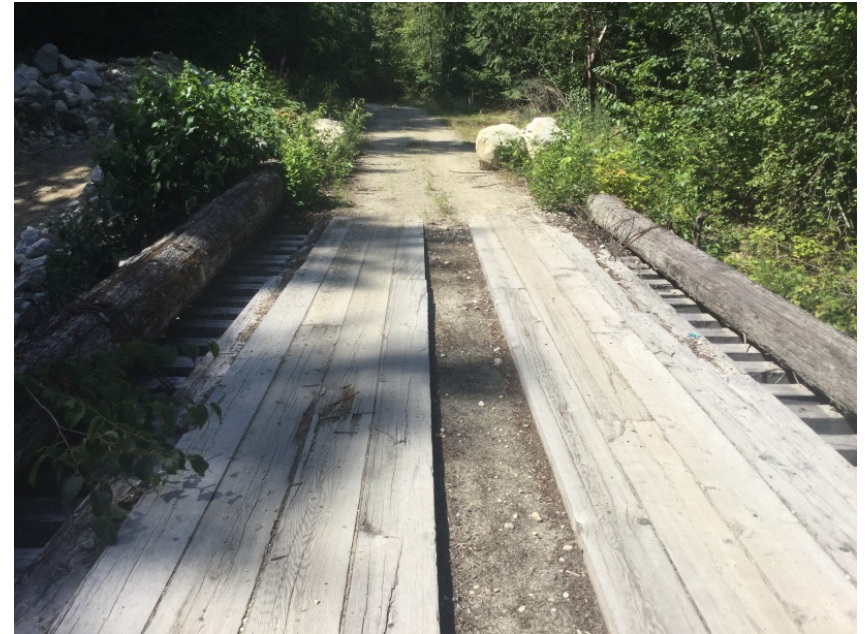
| Running Planks | Poor | Fair to poor. Localized pockets of rot in planks. |
| Sub Deck | Poor | Rotten. |
| Ties | Poor | Rotten. |

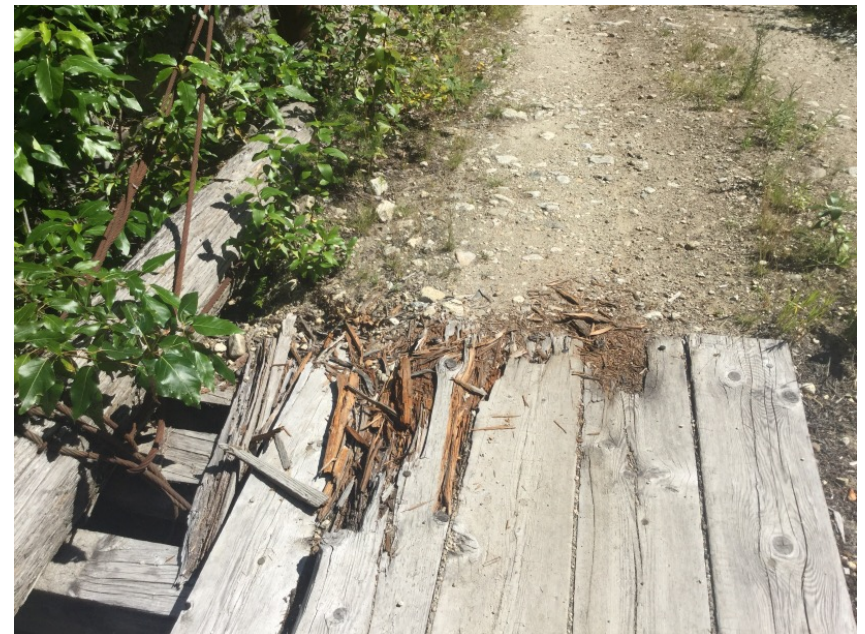
Rotten Deck Planks

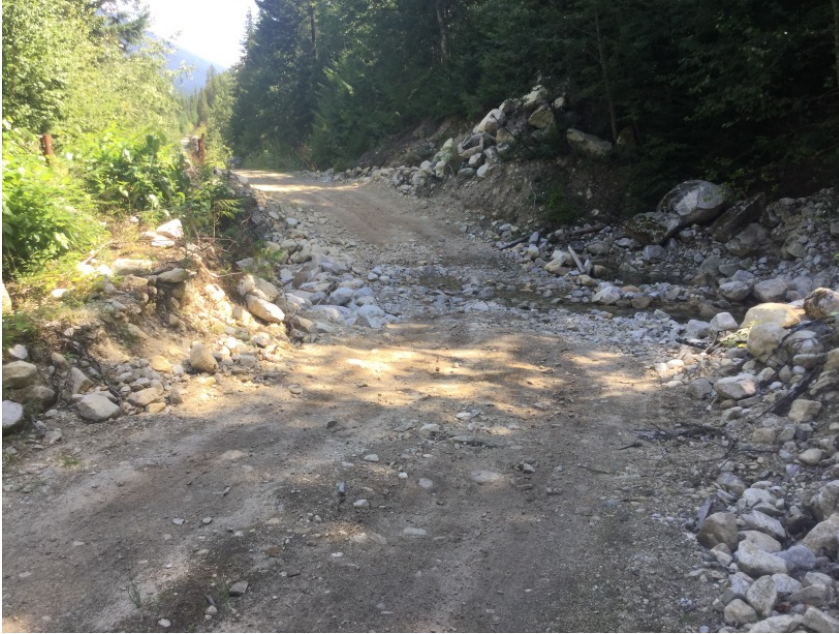
Bridge has been condemned. Stringers are rotten and right abutment has significant scour. No load posting is in place. Access to the bridge should be blocked and structure removed or replaced. The road bypasses the bridge crossing the creek upstream. Error in App, subtract 1 for actual stringer number.

Upstream Bypass Route

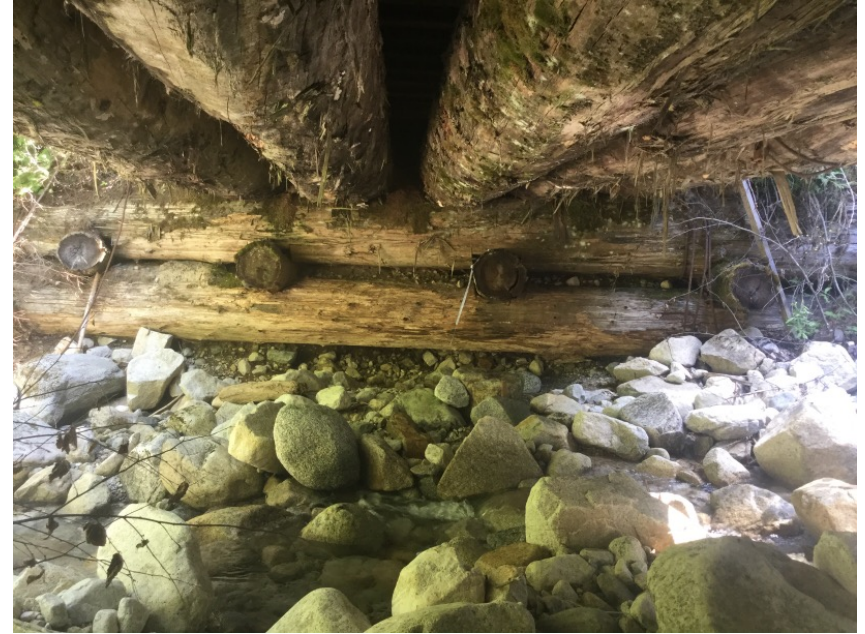
Right Bank Abutment

Log/Timber Cribs Poor Moss growth, sap rot and conks. No signs of crushing or distress. Significant scour under right abutment.

Comments Scour under right abutment log up to 800 mm deep over 3 m, with some scour over remaining length of log.

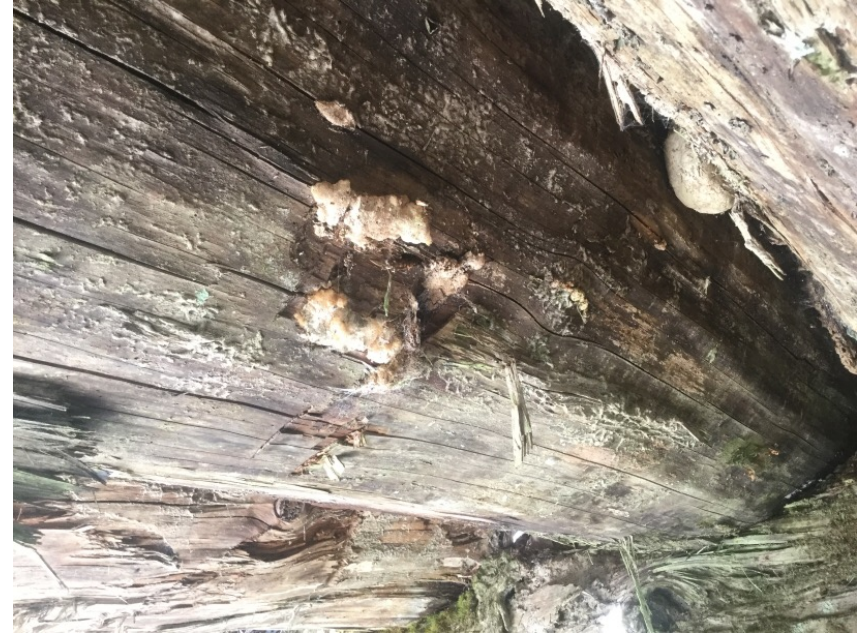
| 2 | Fd | Y | 660 | 200 | Poor | Dry sap rot. |

Stringer 2 Fungal Growth

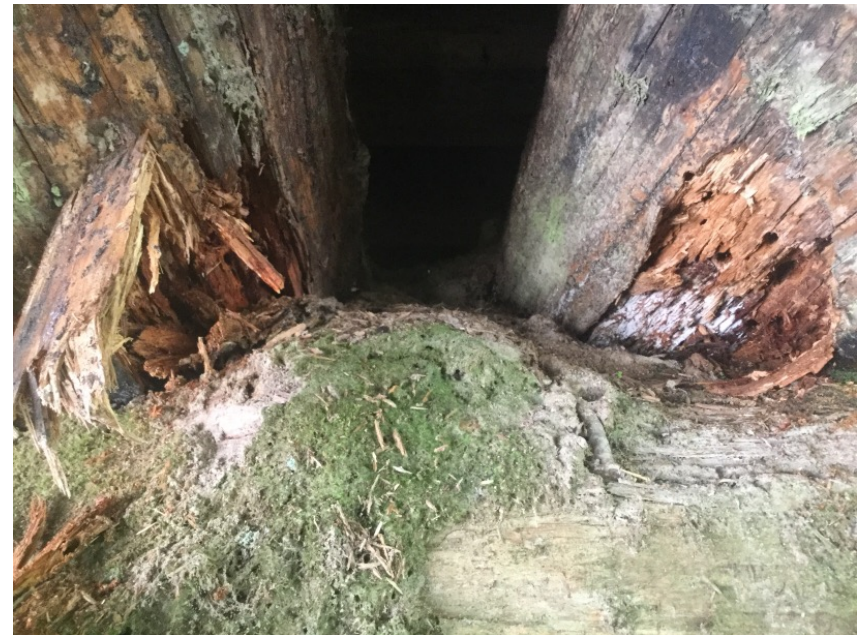
| 3 | Fd | Y | 660 | 100 | Poor | Dry sap rot. Fungal growth. |
| 4 | Fd | Y | 670 | 300 | Poor | Rotten. Conk. |

Rot in Stringers 3 & 4

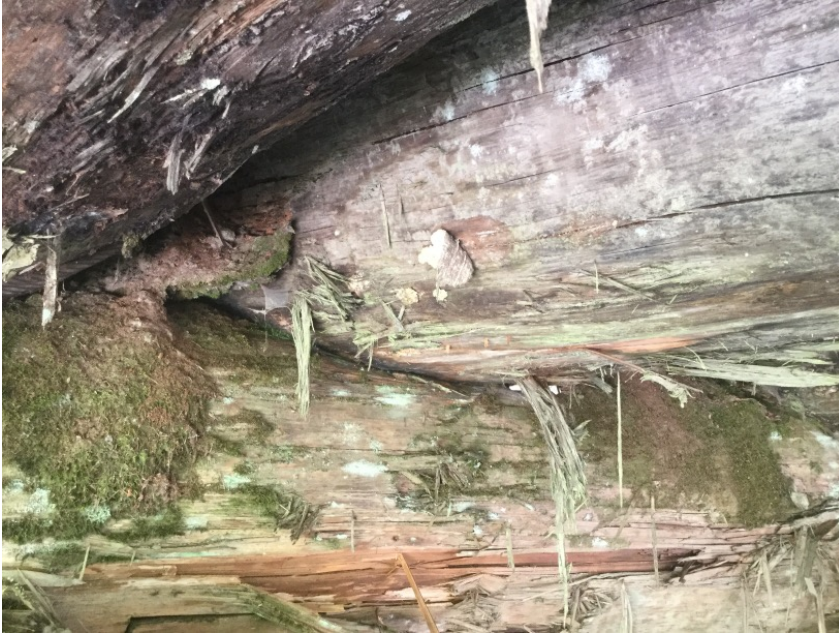
Stringer 4 Fungal Growth

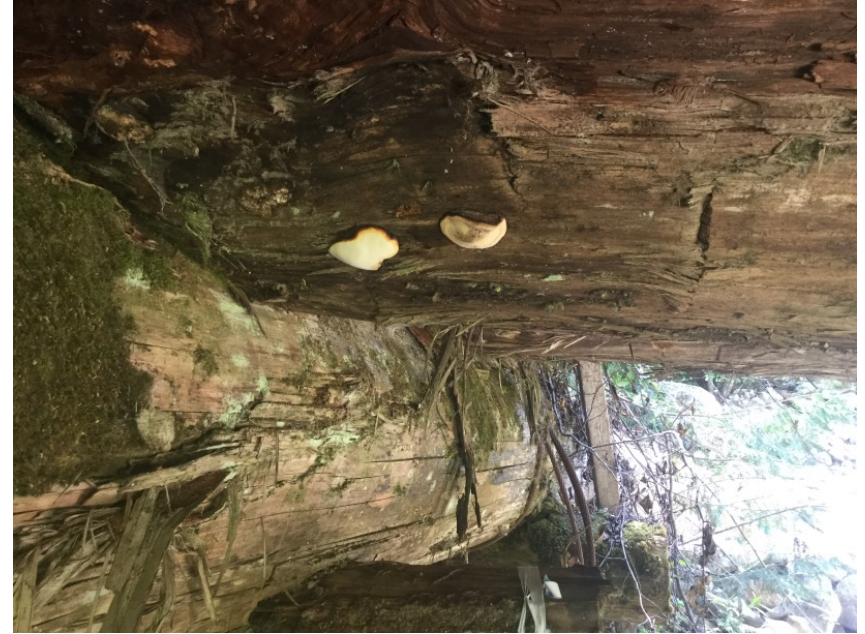
Stringer 3 Conk

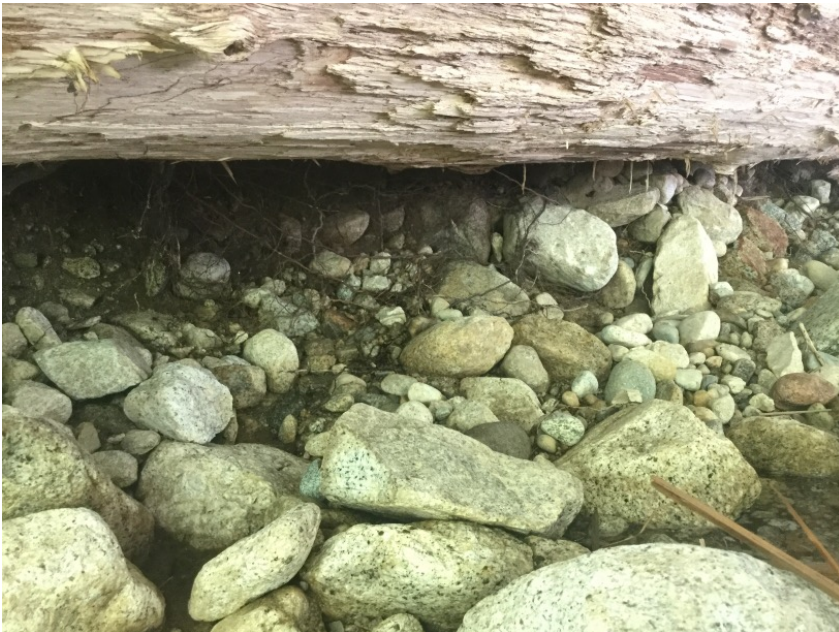
Right Abutment Scour
