CK-2487

STS'AILES 7.9km

2016 Inspection

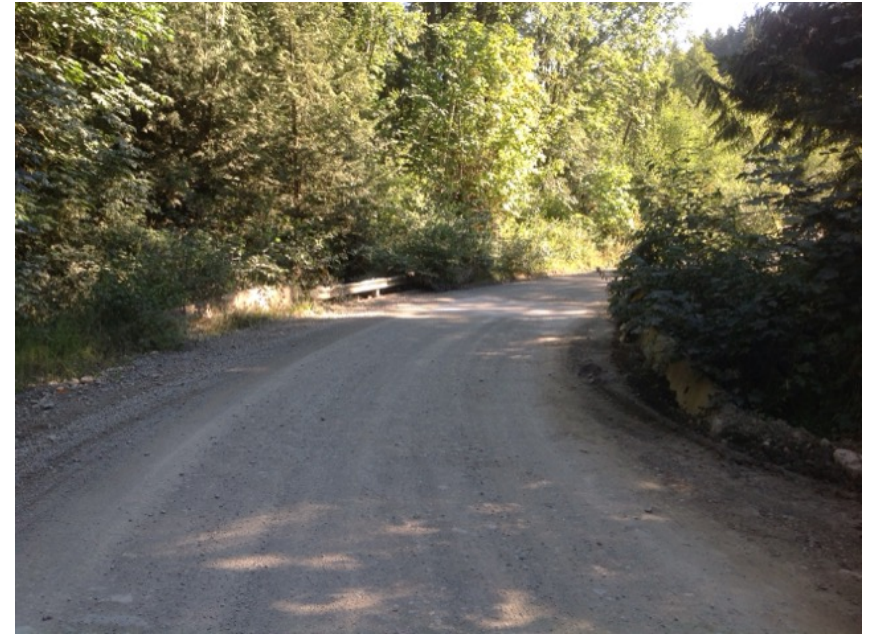
Approach from Right Bank when facing downstream

HC on right approach

Brush approaches. Present load rating of L150 or 136 tonnes to continue.

| Repair Item | Priority | Repair Description |
|---|---|---|
| 1 | Medium | brush approaches |
