CK-2490

CHILLIWACK SOUTH 1.4km

2016 Inspection

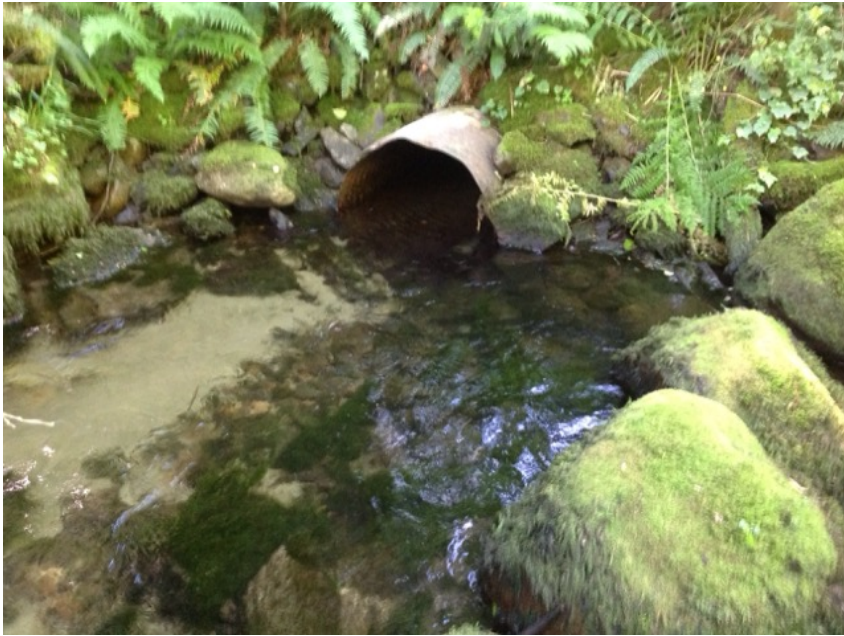
Comments 80% of the flow is going through 900mm CSP

channel being diverted through 900mm CSP, taking 80% of the flow

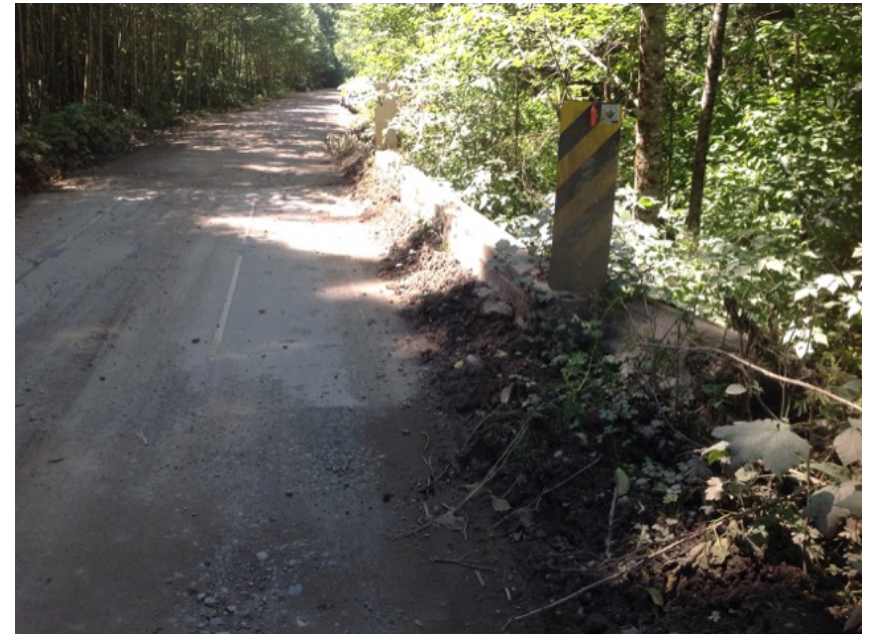
sediment on deck against guardrail

Clean sediment off deck and post bridge ahead signs. The present load rating of L75 or 68 tonnes to continue.

| 2 | Medium | clean sediment off deck |
