CK-2491

CHILLIWACK SOUTH 1.5km

2016 Inspection

| Crossing Name | Chilliwack River |

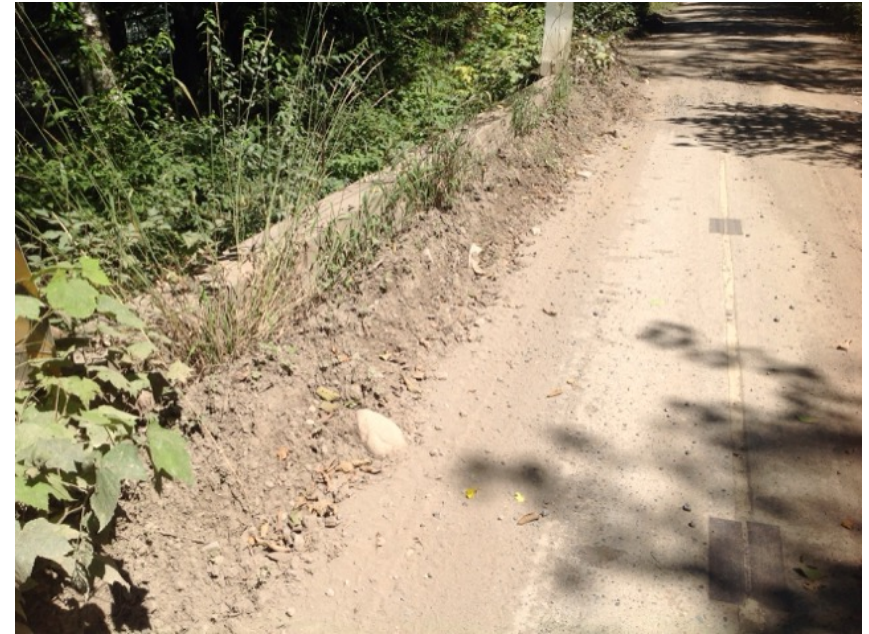
sediment accumulations against guardrail

Clean sediment off deck and post bridge ahead sign. The present load rating of L75 or 68 tonnes to continue.

| 2 | Medium | clean sediment off deck |

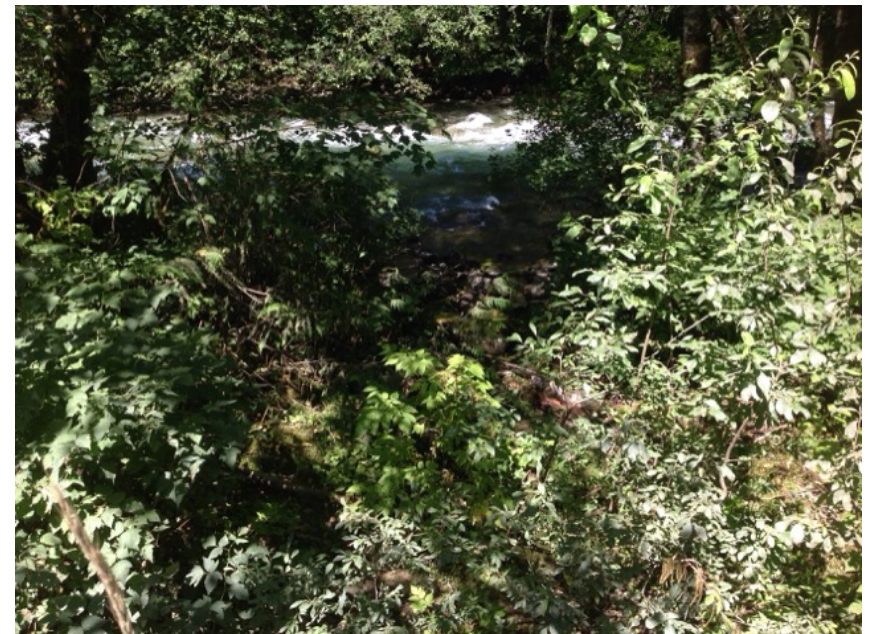
looking downstream from crossing, looking at the Chilliwack River
