CK-2492

CHILLIWACK SOUTH 3km

2016 Inspection

| Crossing Name | Centre Creek |

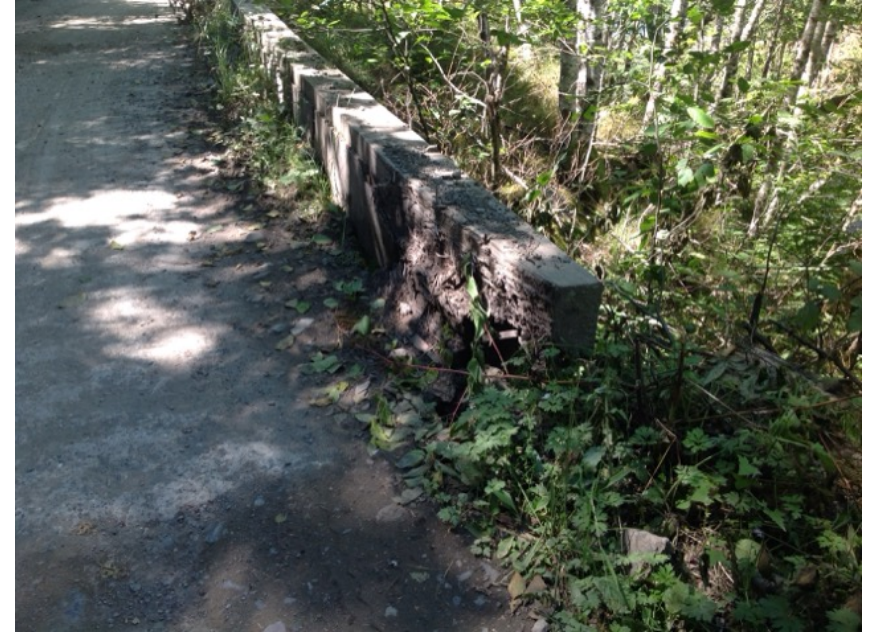
damage to downstream guardrail but still functional
