CK-2496

ENGLISH CREEK TWO 0.5km

2016 Inspection

Crossing Name Side Creek

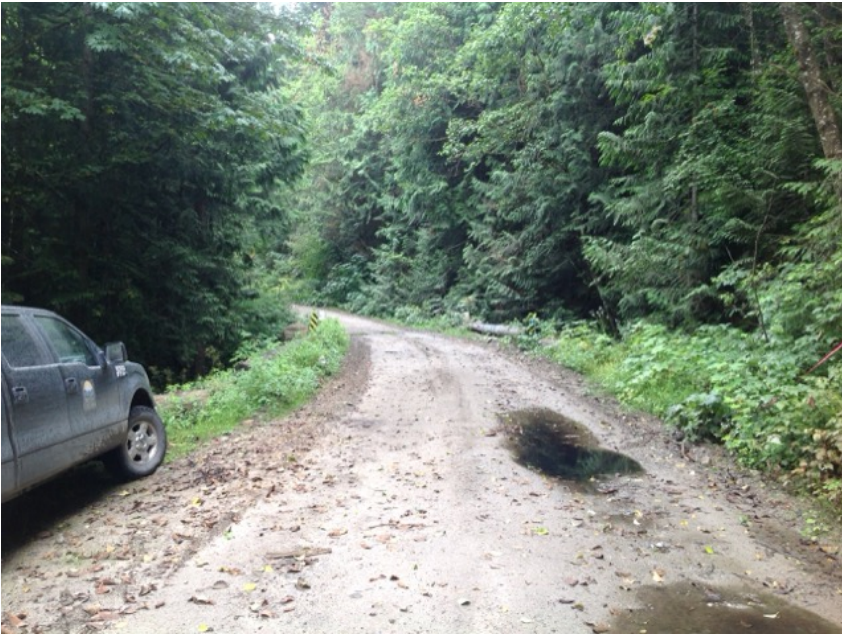
Approach from Left Bank when facing downstream

Bridge Ahead Signs  
Missing ☐ 0 ☐ 1 ☒ 2

Post bridge ahead signs. Present load rating of L120 or 109 tonnes to continue.

| Repair Item | Priority | Repair Description |
|---|---|---|
| 1 | Medium | post bridge ahead signs |

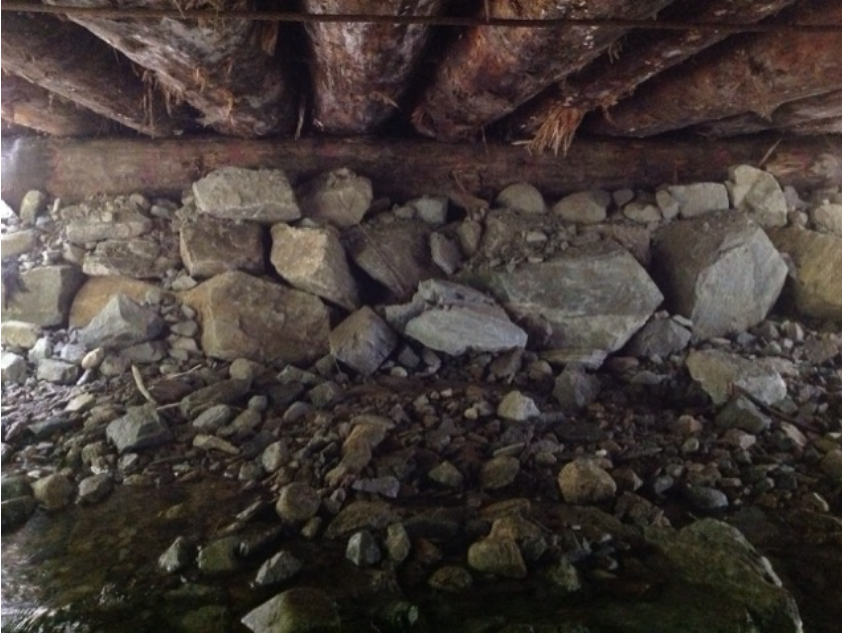
Left Bank Abutment when facing downstream

| Hardware | Fair | outside stringers not lashed to sill and can't tell if they are pinned - no signs of movement |

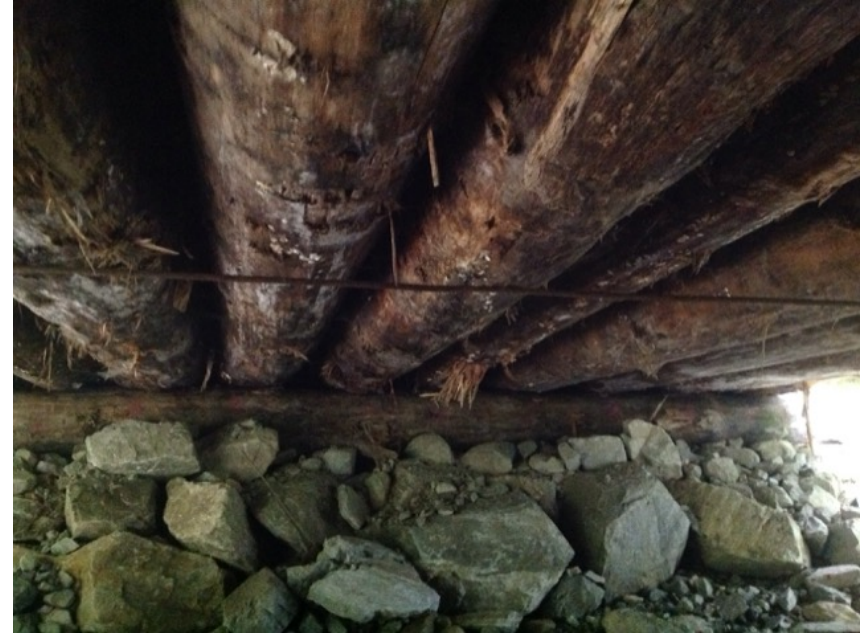
Stringers

8.2m span  
log stringers all starting to show mycelium growth but still solid
