CK-2497

ENGLISH CREEK TWO 1.1km

2016 Inspection

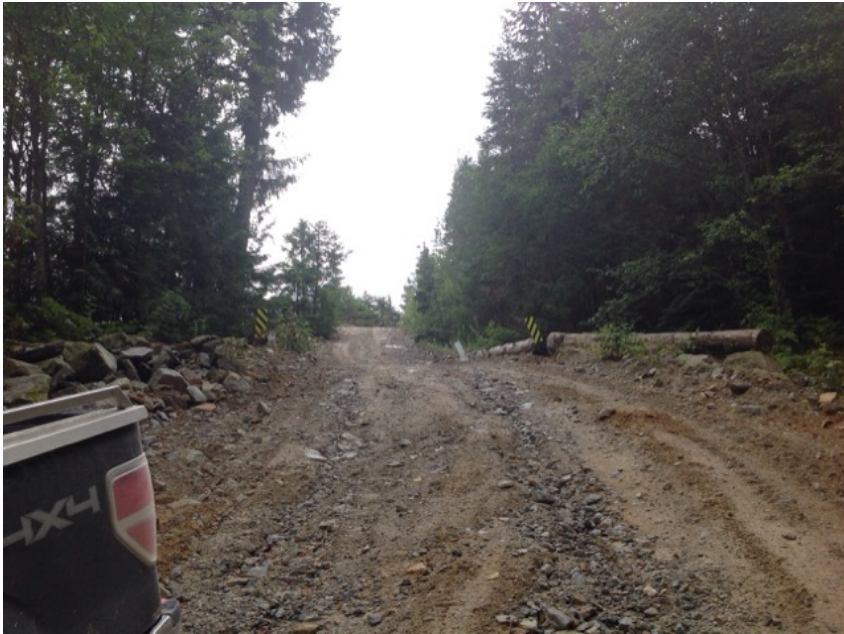
very steep VC on both approaches

Approach from Left Bank when facing downstream - 26%

Post bridge ahead signs. Present load rating of L100 or 91 tonnes to continue. Monitor steep approaches.

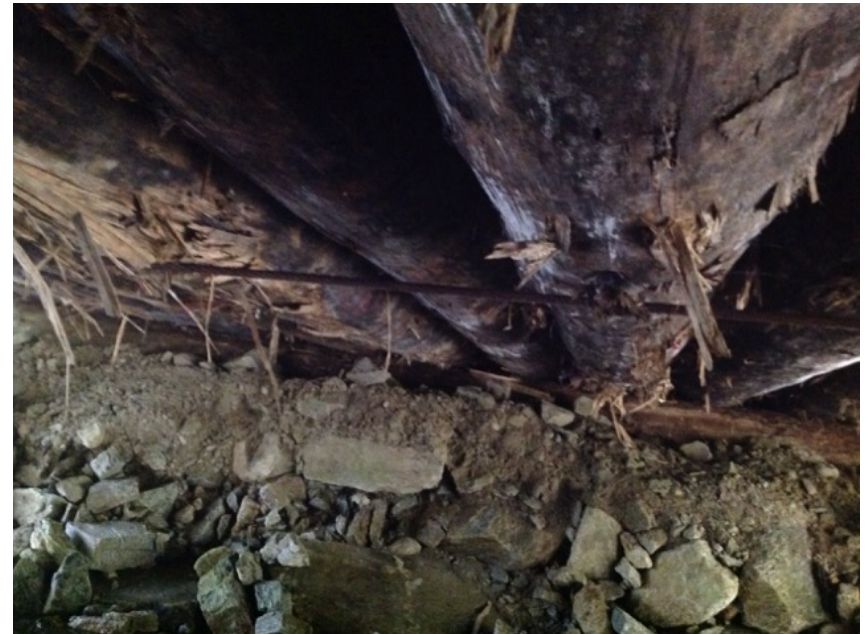
Stringers

| Hardware | Unrated | outside stringers not lashed to sill and can't tell if pinned - no movement apparent |

| Stringer<br>Number | Needle Beam to Crib (m) | | Diameter<br>(mm) | Needle Diameter (mm) | | |
|---|---|---|---|---|---|---|
| 1 | Fd | Y | 630 | | Fair | mycellium |
| 2 | Fd | Y | 550 | | Fair | mycellium |
| 10 | Fd | Y | 510 | | Fair | mycellium |
| 11 | Fd | Y | 530 | | Fair | mycellium |
| 12 | Fd | Y | 540 | | Fair | mycellium |
