CK-2502

CHEHALIS-FLEETWOOD 7km

2016 Inspection

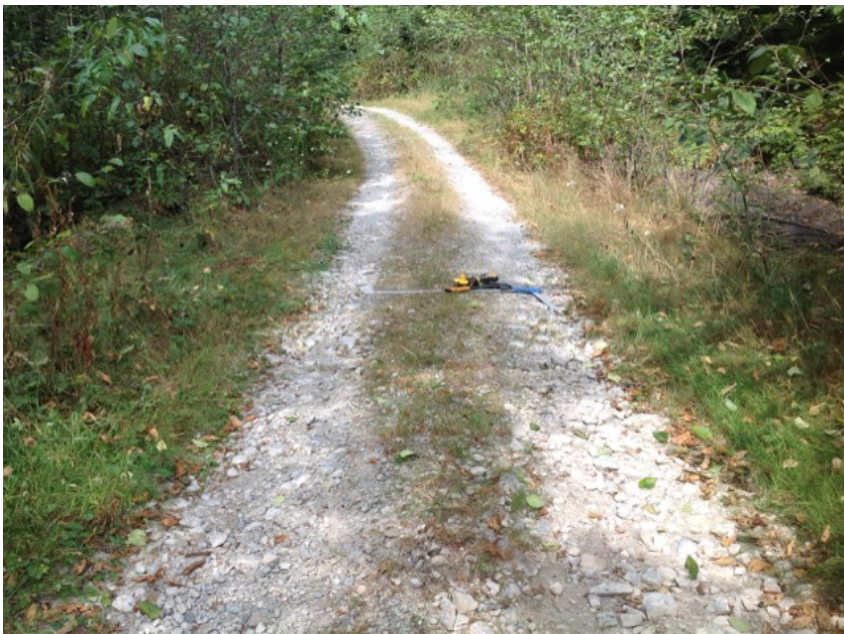
| Curb Rail/Blocks/Posts | Poor | too low at downstream |
| Overall Deck Condition | Poor | due to downstream rail |

| 2 | Medium | post bridge ahead signs, place curb logs and replace missing delineators |

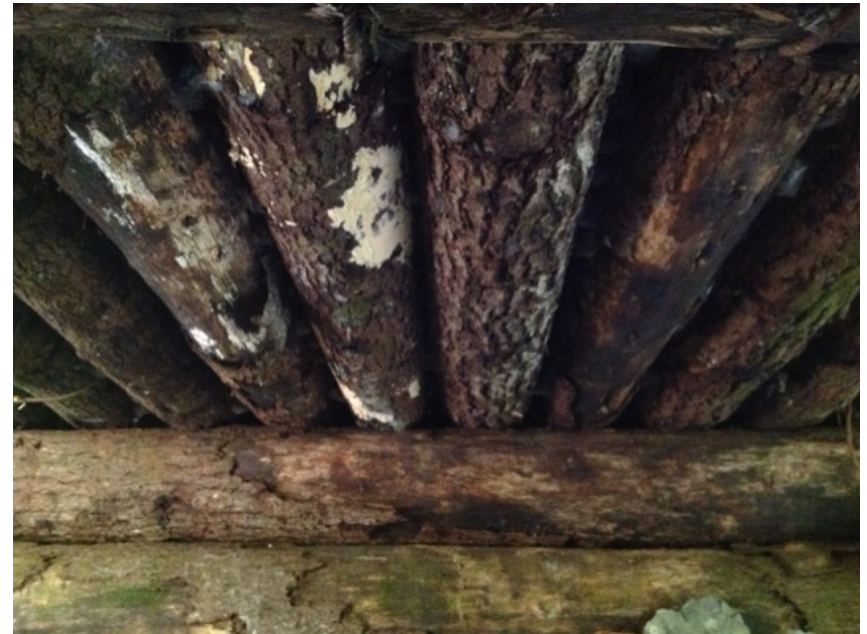
Stringers

| 5 | Fd | N | 530 | 30 | Fair | mycellium growth |
| 7 | Fd | N | 600 | 50 | Fair | pocket rot detected |
