CK-2504

Chehalis-Maisal 5.3km

2016 Inspection

| Structure Class | Temporary Bridge |

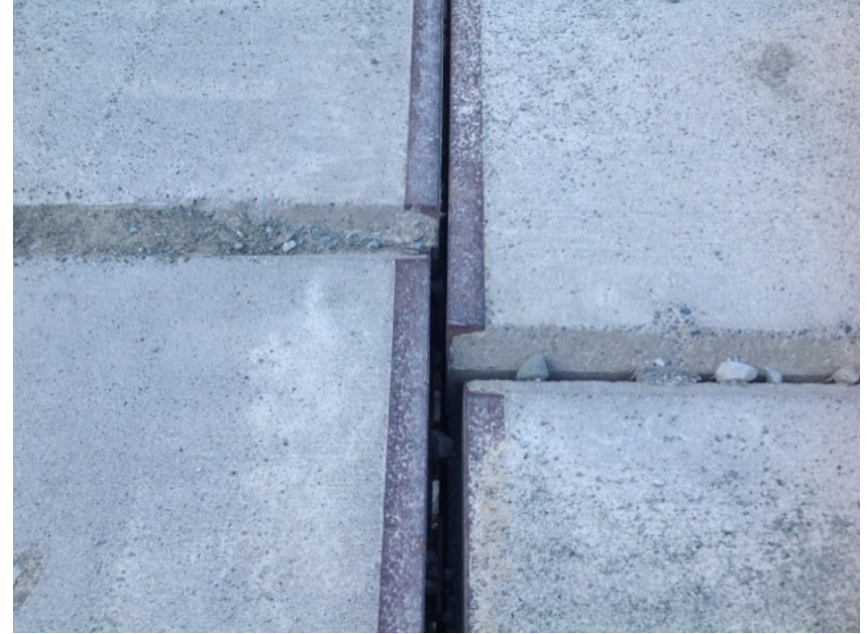
some panels different length

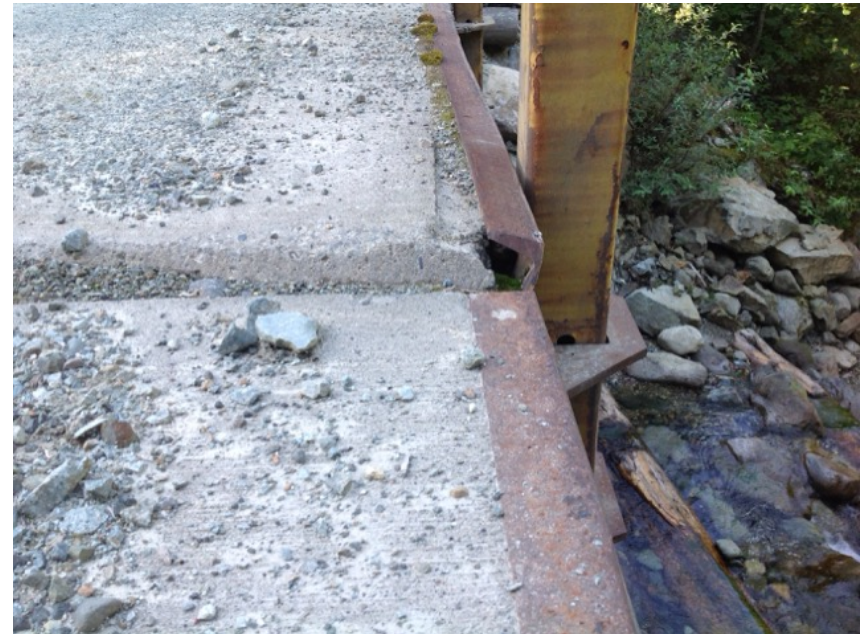
minor damage to panel

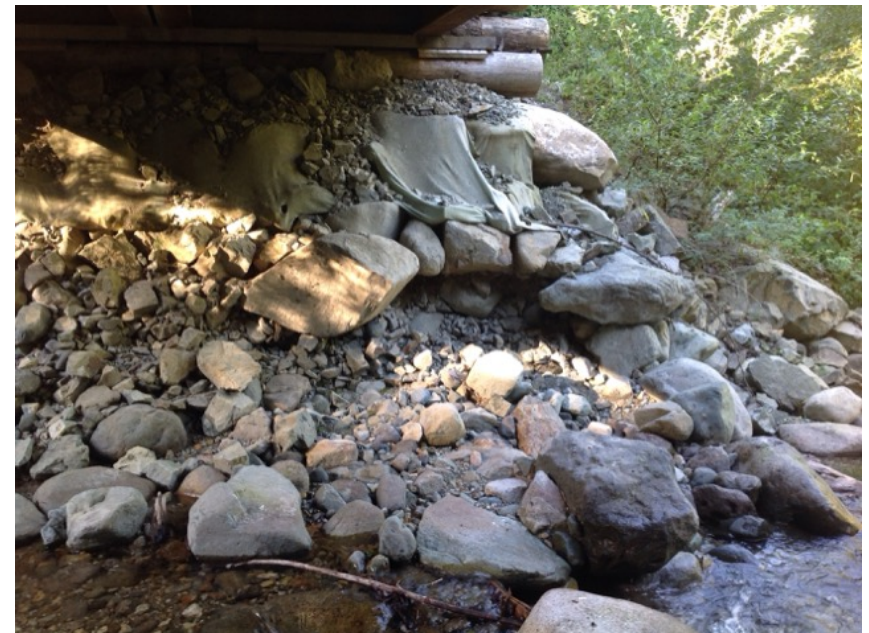
Riprap Fair fair to pour as scour is evident - structure was installed as a temporary structure

downstream left bank riprap scour

Repair eroded riprap on the downstream left abutment prior to industrial activity. Monitor the timber cap condition on top of the log sills. Considering this install was originally planned for 5 years or less (installed in 2013) consider deactivating the structure. Reduce loading to 40 tonnes until the riprap and bearing material have been replaced/stabilized. Replace missing delineator.

| Repair Item | Priority | Repair Description |
|---|---|---|
| 1 | High | repair scoured riprap on left abutment |

| Item | Monitor Description | Frequency |
|---|---|---|
| 1 | riprap scour | Anually |

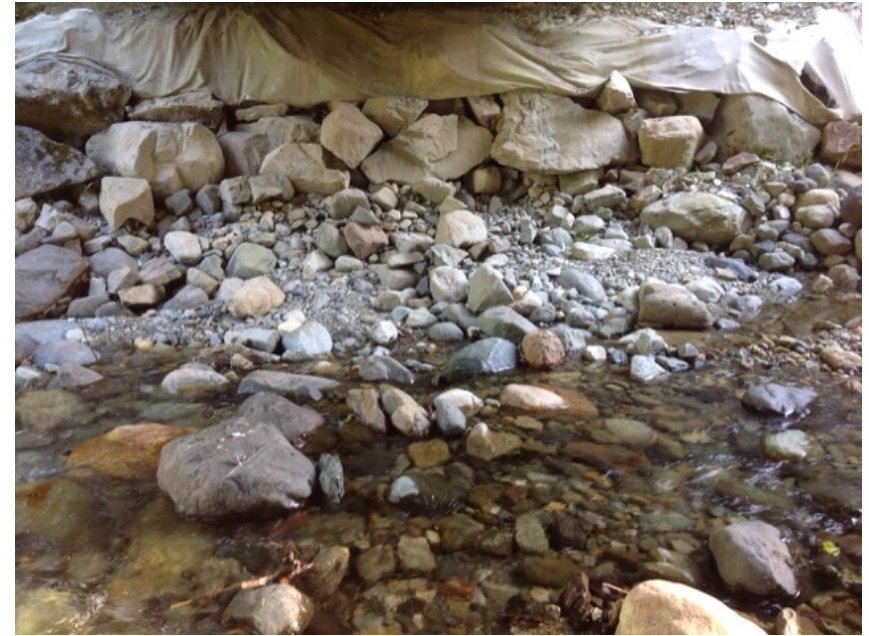
stream bottom approx 1.0m below bottom riprap elevation

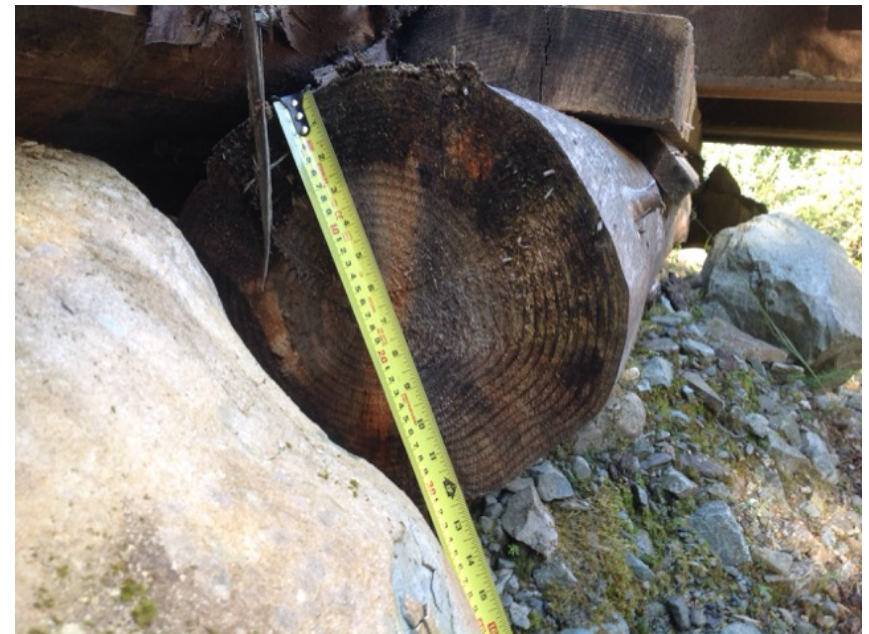
upstream log sill diameter

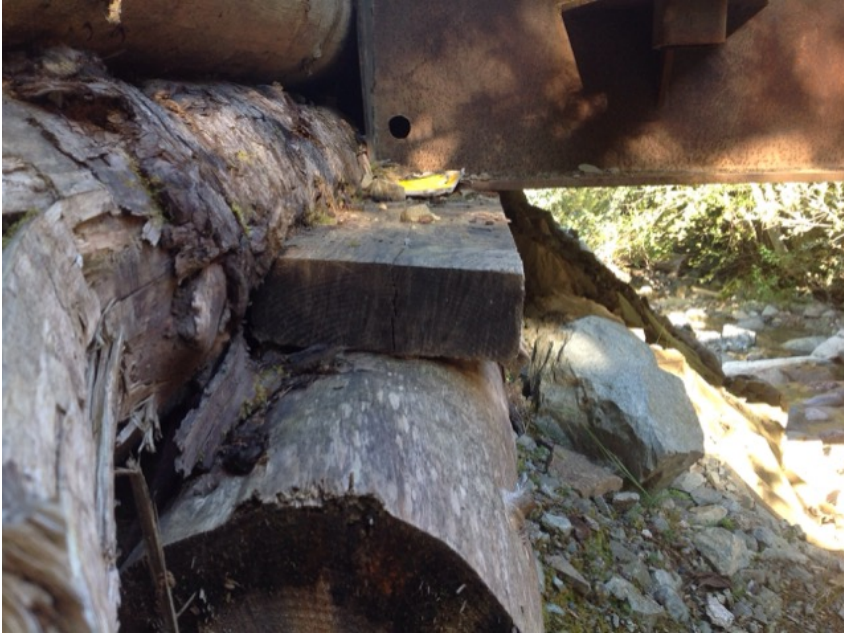
Caps or Sills Fair timber starting to crack

Bearings Fair monitor timber cap

100mm x 300mm timber nailed to log sill for bearing - both banks

| Item | Monitor Description | Frequency |
|---|---|---|
| 2 | timber cap condition | Anually |

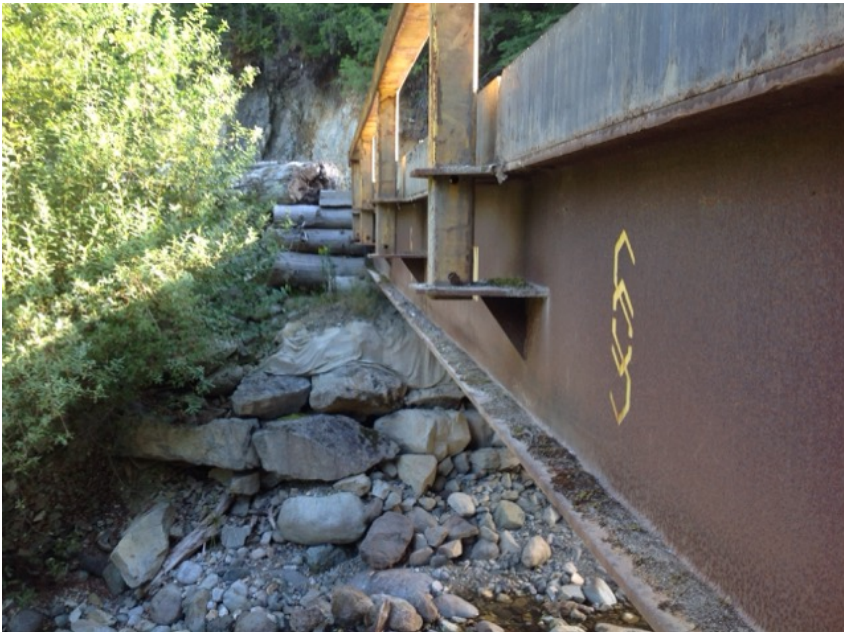
Hardware Fair rail connection missing bolts

Curb Rail/Blocks/Posts Fair loose rail connection

rail connection - slides down through steel plates
