CK-2505

MURDO SIXTEEN 0.4km

2016 Inspection

| Structure Class | Woodbox/Log Culvert | | |

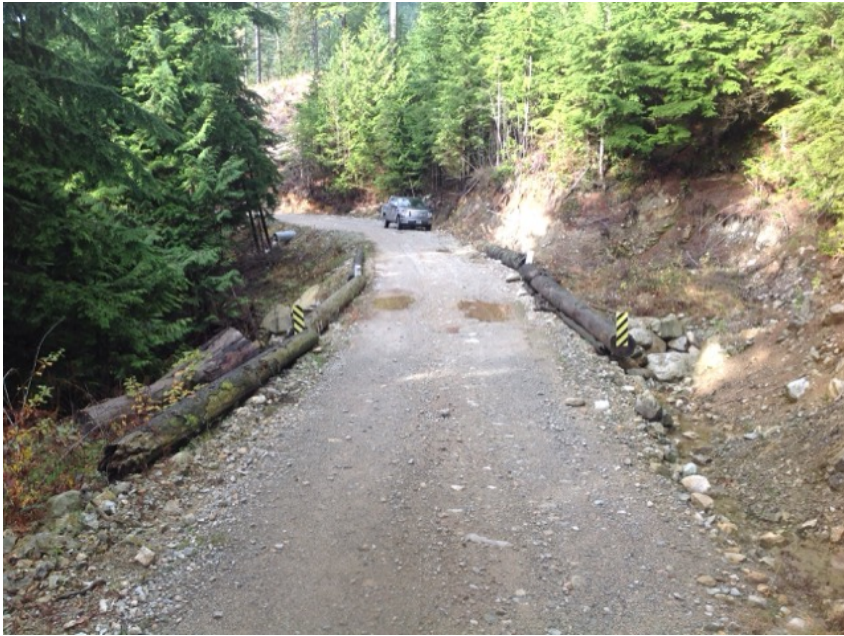
Approach from Left Bank when facing downstream

missing left upstream approach

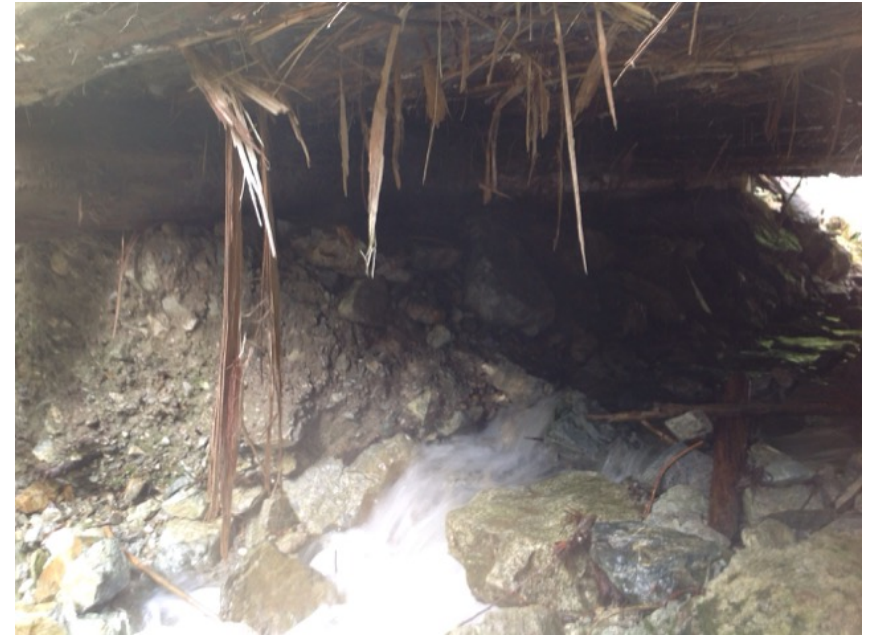
Right Bank Abutment when facing downstream

scoured and incomplete bearing

eroding under sill

| 1 | High | remove or repair structure |

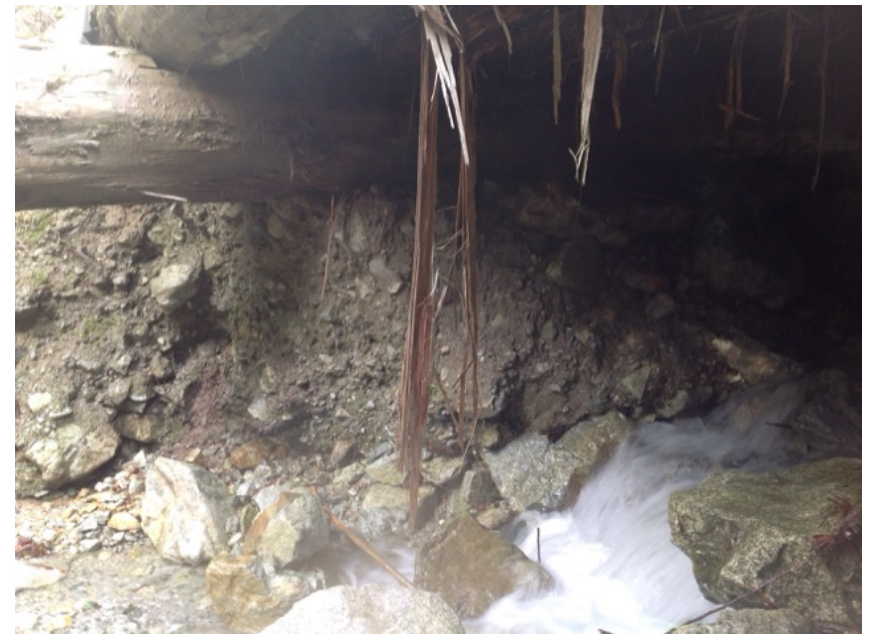
incomplete bearing under both log sills  
the high flows are eroding material under each sill  
remove or repair and block access ASAP

Comments    The material under both log sills has further scoured putting users at risk. Deactivate or repair ASAP.

right bank abutment erosion

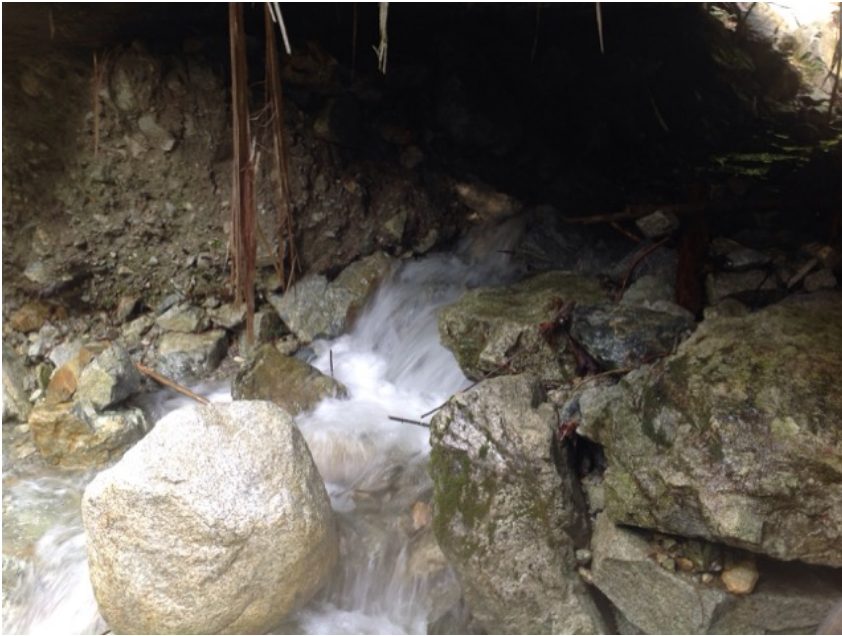
eroding

stream erosion is leading to abutment erosion

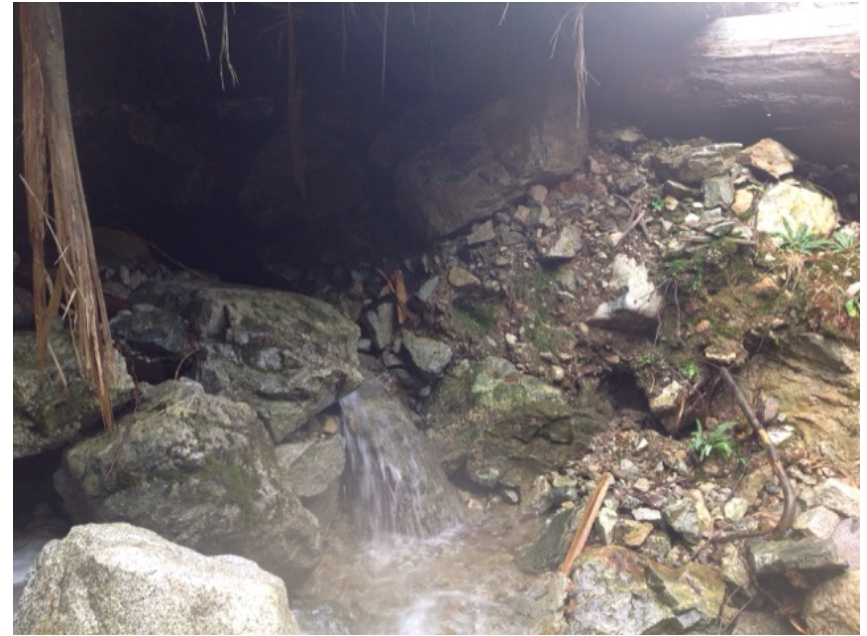
stream erosion leading to abutment erosion
