CK-2506

Chehalis-Alf 0.2km

2016 Inspection

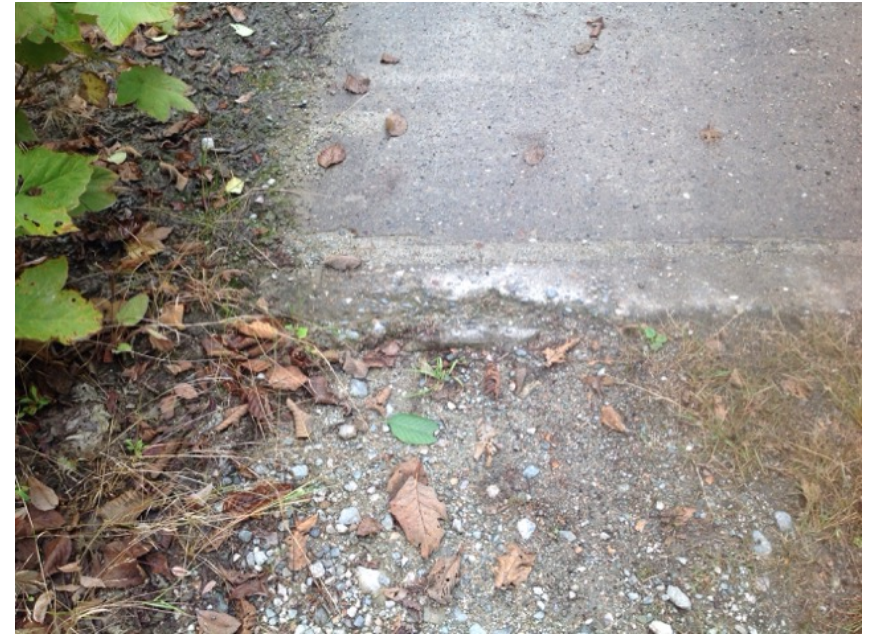
some damage noted on left bank wall

damage to left bank ballast wall

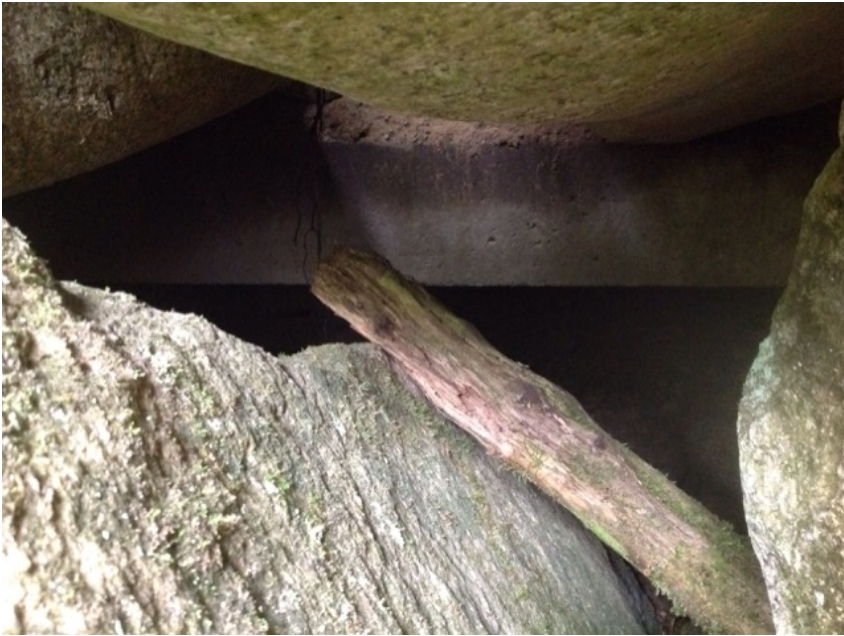
The right downstream precast footing is still undermined and subject to further erosion. The upstream footing is exposed and subject to erosion. The riprap is all rounded and not well graded or tied together which will lead to further erosion. The guardrail is rotten; there are missing bracing bolts; and the road is brushed in. I recommend a complete replacement for long term use. The present load rating of 40 tonnes to continue.

due to undermined precast footing

right bank downstream precast footing undermined -approx 400mm

| 1 | High | repair undermined precast footing at right downstream |

1 right downstream footing scour

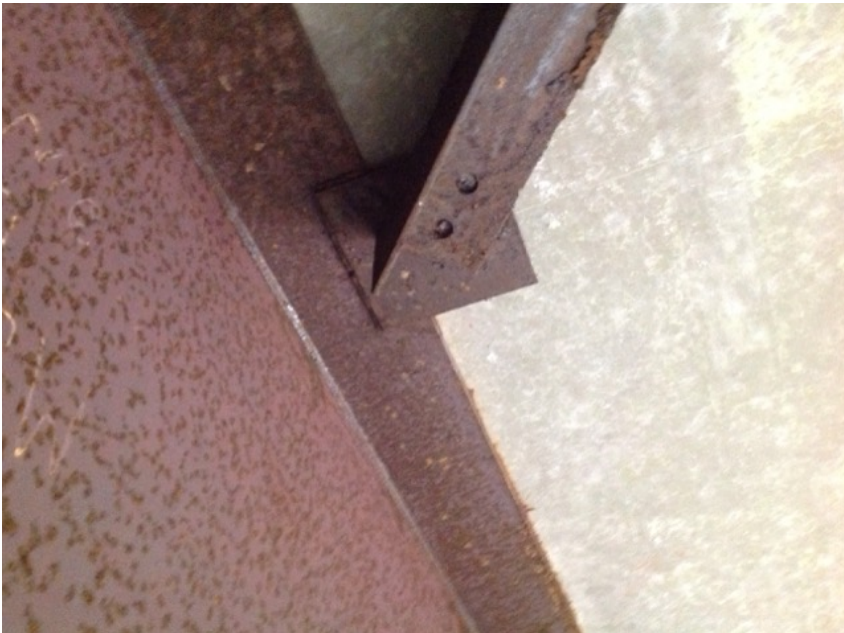
Hardware Poor missing bracing bolts

missing bracing bolts
