CK-2509

CHEHALIS-STATLU 11.2km

2016 Inspection

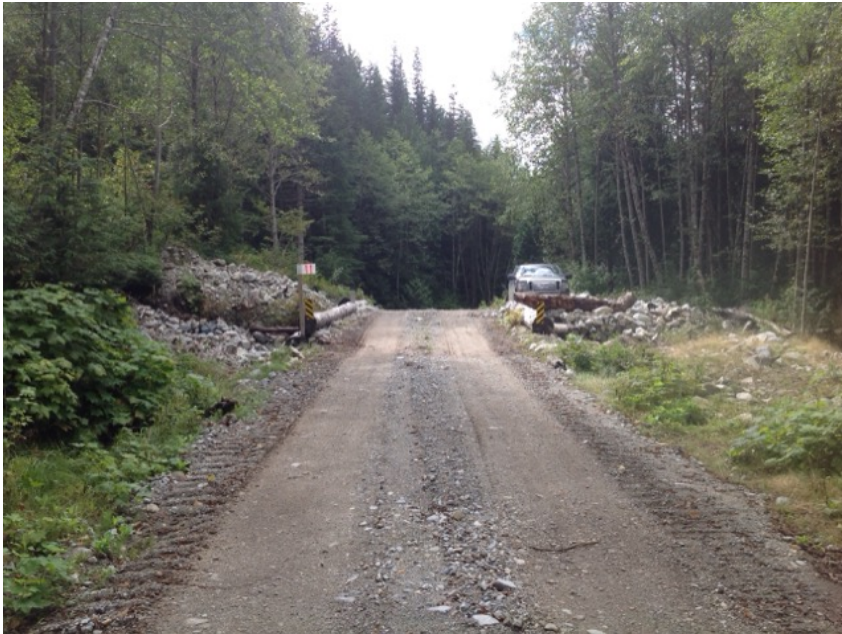
Approach from Right Bank when facing downstream

missing right approach

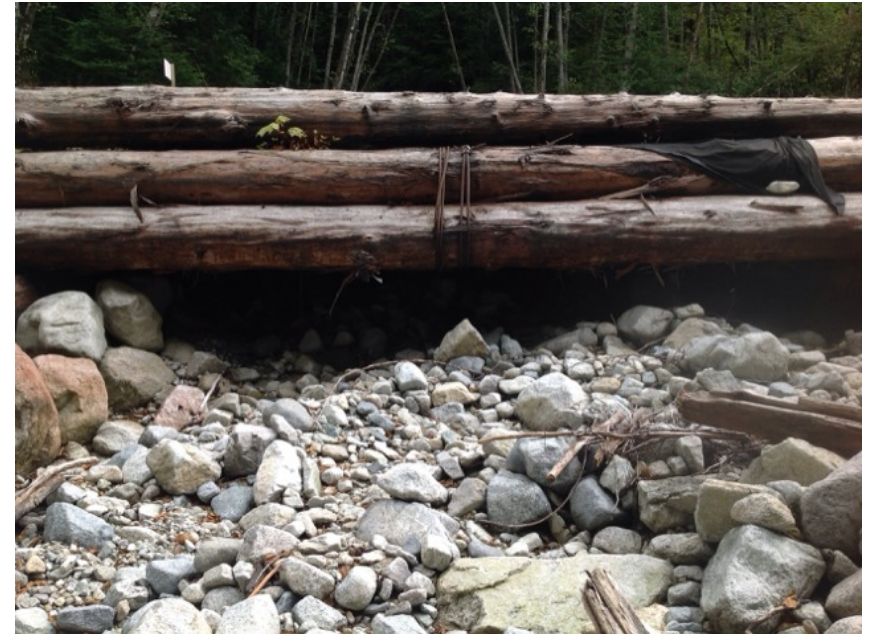
Outlet

log sill scouring downstream left bank

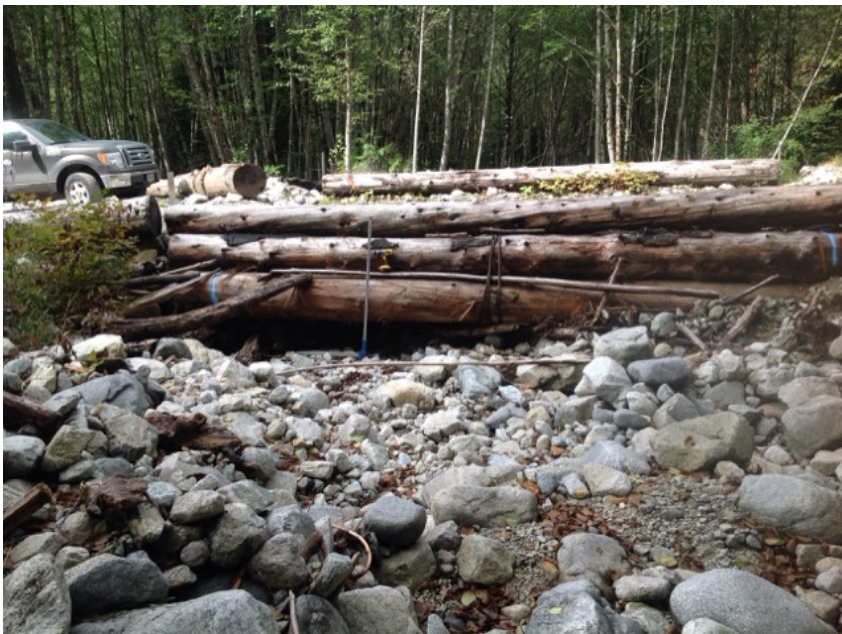
Inlet

Stingers not fully assessed due to aggrading inlet. Dig out inlet to allow flows to pass under the structure and fully assess stingers at that time. Limit loading to BCL-625 or 63 tonnes until such time. Post load rating sign, bridge ahead signs and place fenders. Monitor for aggradation and if stream non fish bearing consider removing and replacing with a ford.

| Repair Item | Priority | Repair Description |
|---|---|---|
| 1 | High | dig out inlet to allow flows to pass |

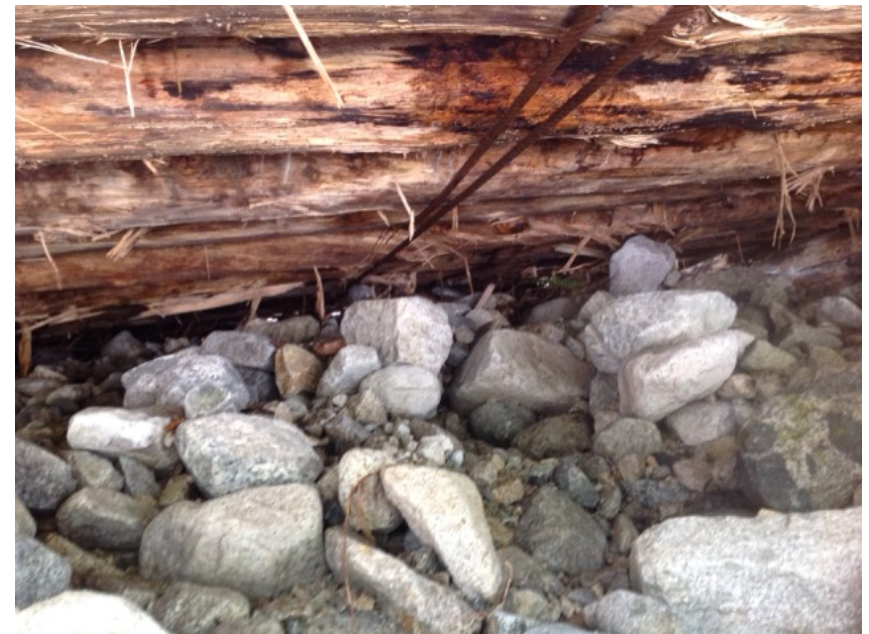
looking through from outlet

Comments cannot properly assess log stringers - appear in good to fair condition  
6.8m span downstream  
if not fish bearing build modified ford
