CK-2511

CHEHALIS-BOULDER 3km

2016 Inspection

| Crossing Name | Boulder Creek |

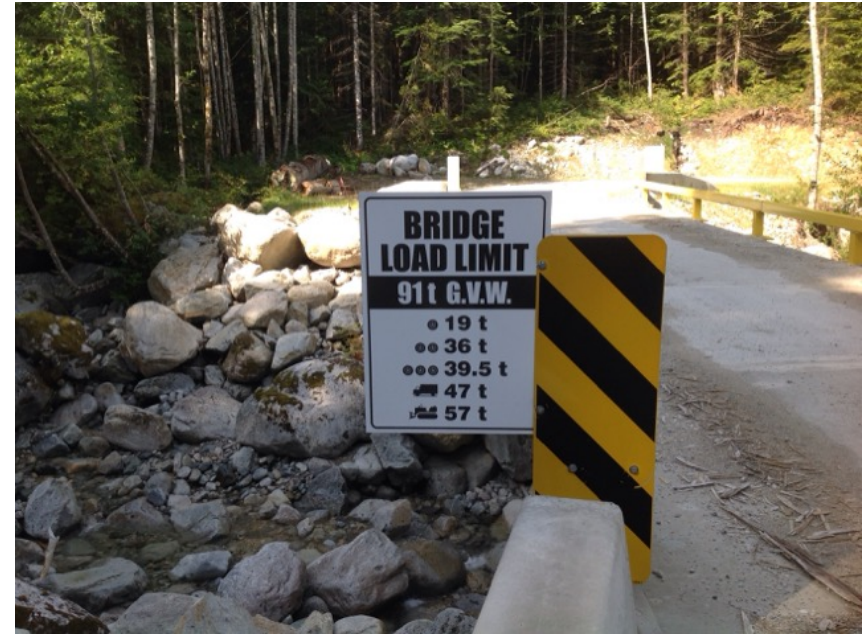
Posted Load Rating 91 new sign with multiple restrictions

load rating sign

Monitor the bearing plate deformation and the riprap stability. The record drawing indicates L100 or 91 tonnes load rating, please send the Crossing Assurance Statement for confirmation.

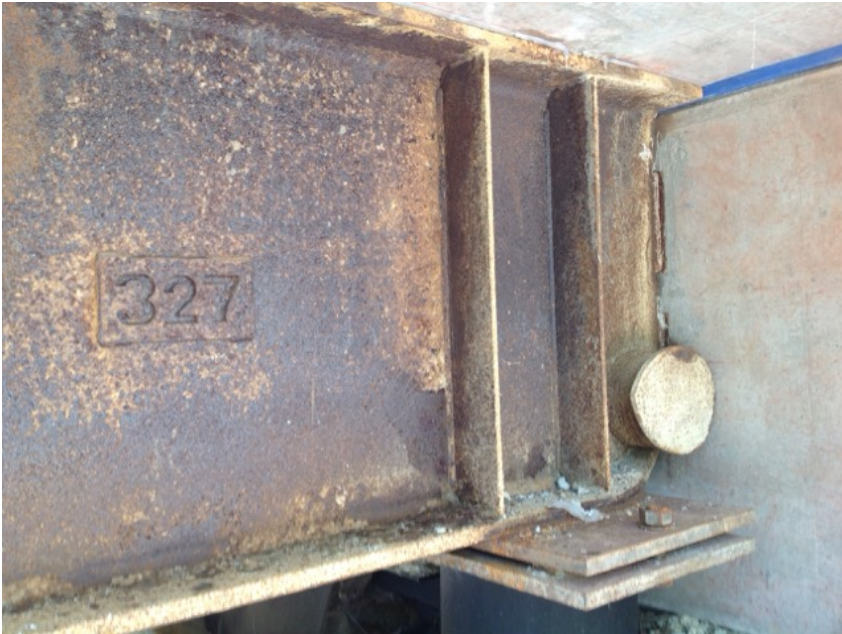
Girders Fair recycled - approx 2240mm center to center

recycled steel girders

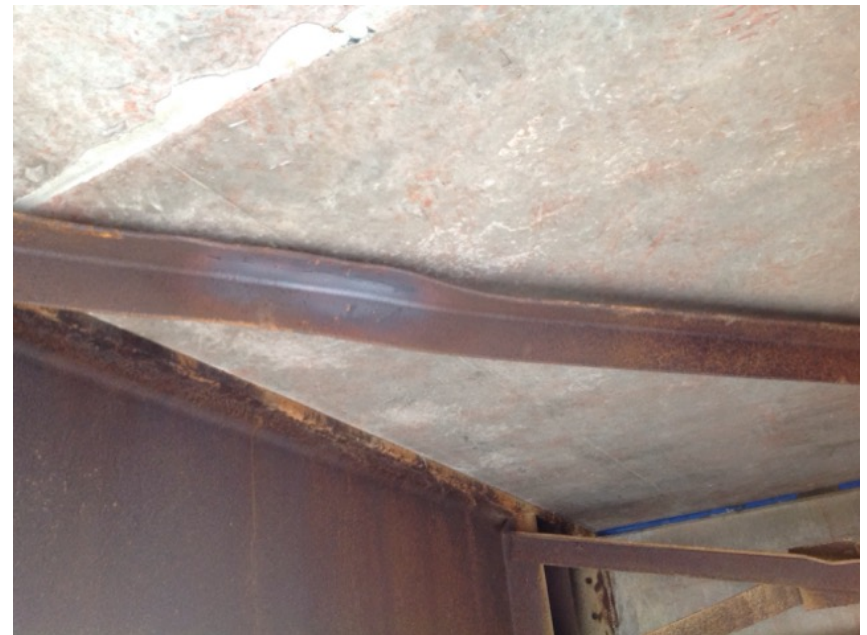
Bracing Fair

minor bracing damage

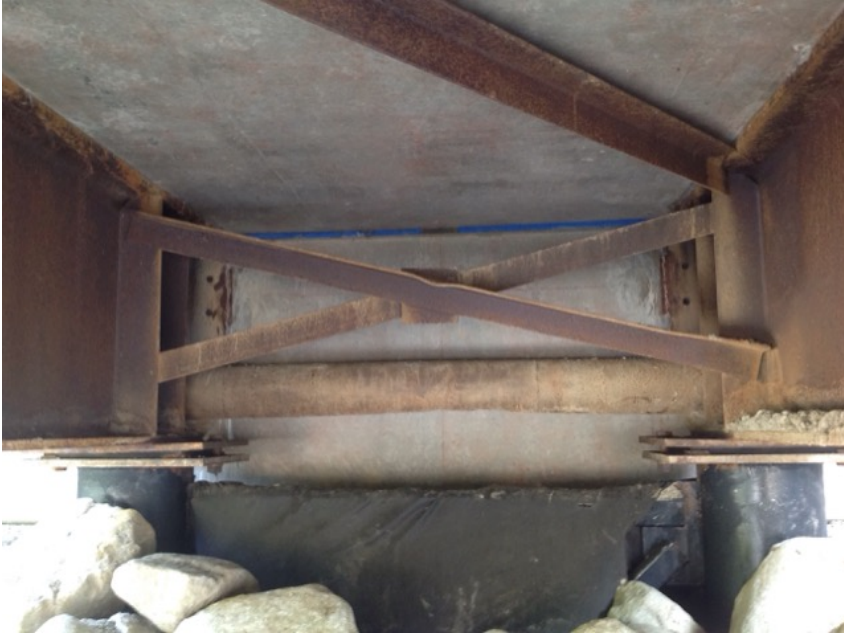
Diaphragms Fair

minor diaphragm damage

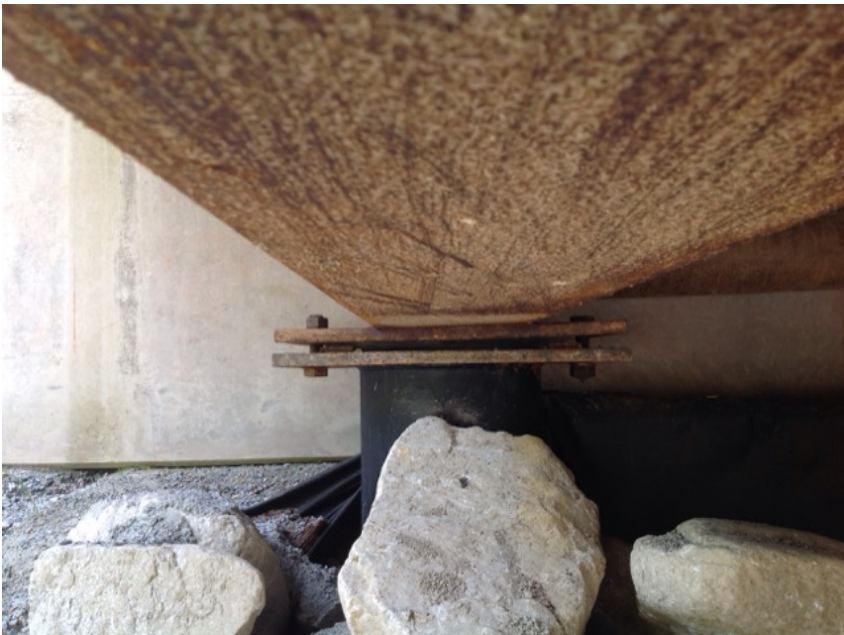
Caps or Sills Fair recycled plates - slightly deformed on 3 of 4

Bearings Fair

bearing plates slightly deformed on right bank and downstream left bank

| Item | Monitor Description | Frequency |
|---|---|---|
| 1 | bearing plates | Anually |
