CK-2524

BIG SILVER 0.3km

2016 Inspection

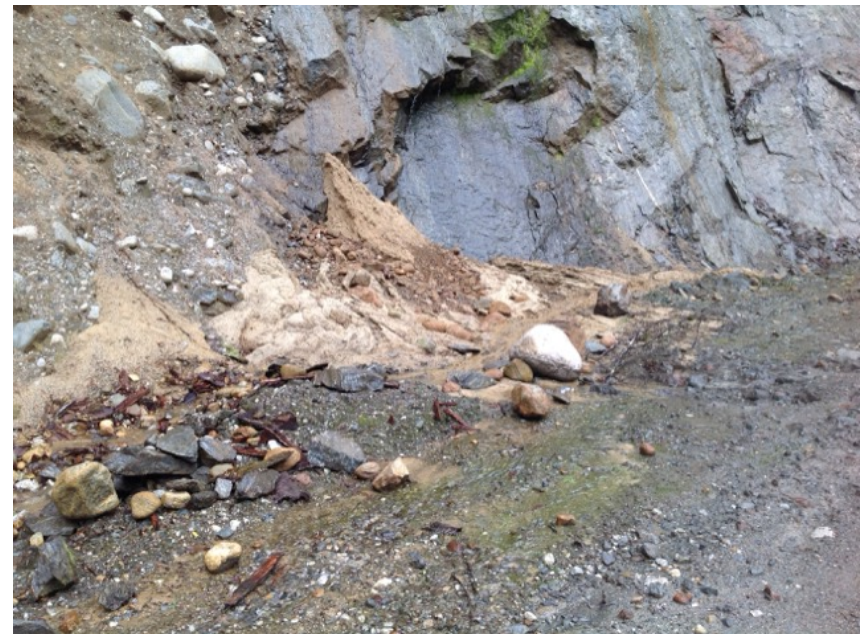
ditch plugged

Clean ditch at right approach and monitor crib where tieback has sheared. Inspect again next year. Present load rating of L100 or 91 tonnes to continue.

| Repair Item | Priority | Repair Description |
|---|---|---|
| 1 | High | open up ditch at right approach prior to snow fall |

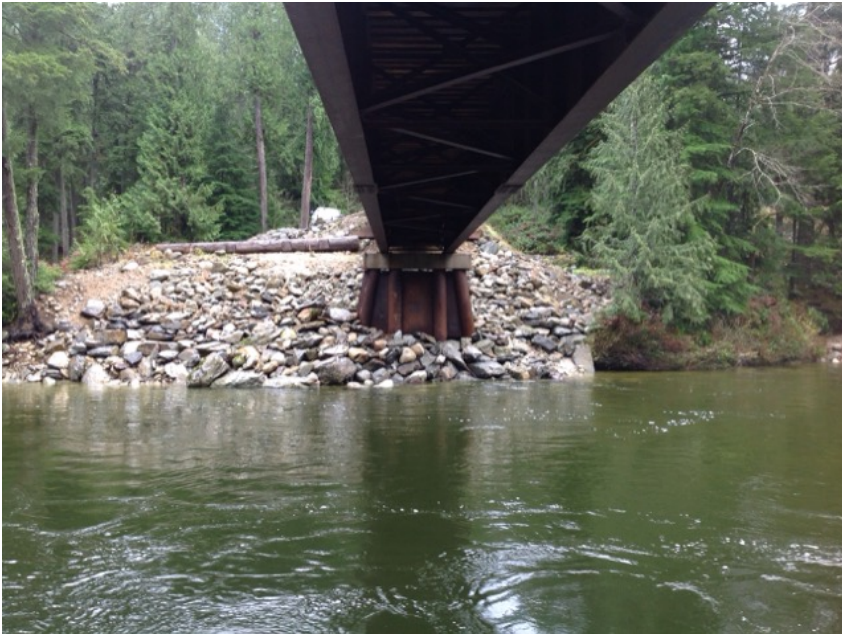
concrete cap on pier repaired

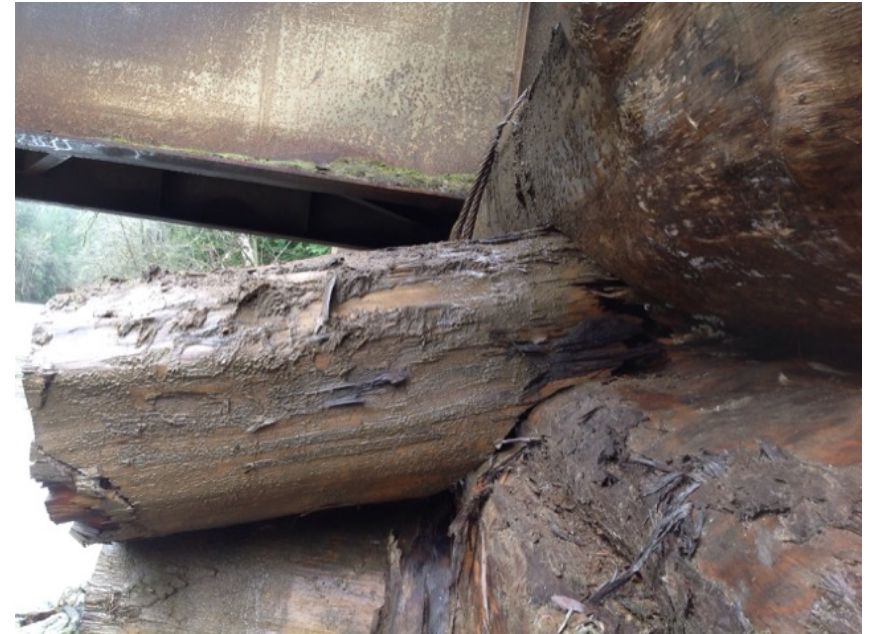
top tieback on right upstream bank sheared off

top tieback upstream right bank completely sheared off

| Item | Monitor Description | Frequency |
|---|---|---|
| 1 | top crib log for movement as tieback on right upstream has sheared off | Anually |

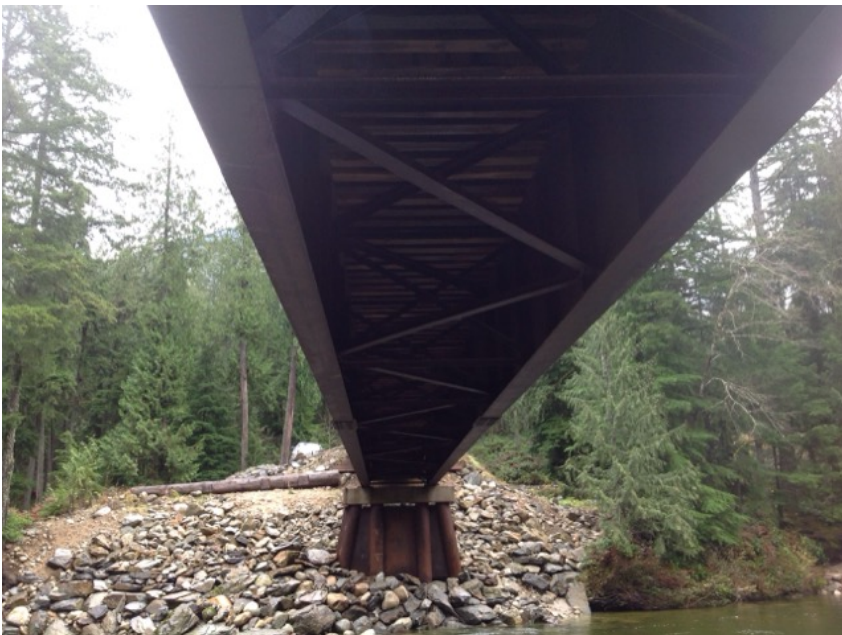
superstructure

Girders Fair good on jump span, fair on main span

Diaphragms Fair good on jump span, fair on main span

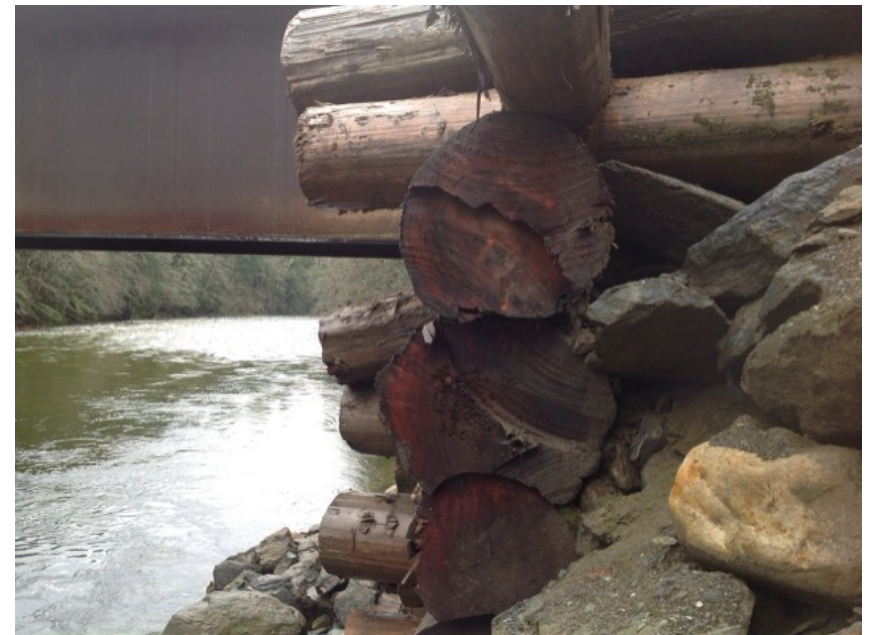
top crib log does not appear to have shifted - monitor

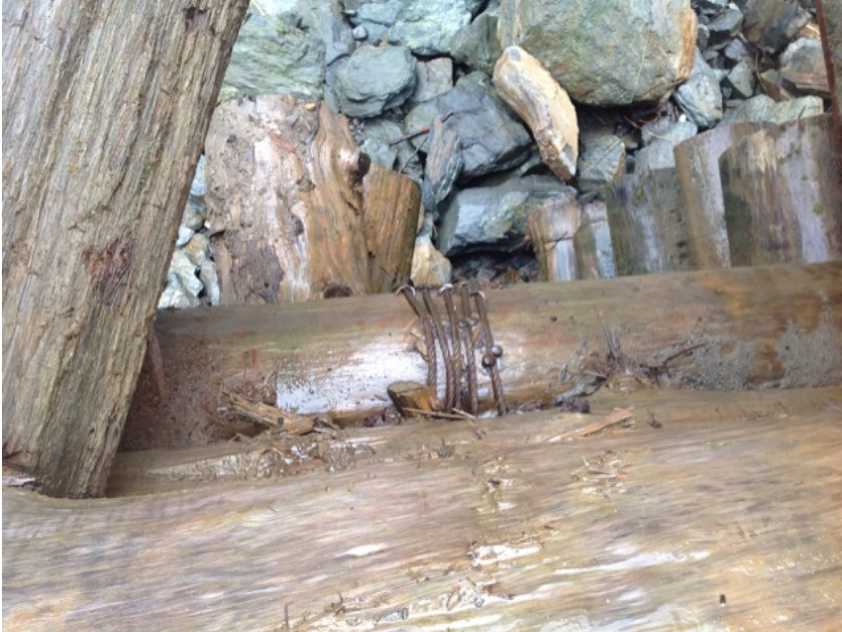
top crib log well lashed
