CK-2525

BIG SILVER 2.5km

2016 Inspection

| Crossing Name | Side Creek |

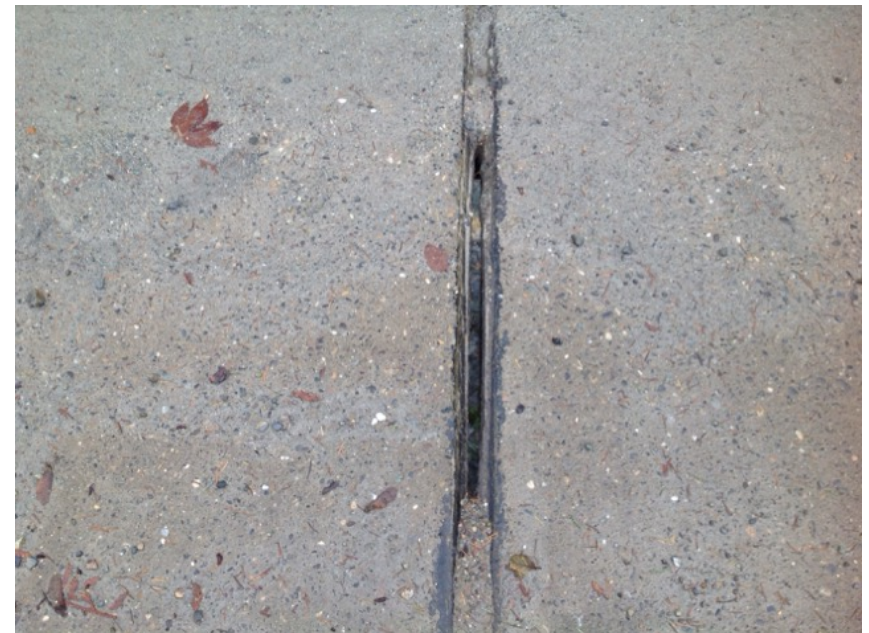
Deck Joints Fair deck seals missing in couple locations

deck seals missing in some locations

| 2 | Medium | replace missing deck joint seals |

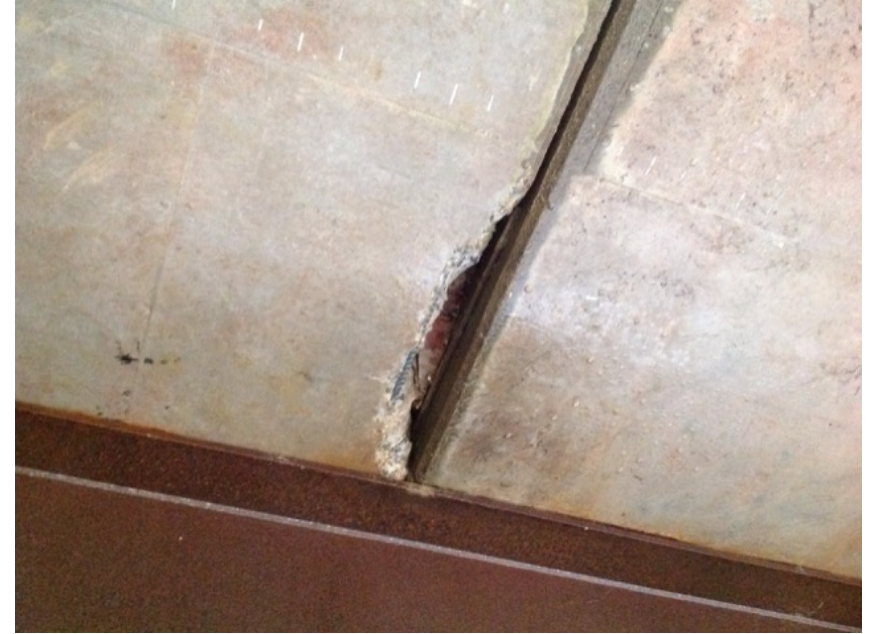
Concrete Deck Fair some damage to underside of 2 panels

deck panel damage and rebar exposed

| 1 | Medium | repair damaged panels |

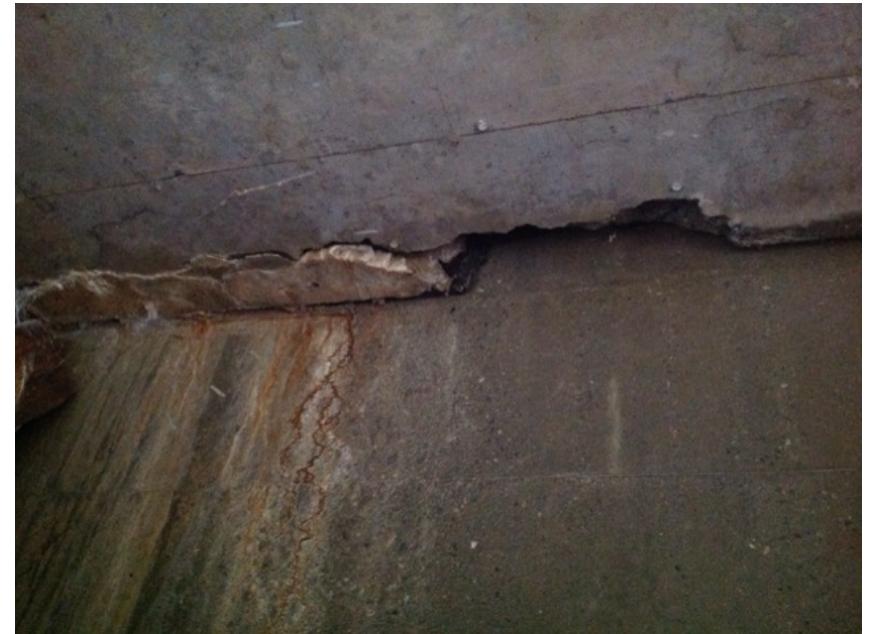
deck panel damage at right bank

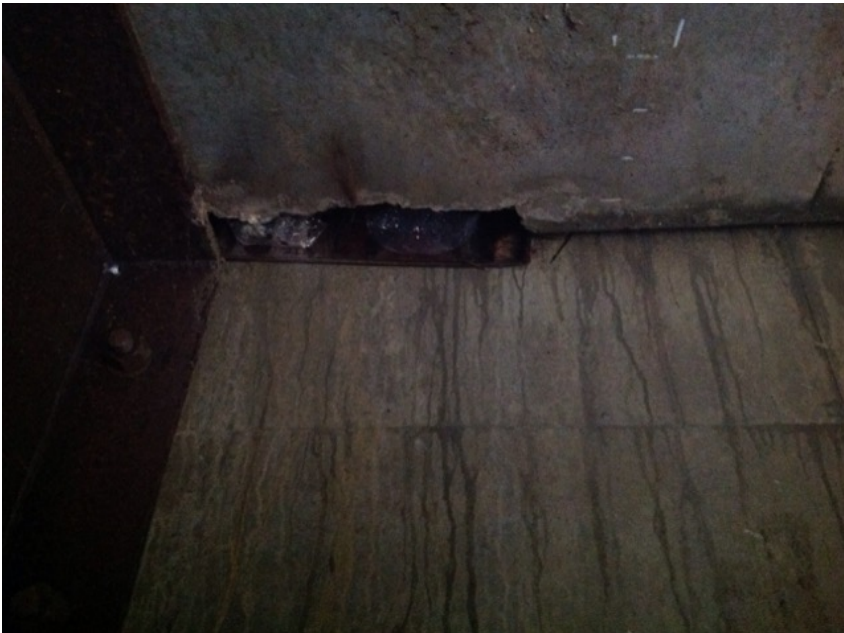
deck panel damage at left bank
