49km Harrison

Harrison East FSR 48.8km

2016 Inspection

| Structure Class | Major Culvert |

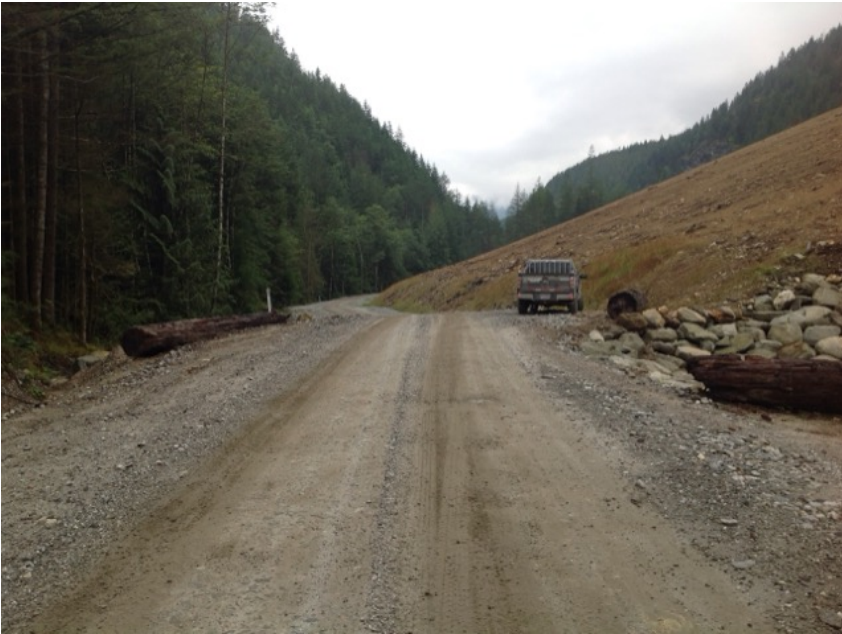
Approach from Left Bank when facing downstream

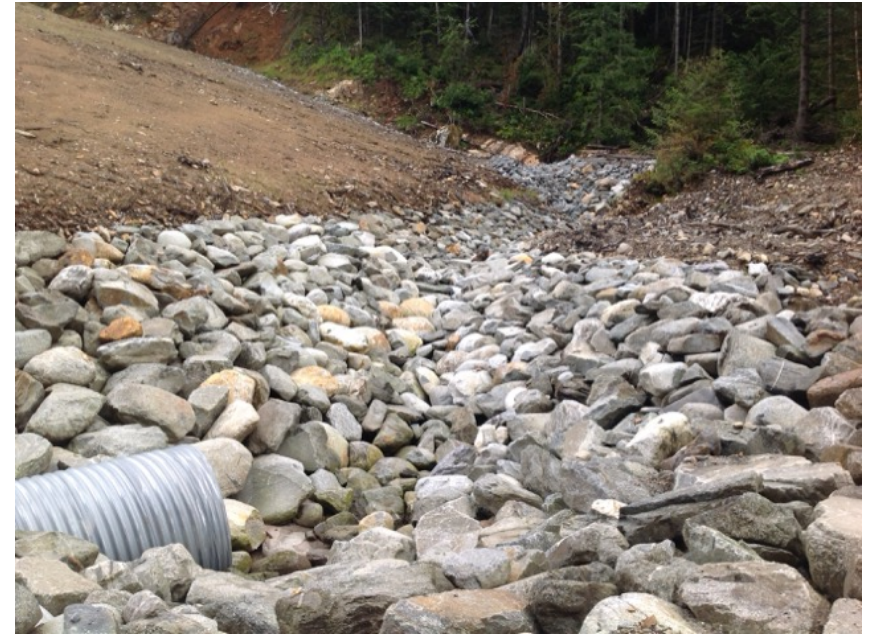
looking upstream from road surface

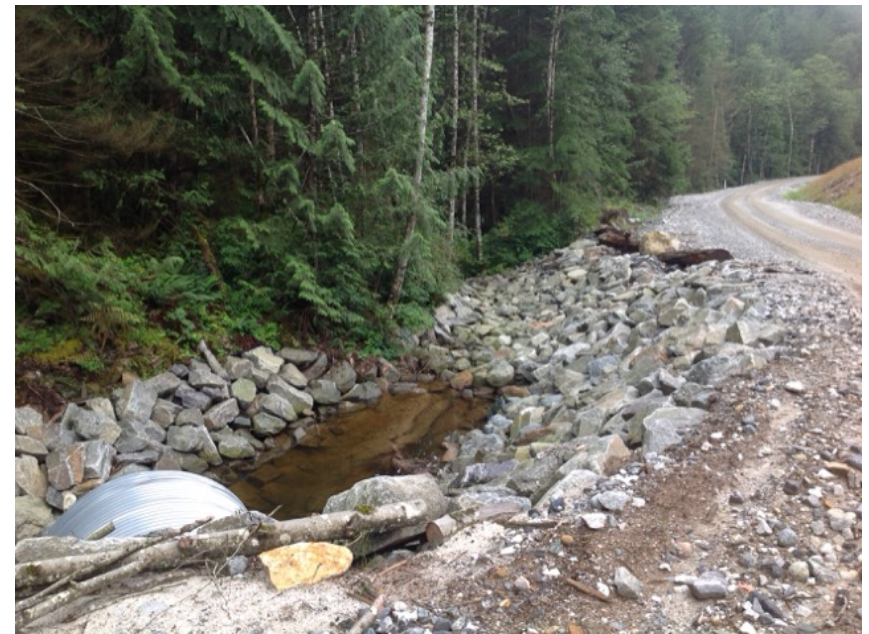
looking downstream from road surface

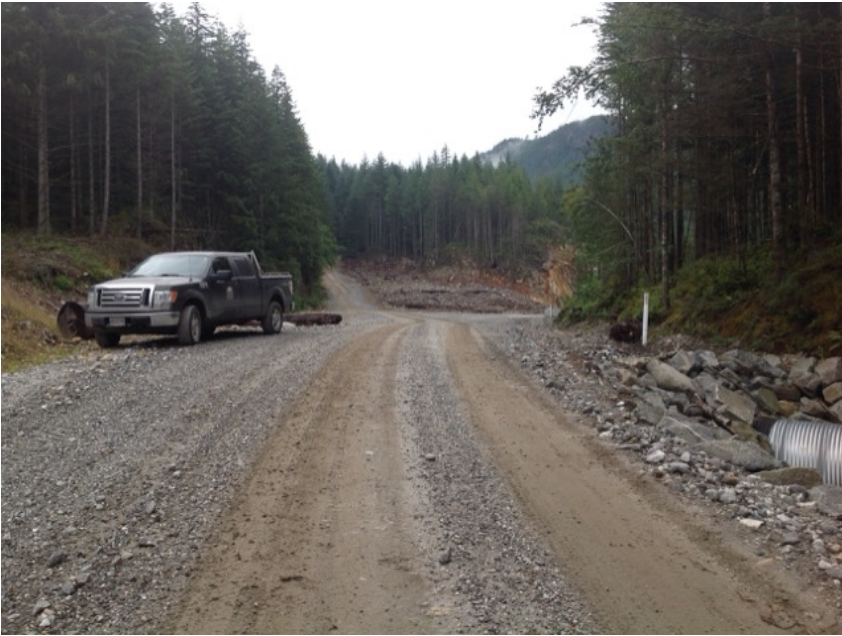
Approach from Right Bank when facing downstream

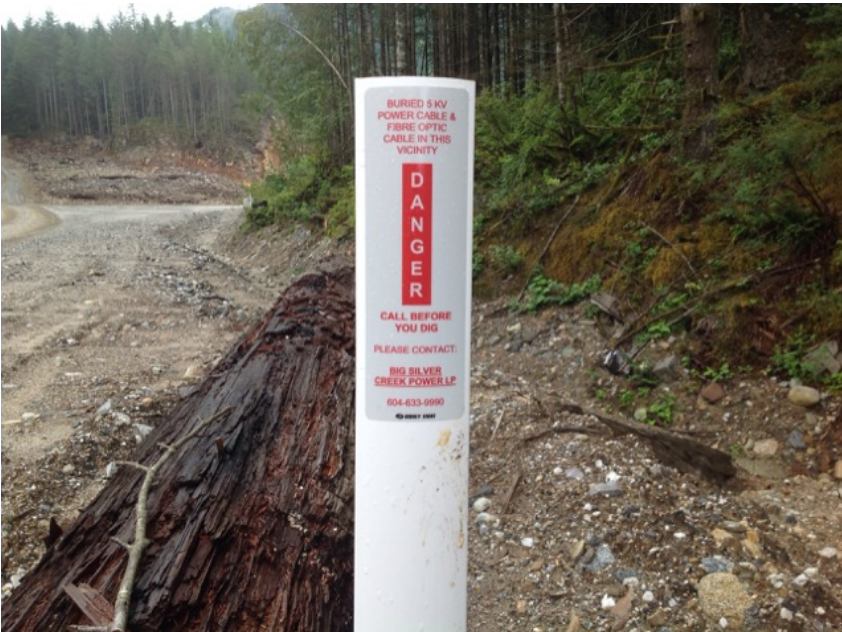
fibre optics line buried in road
