CK-2533

KAREN CREEK km

2016 Inspection

| Crossing Name | Dewdney Creek |

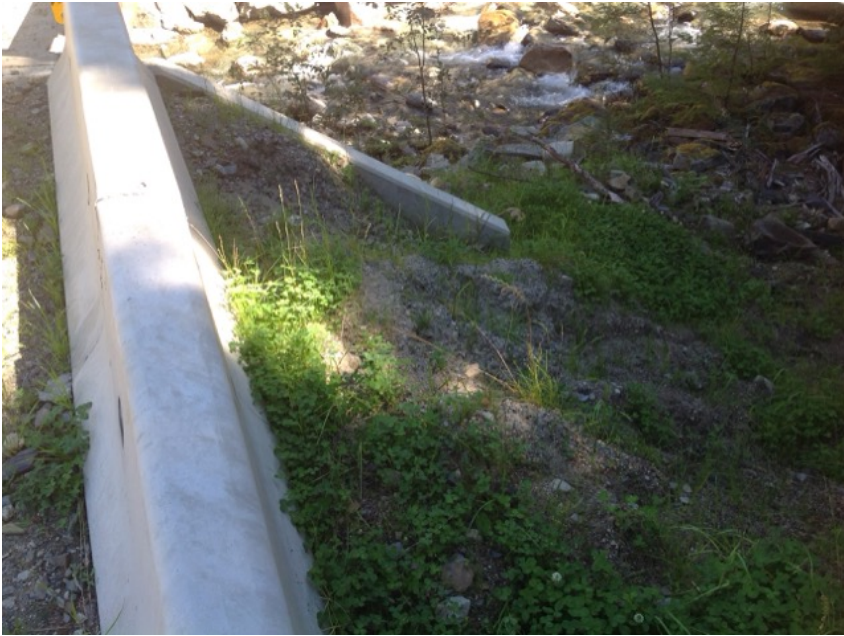
Fill Fair

let upstream fill erosion

Repair eroding fillslope at the upstream left bank. Present load rating of L100 or 91 tonnes to continue.

| Repair Item | Priority | Repair Description |
|---|---|---|
| 1 | Medium | add fill to upstream left bank while machines there |
