CK-2537

NORRISH WEST km

2016 Inspection

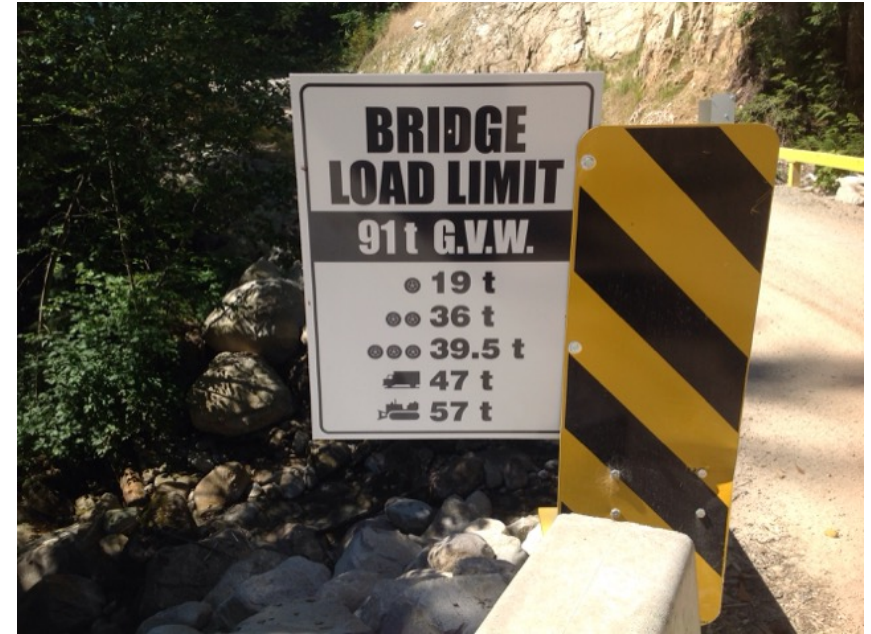
Posted Load Rating see picture

lad limit sign

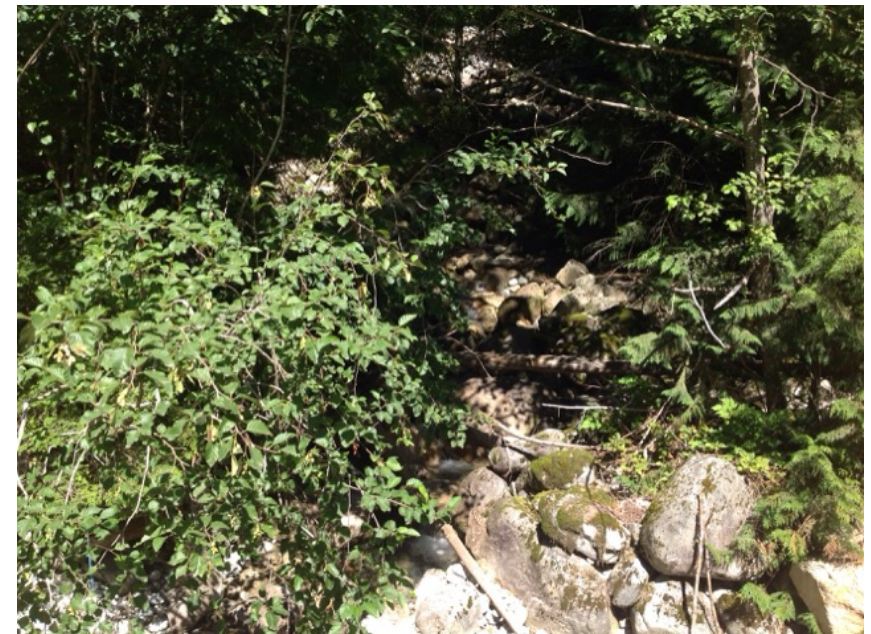
looking upstream from deck

| Comments | round riprap st 2:1 slope | | | | |

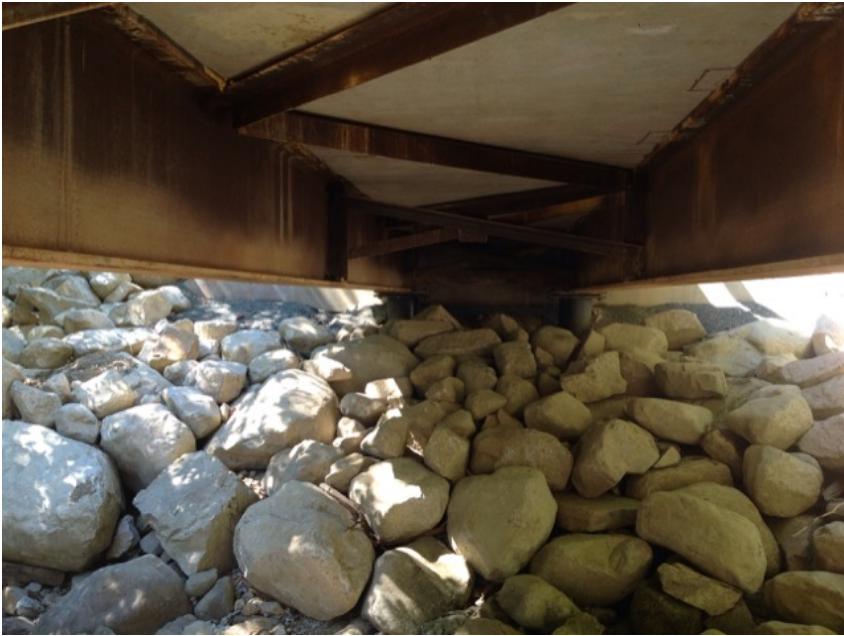
superstructure

Girders Fair girders 2.3m width apart

Diaphragms Fair 4 welded sets
