Squeah FSR 0.4km

2016 Inspection

| Structure Class | Major Culvert |

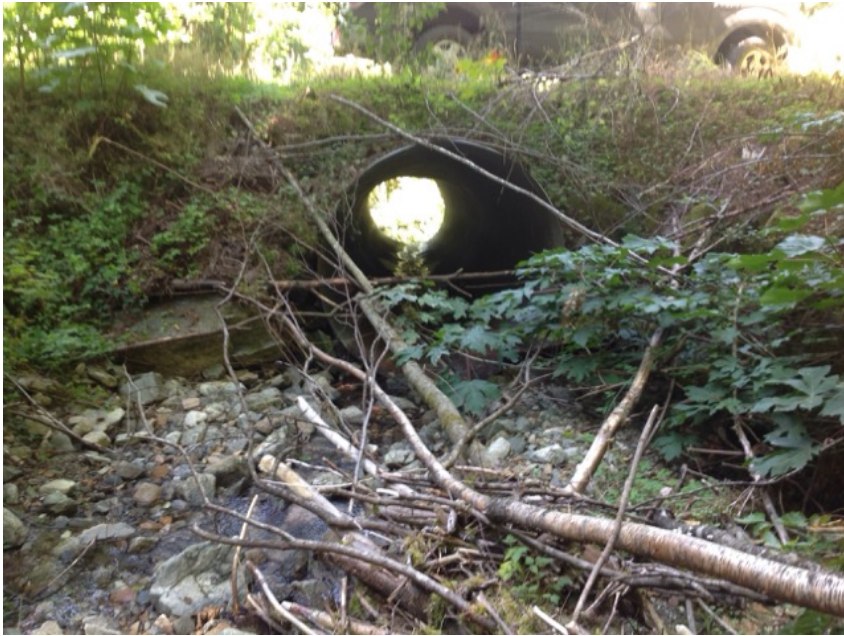
| Inlet | Fair | aggradation and debris accumulations |

| Estimated Present Water Level Width (m) | 1.0 | Aggradation | <input checked="" type="checkbox"/> | Scour | <input type="checkbox"/> |

No information on file with regards to this structure or install. Limit loading to BCL-625 or 63 tonnes load rating. Monitor debris accumulations and aggradation at the inlet.

| Item | Monitor Description | Frequency |
|---|---|---|
| 1 | aggradation and debris accumulations | Routine Inspection |

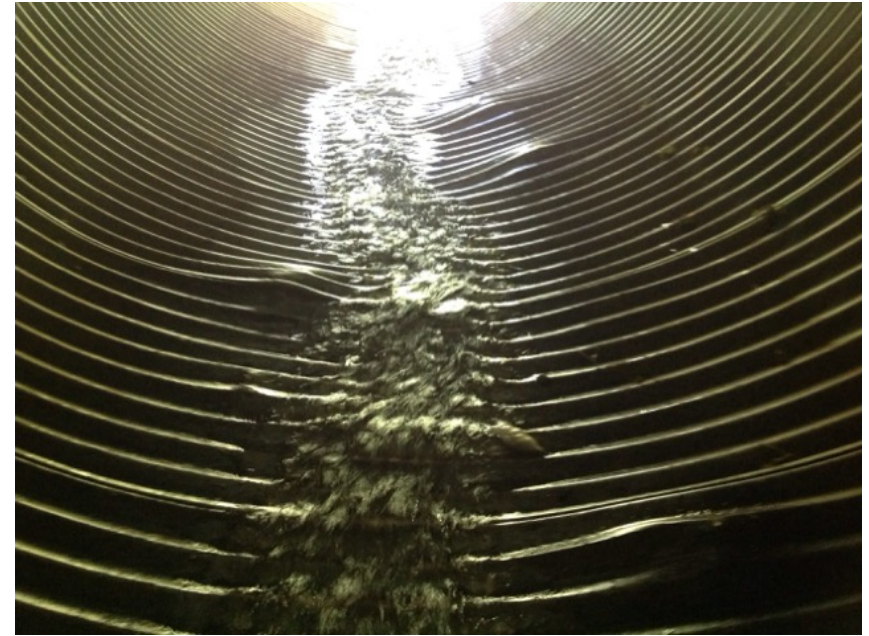
| Floor | Fair | some damage most likely from installation |

damage to floor

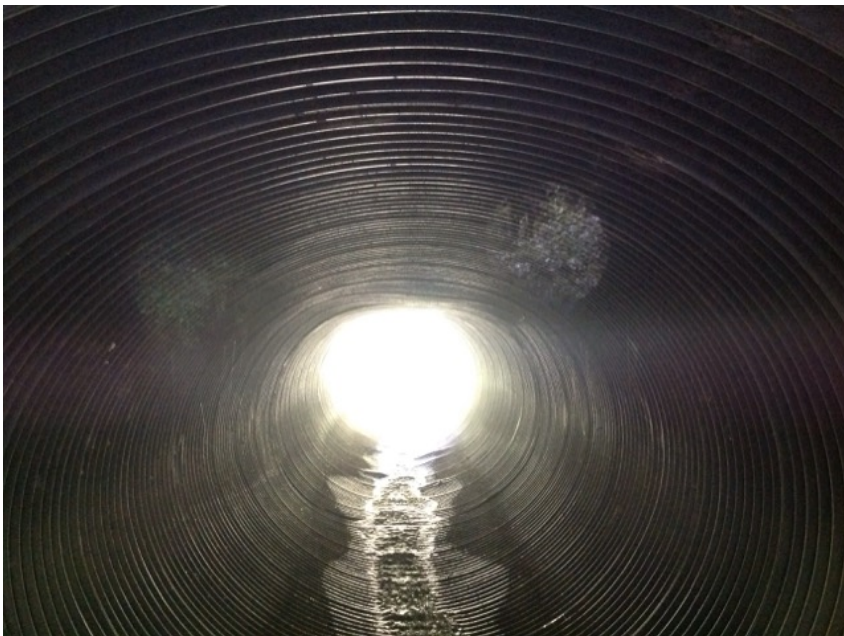
| Roof | Fair | some damage most likely from installation |

damage to roof

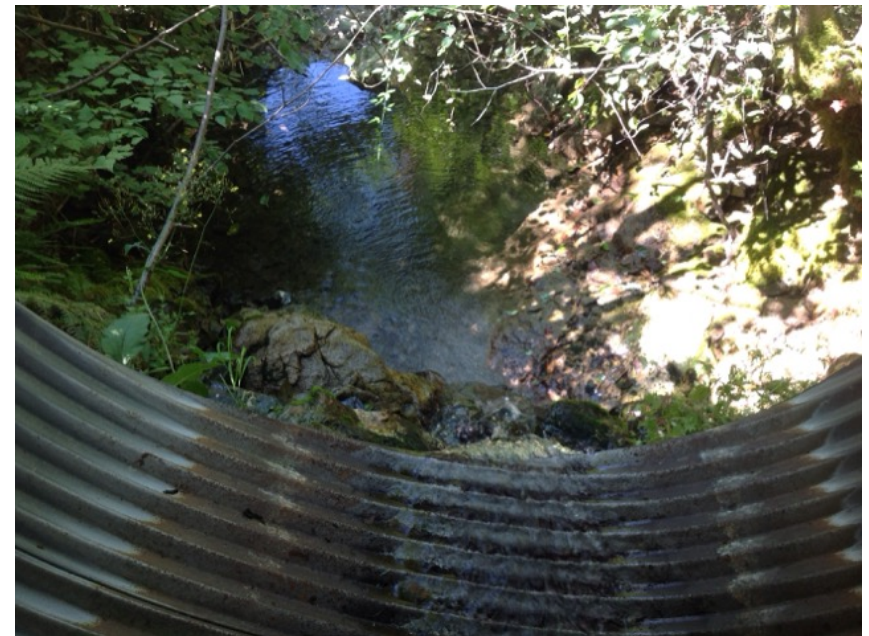
| Outlet | Fair | 2m drop but rock and bedrock noted - stable |

2.0m drop at outlet
