CK2477

NAHATLATCH 39.8km

2016 Inspection

| Crossing Name | Nahatlatch Creek |

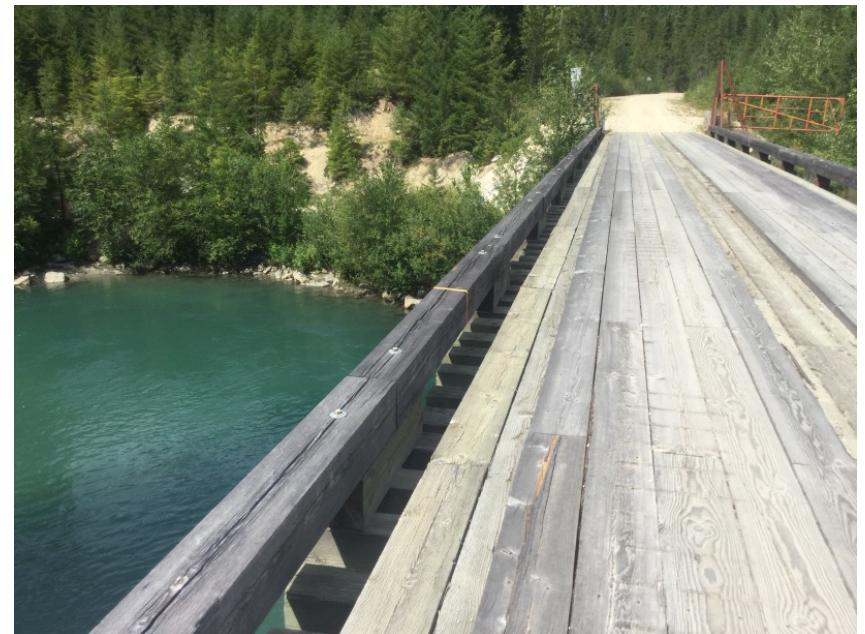
Guard Rail

| Curb Rail/Blocks/Posts | Good | Weathering and checking of guardrail, some sections slightly loose. |

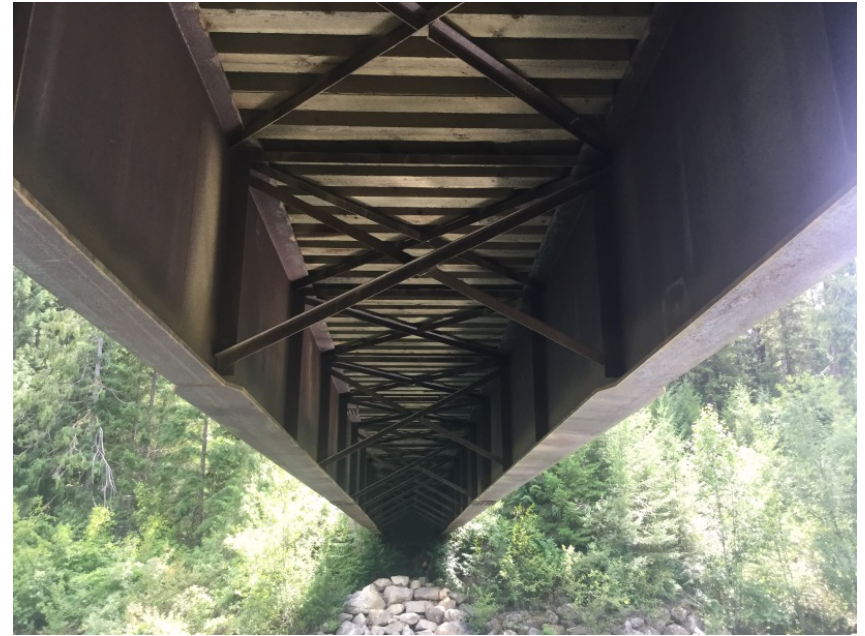
Girders Good

Girders cantilever over steel posts.

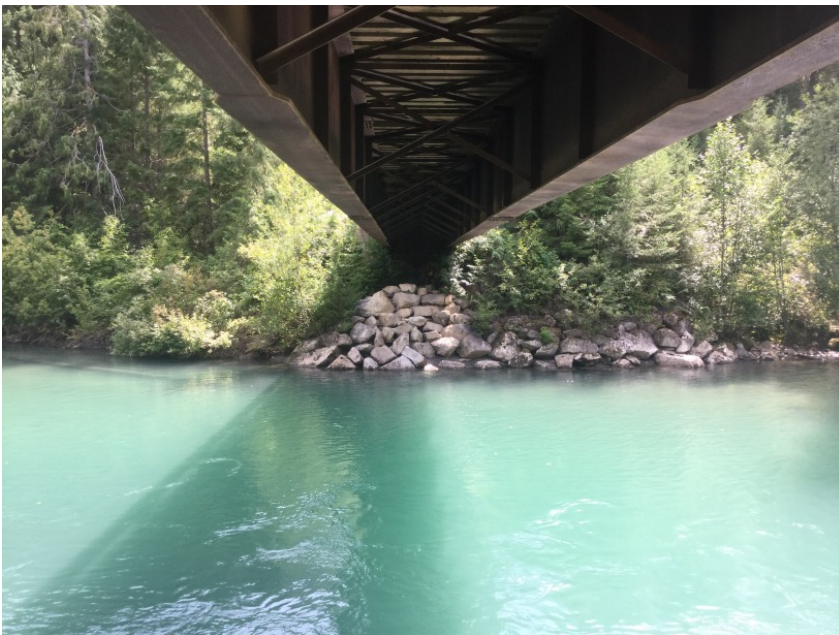
Right Bank Abutment

Ballast Wall Fair Pressure treated. Planks reinforced between girders at both abutments. Typically slightly misaligned, R/B D/S bending due to fill.

| Item | Monitor Description | Frequency |
|---|---|---|
| 1 | Monitor bending and alignment of abutment ballast walls. | Routine Inspection |

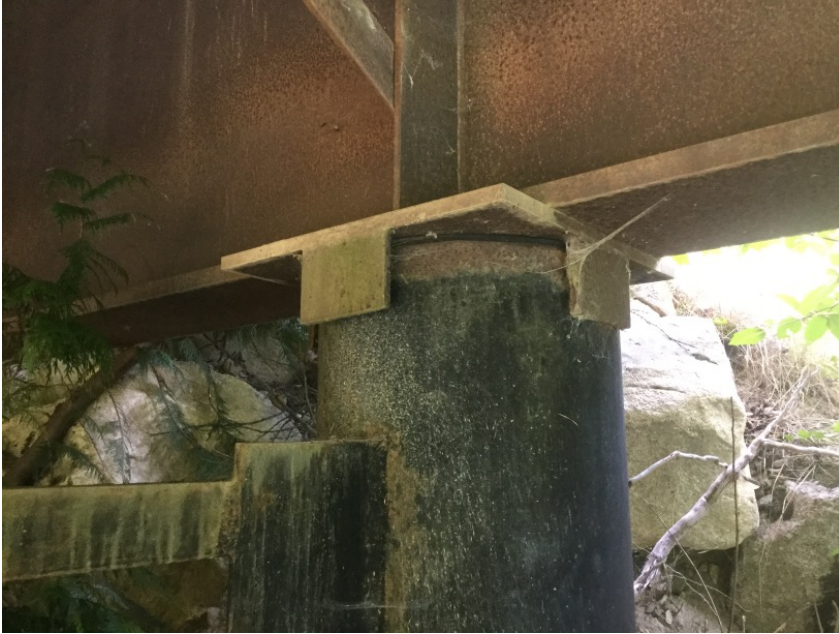
Bearing

Bearings Good Thin rubber pads on top of posts.
