CK2479

NAHATLATCH GRIZZLY 2.1km

2016 Inspection

| Road Name | NAHATLATCH GRIZZLY |

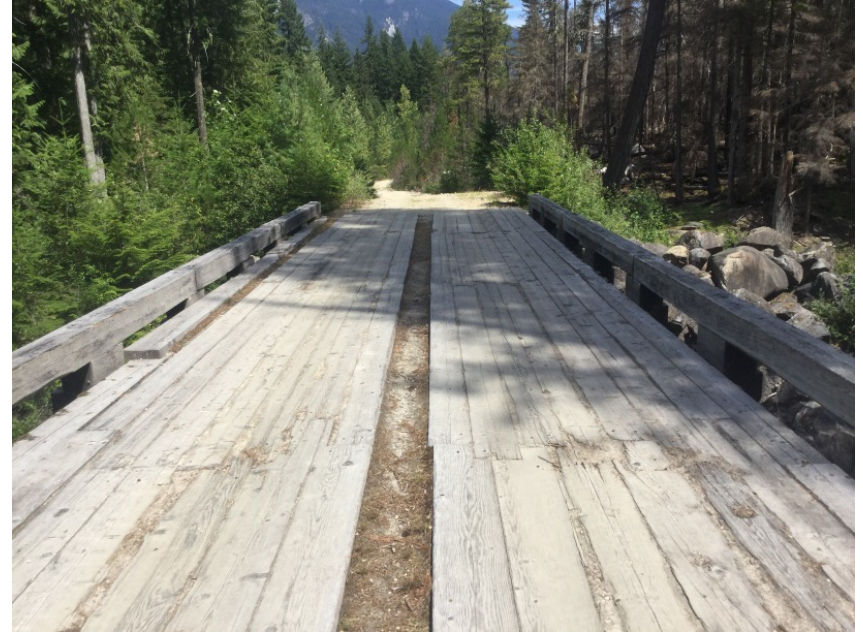
| Overall Deck Condition | Poor | Rotting running planks and rotten guardrail. |

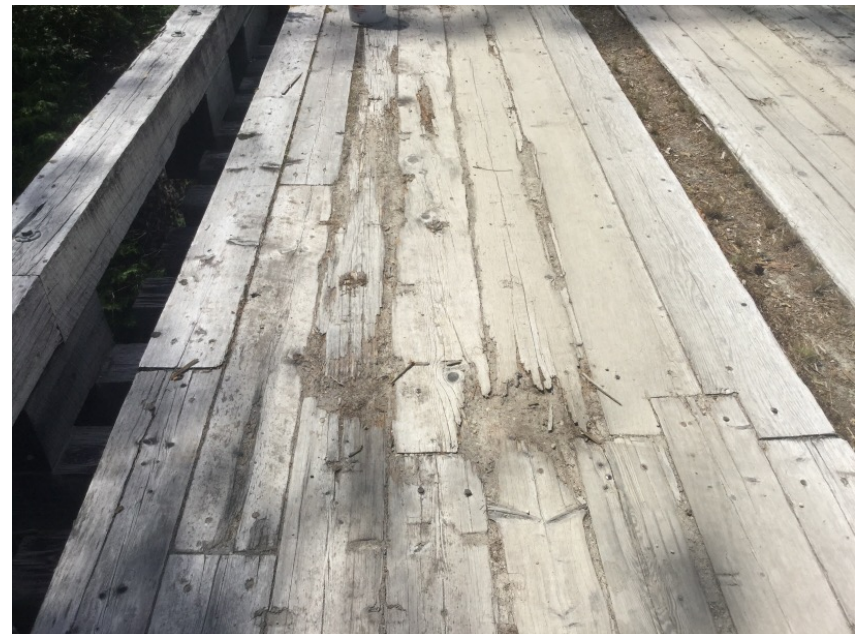
| Running Planks | Fair | Pockets of rot developing in the majority of running planks. |

Pockets of Rot in Running Planks

| Item | Priority | Repair Description |
|---|---|---|
| 1 | High | Replace guardrail and running planks. Requires: 40 m of 250x250 mm guardrail sections, 18 650x250x250 mm risers. Running planks 90 mm thick for 20 m long deck with 4.2 m wide wearing surface. |

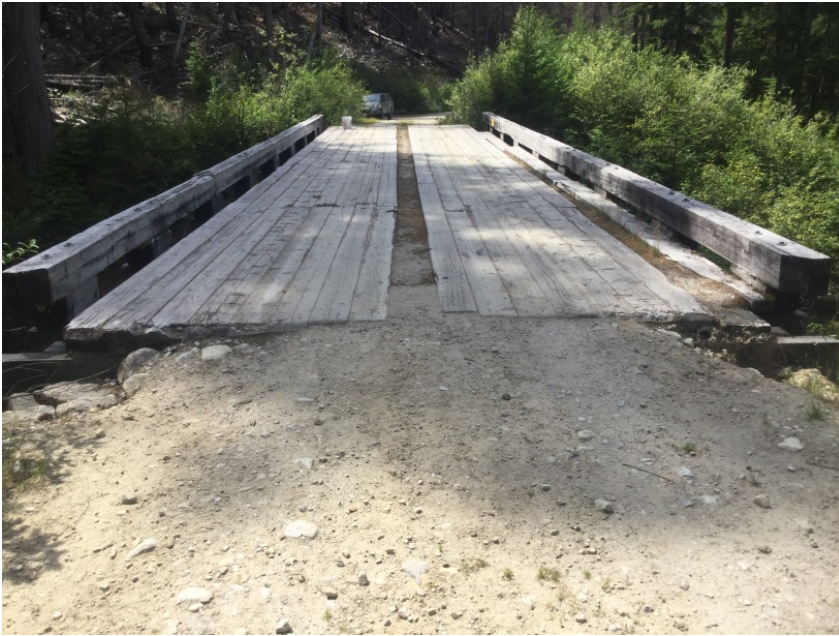
Oversteepened fill at right abutment has resulted in reduced road width and made approach lower than deck.

Poor Fill at Right Abutment

| Item | Priority | Repair Description |
|---|---|---|
| 3 | Medium | Place additional slope protection and fill at right approach. |

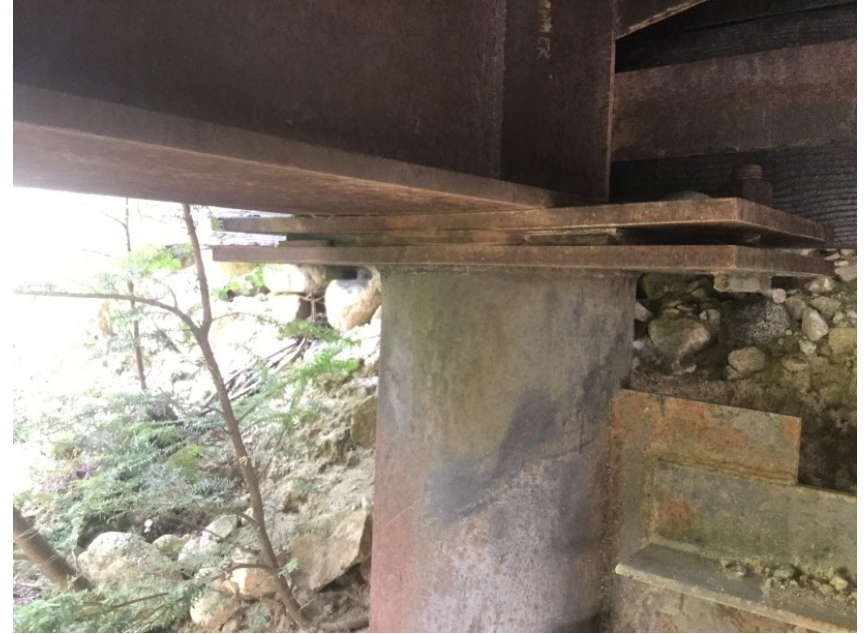
Right abutment downstream bearing is bulging.

Right Abutment Downstream Bearing Bulging

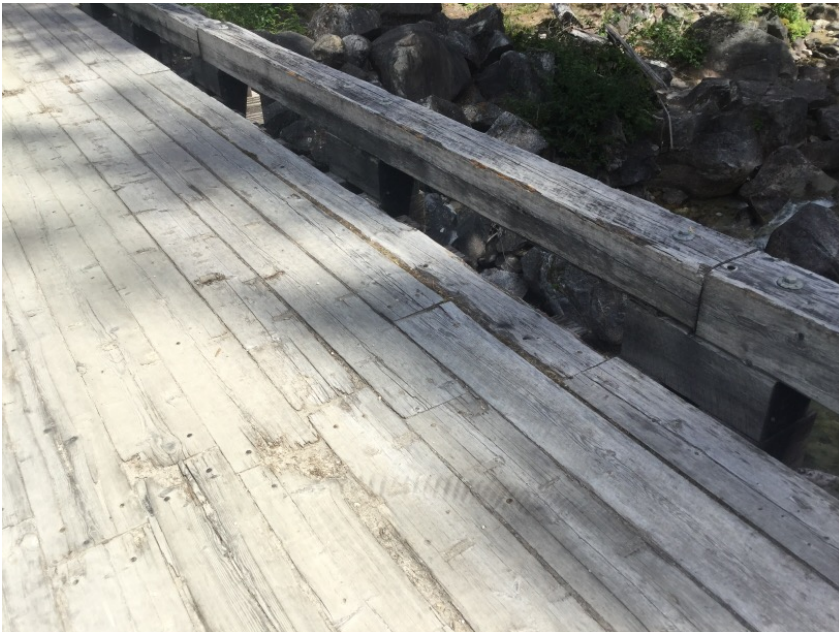
Guard Rail

| Curb Rail/Blocks/Posts | Poor | Rotten risers and pockets of rot in guardrail. |
