CK-2002

AMERICAN CREEK 4.6km

2017 Inspection

| Crossing Name | Three Mile Creek | | |

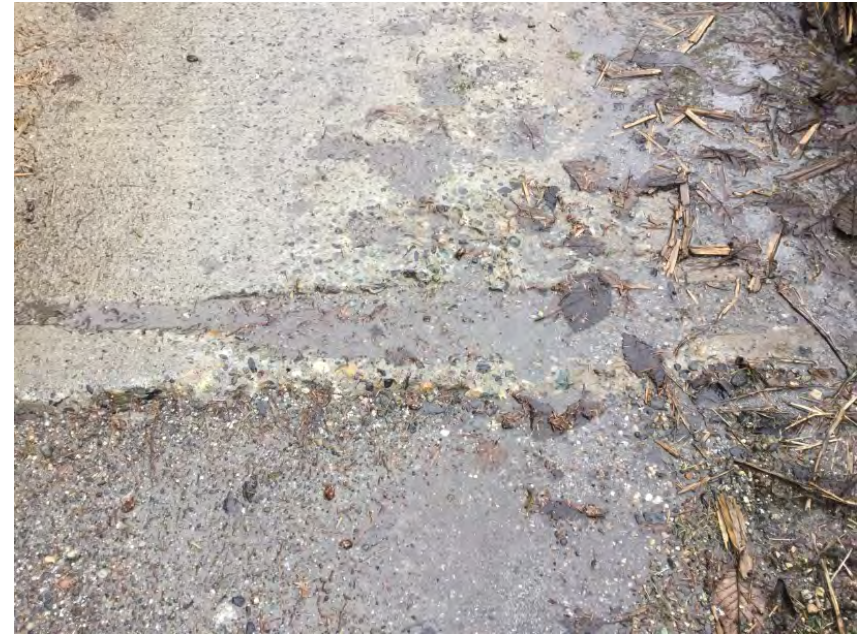
Concrete Deck Fair Minor damage on right bank panel

Some deck damage - no rebar noted

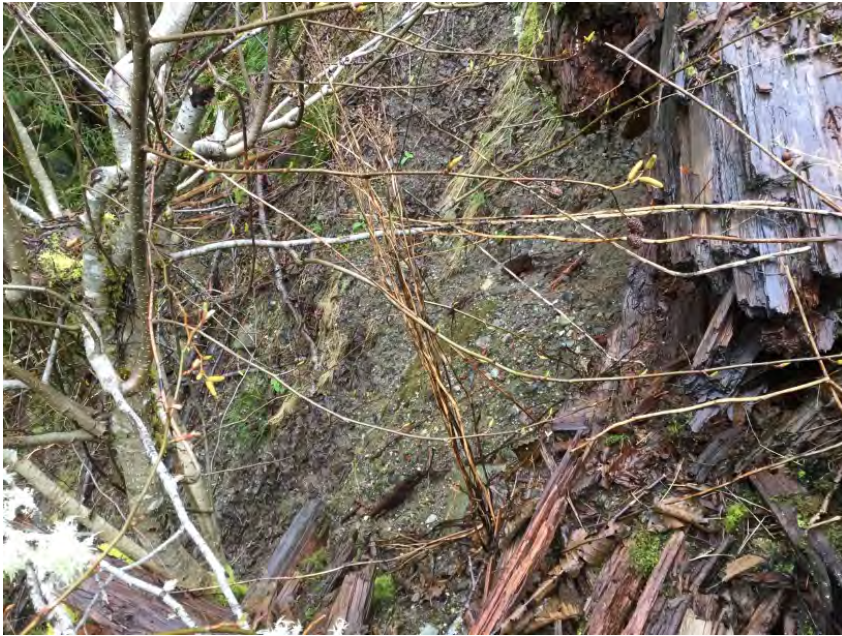
Fill Fair Failing at downstream right bank

Fill on right downstream banking eroding

I reviewed the last inspection (2014) and there does not appear to be any difference in slope of the Bin Wall. Replace the 2 Right Hand delineators with proper ones and consider repairing the failing fill slope on the down stream right bank. The present load rating of L60 or 54 tonnes to continue.

| 2 | Medium | Repair failing fill at downstream right bank |

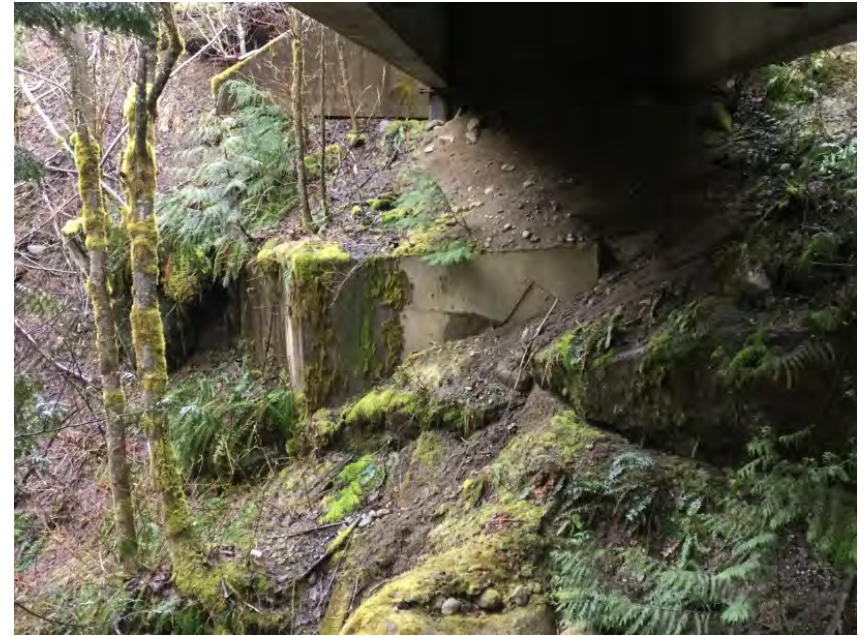
Check asbuilt docs and/or old inspections for right bank CIP bin wall - check slope

Bin Wall Fair only on right bank

Right bank CIP place sloped to downstream

| Item | Monitor Description | Frequency |
|---|---|---|
| 1 | Right bank CIP bin wall | Routine Inspection |
