CK-2003

AMERICAN CREEK 8.5km

2017 Inspection

| Crossing Name | American Creek | | |

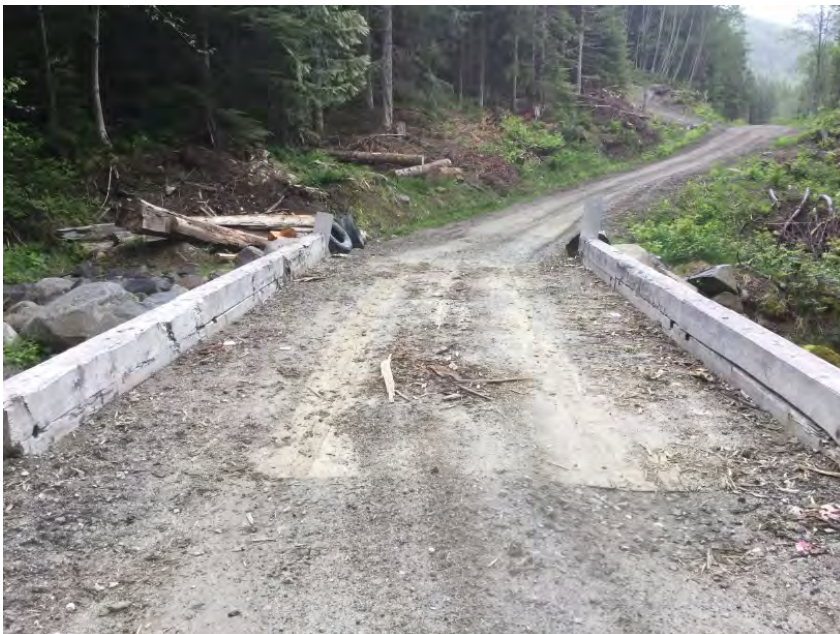
Overall Deck Condition      Fair

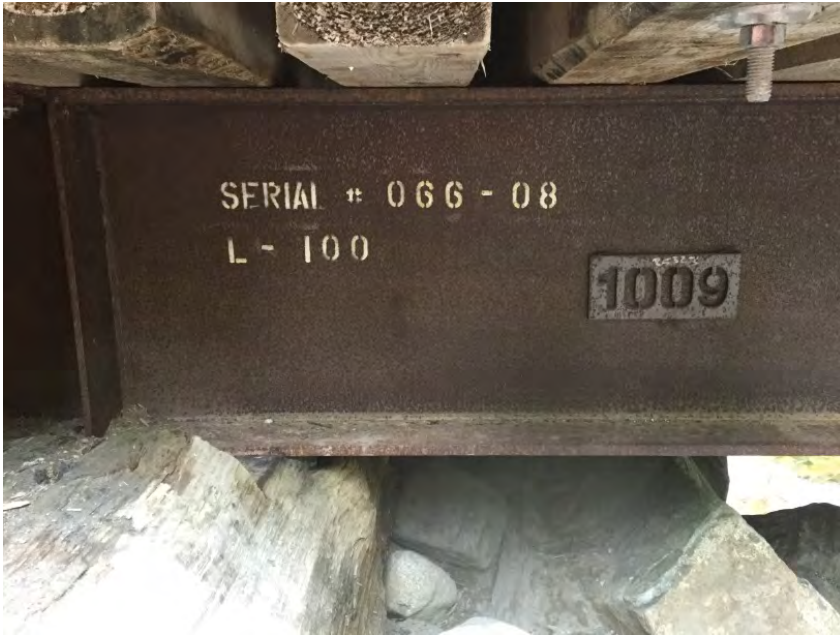
Structure ID

Serial/ID Plate L100, serial # 066-08, with welded plate - 1009

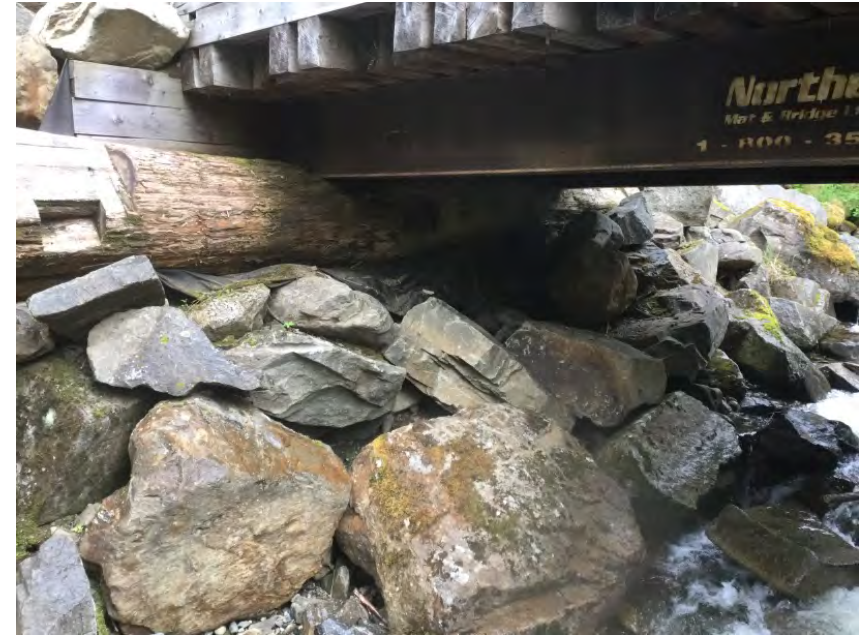
Right Bank Abutment when facing downstream

Old log sills, but still in fair condition

3 - 100mm x 250mm stacked timbers, not tied together

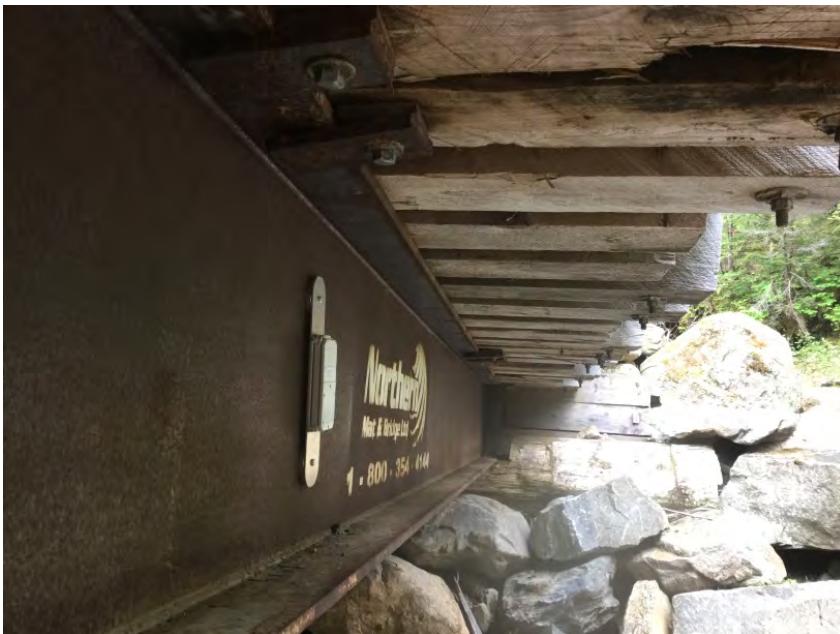
Deck clips

Deck to Girder Bolts      Good      Each modular panel connected in 2 locations

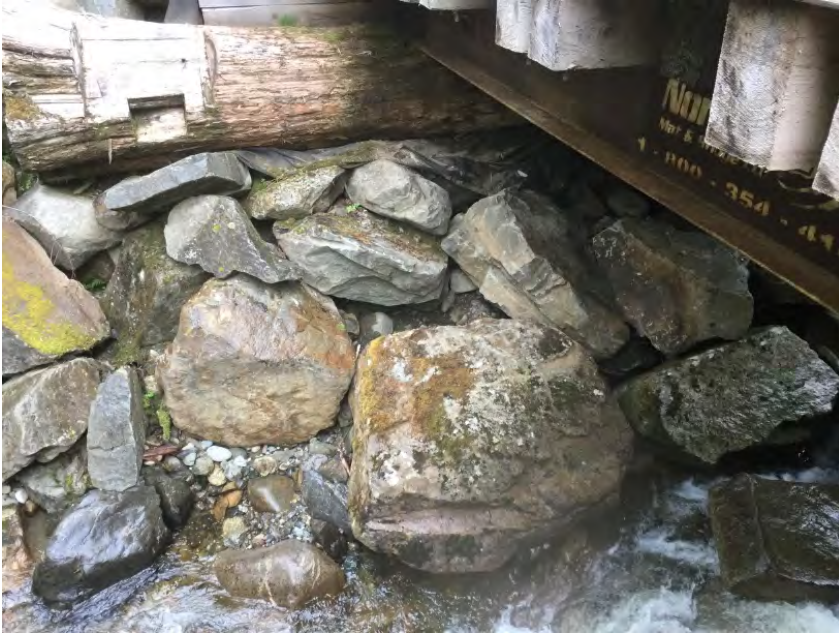
At the time of this installation a 3 year lifespan was assumed and oversized riprap was used for armouring - it was placed steeper (1:1) than what is typical for permanent crossings. The record drawings indicate L100 or 91 tonnes load rating, which can continue. Replace the missing delineators and monitor riprap stability. Please submit the structural drawings for the file.

Large piece size, steeply sloped at 1:1, and not well graded or tied together

Riprap not well keyed/tied together

| 1 | Riprap condition | Anually |

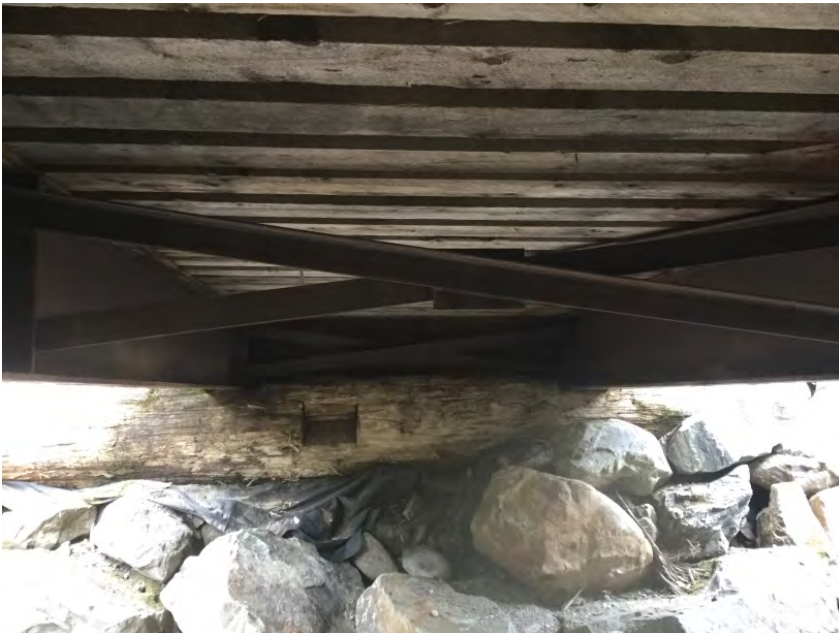
Superstructure

Girders Fair Light corrosion

Diaphragms Fair 3 bays, welded - light corrosion

Bracing Fair Light corrosion
