CK-2012

BLUE MTN TWO 0.8km

2017 Inspection

| Crossing Name | McFadden Creek |

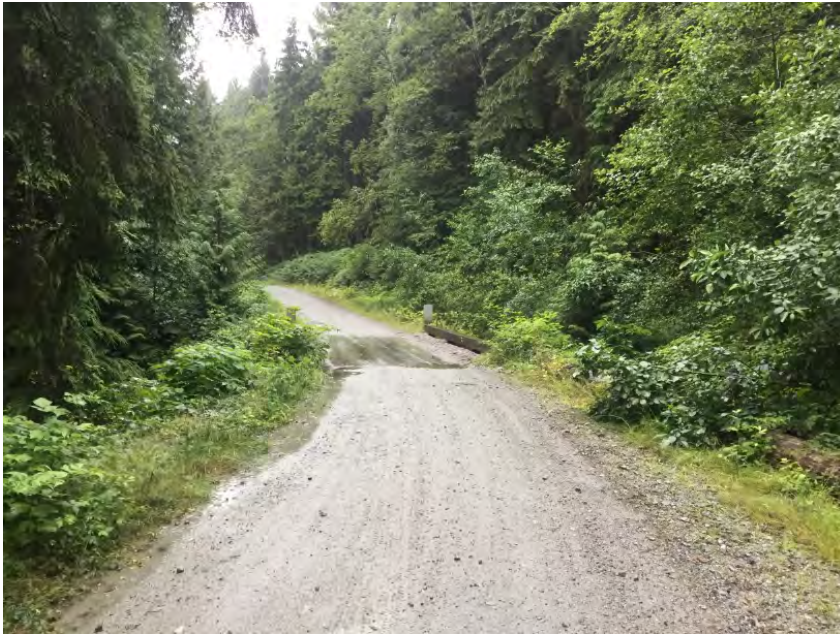
Approach from Left Bank when facing downstream

| 2 | Low | Brush approaches |

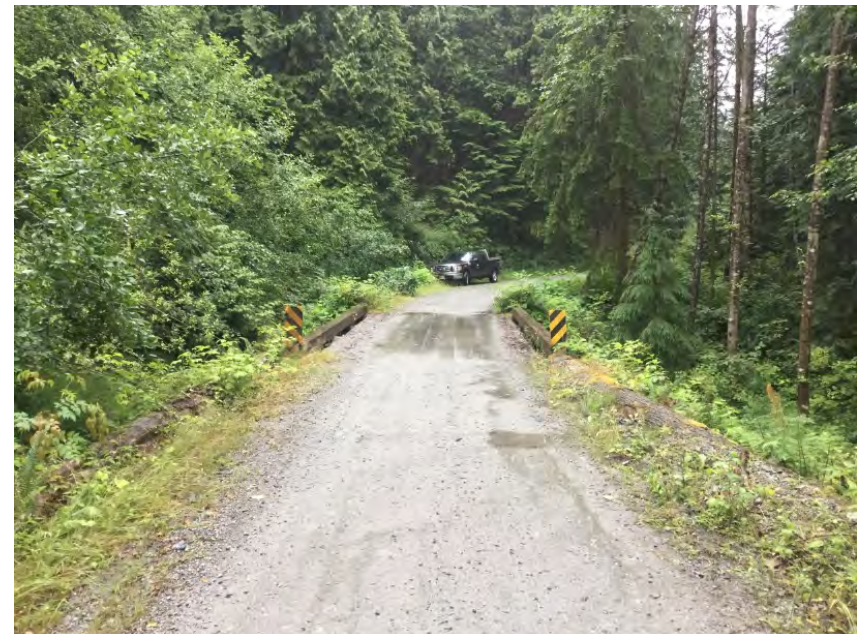
Approach from Right Bank when facing downstream

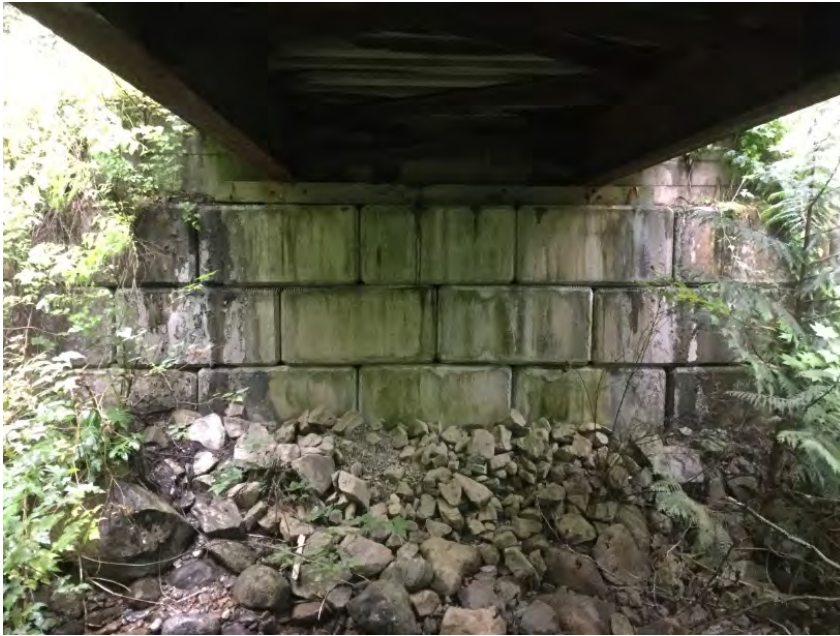
Concrete Fair 3x lock block abutments

Caps or Sills Fair Treated timbers and shimmed both banks

Riprap Fair Seems undersized

Left Bank Abutment when facing downstream

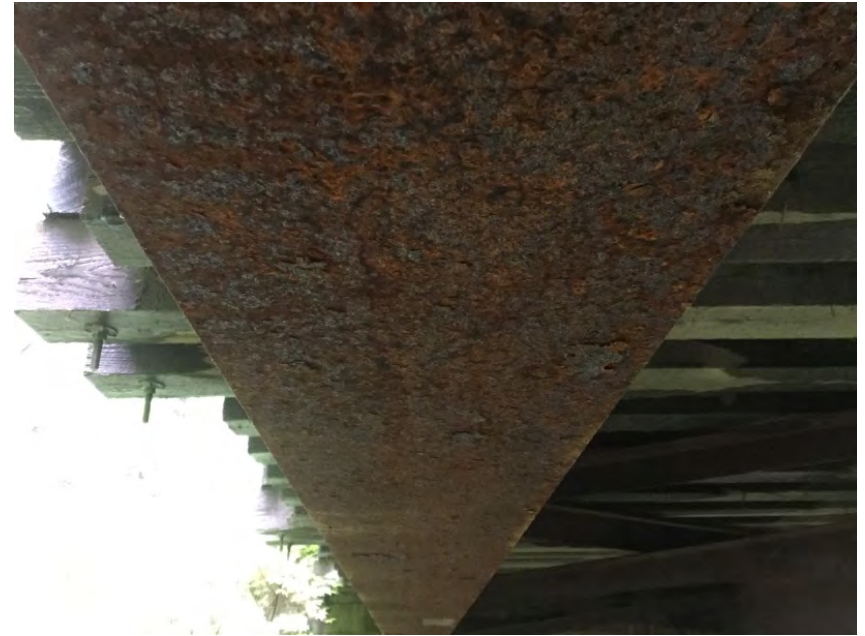
Girders Fair Slight corrosion

Diaphragms Fair 3 bolted bays, slight corrosion

Bracing Fair Slight corrosion

Slight corrosion noted on superstructure

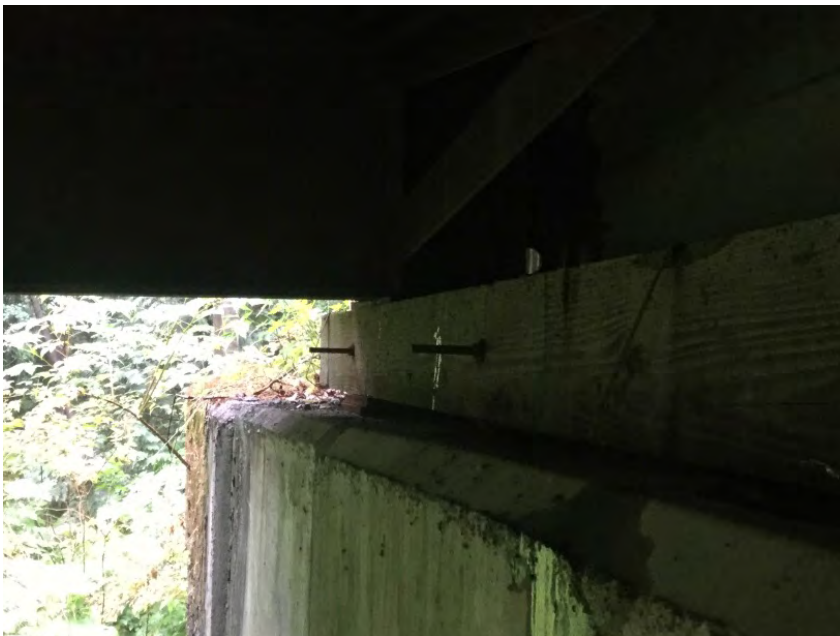
Bearings Fair Shimmed at both abutments therefore not uniform

Right bank, downstream girder shimmed at bearing

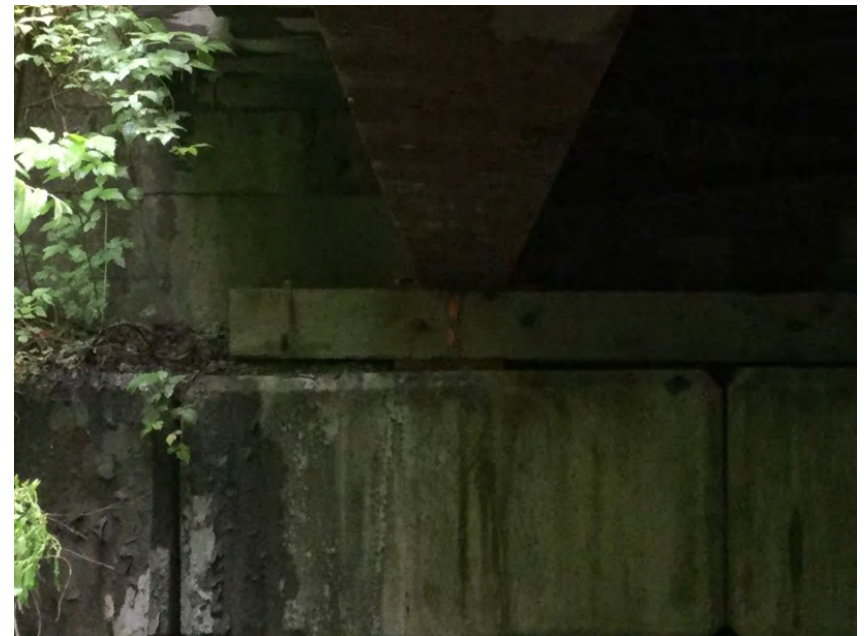
Left bank, upstream girder shimmed at bearing

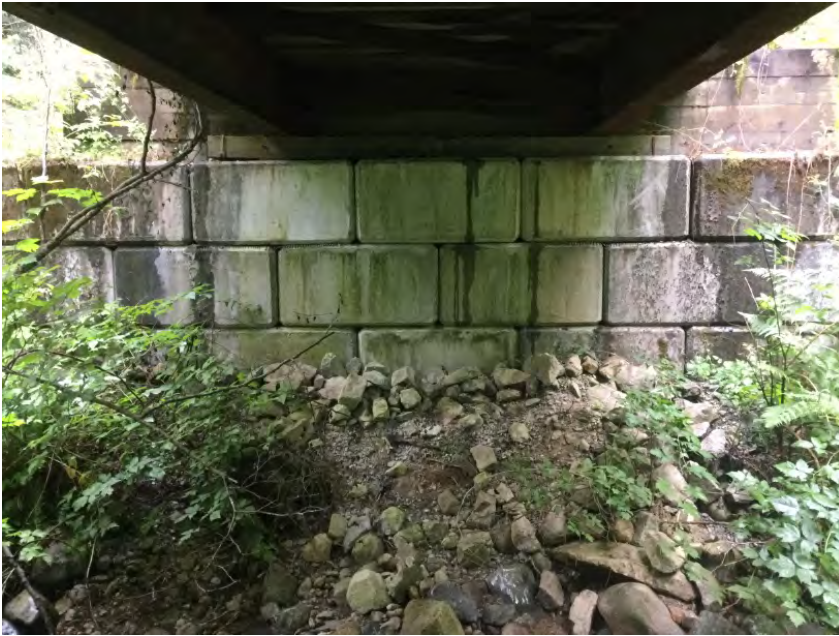
Right Bank Abutment when facing downstream
