CK-2018

CANTELON CREEK 0.3km

2017 Inspection

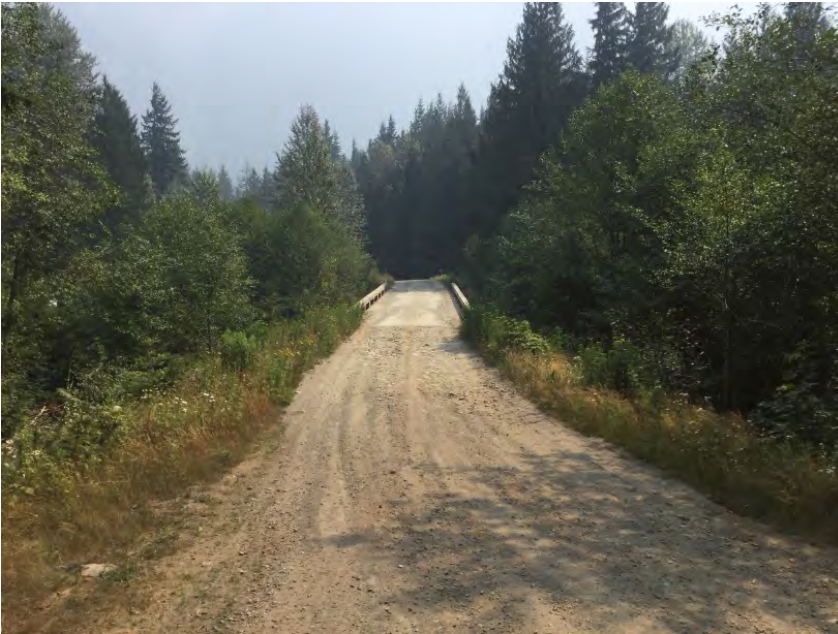
Approach from Left Bank when facing downstream

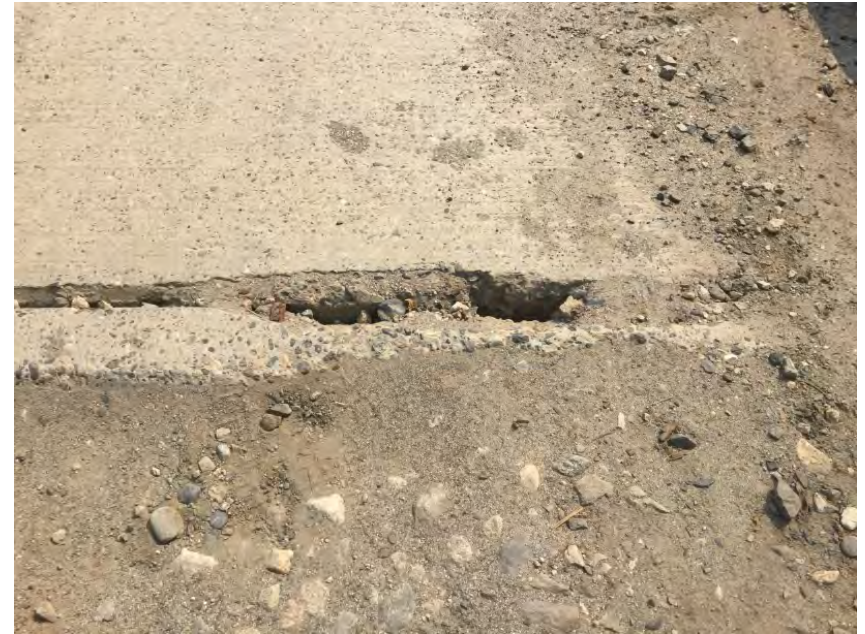
Ballast Wall Fair Requires repair to both walls

Concrete Deck      **Fair**      Damage sustained to Panels at either approach

Damage to left bank ballast wall and deck panel

| Repair | | Repair Description |
|---|---|---|
| 1 | Medium | Repair damage to ballast walls and deck panels |

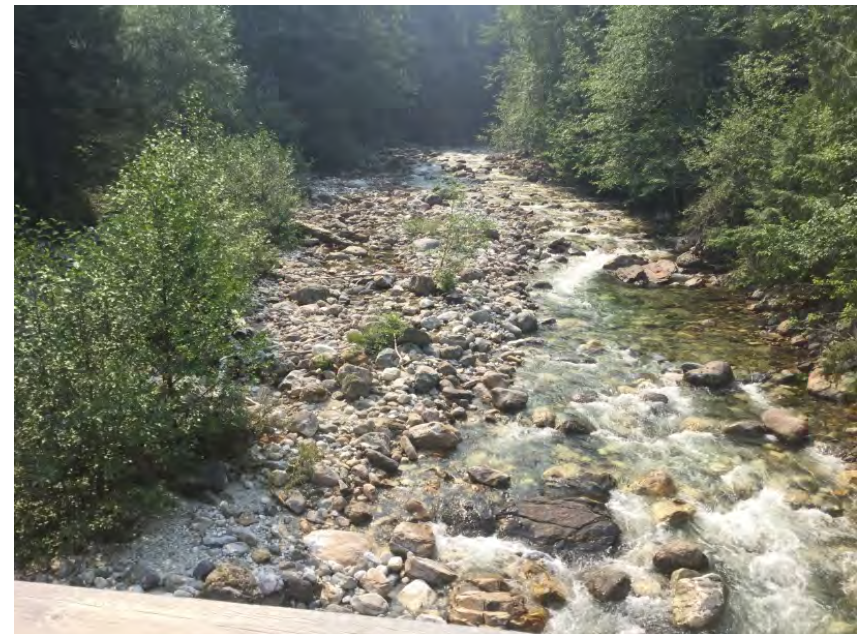
Looking upstream from deck

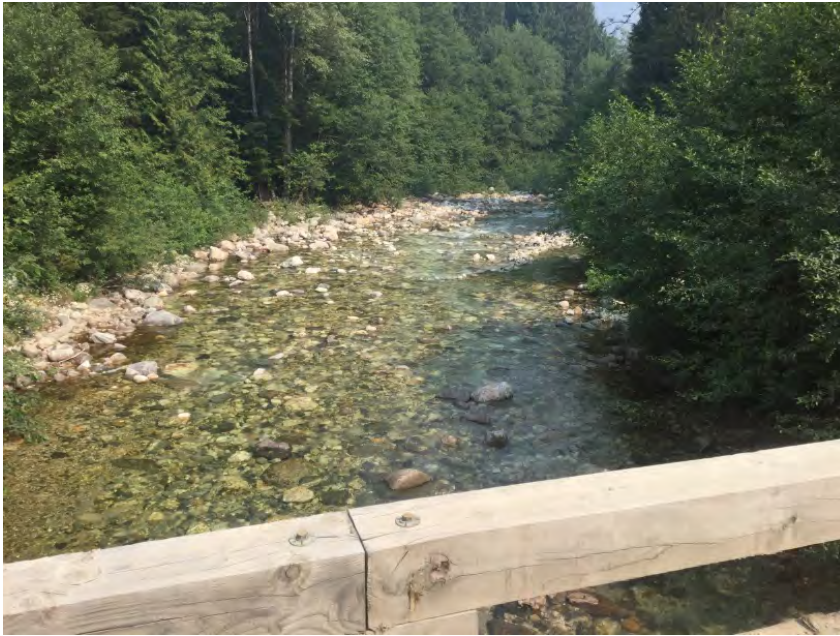
Looking downstream from deck

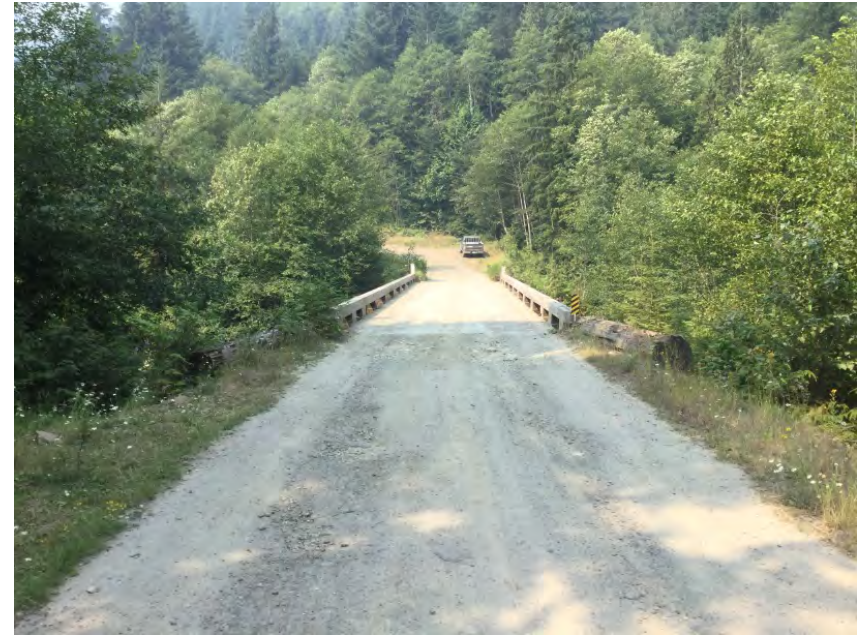
Approach from Right Bank when facing downstream

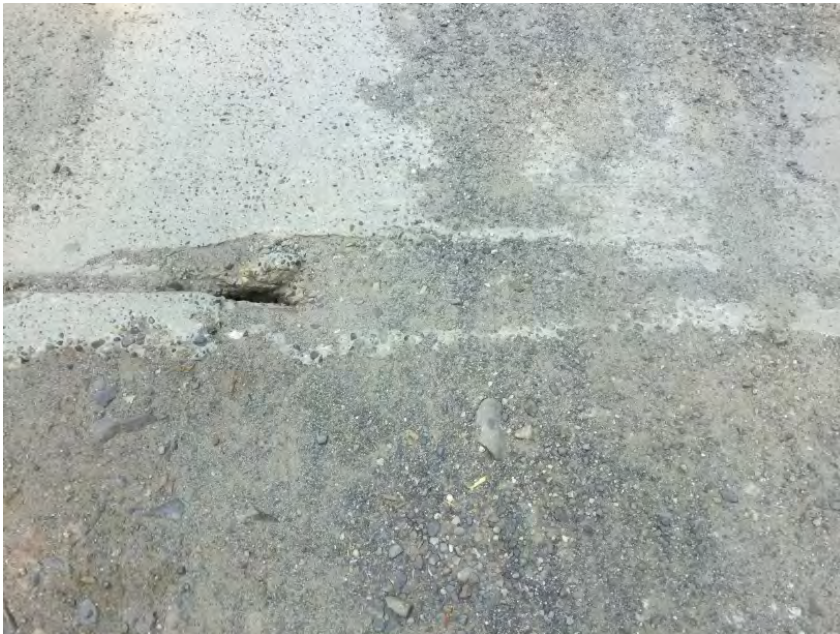
Damage to right bank ballast wall and deck panel

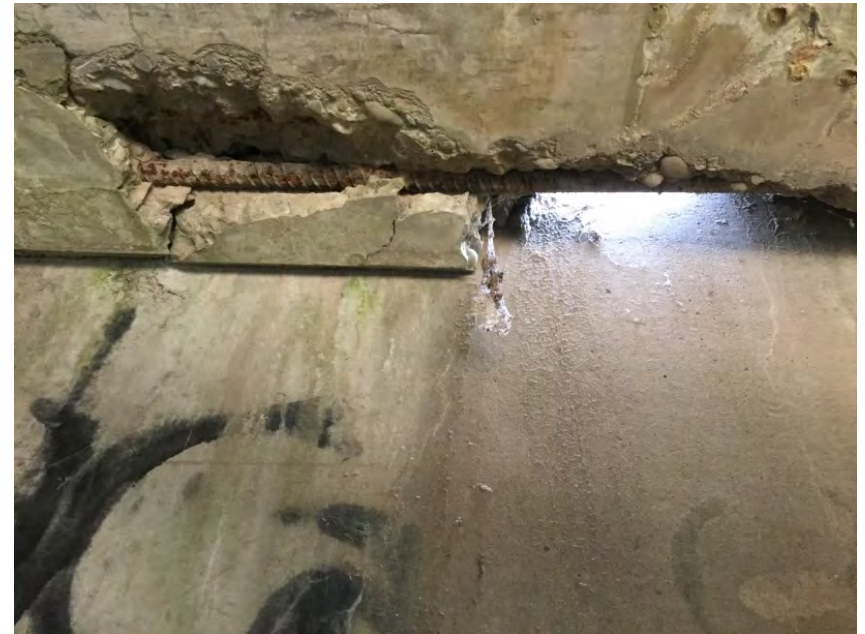
Damage to deck panel on right bank

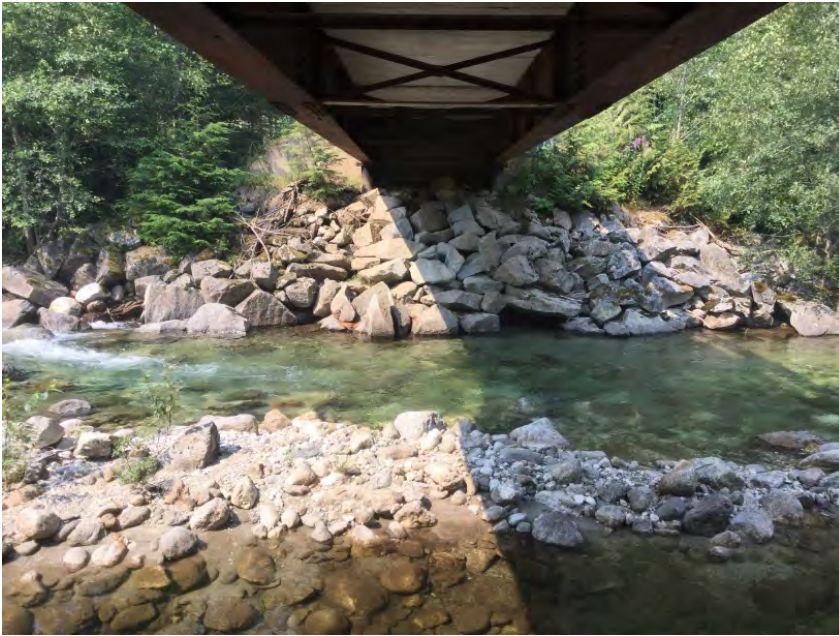
Left Bank Abutment when facing downstream

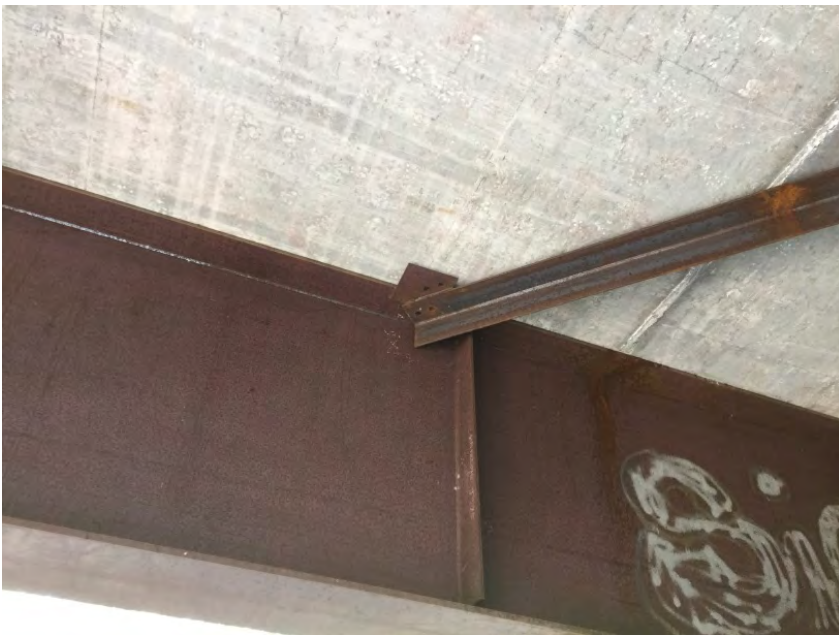
Missing bolts but have been welded

Bracing at right bank missing bolts but welded

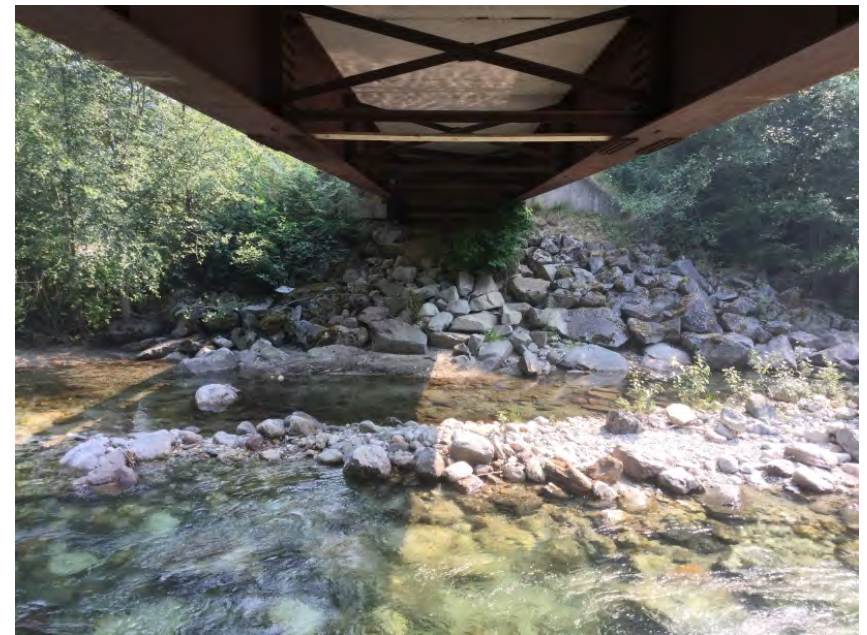
Right Bank Abutment when facing downstream

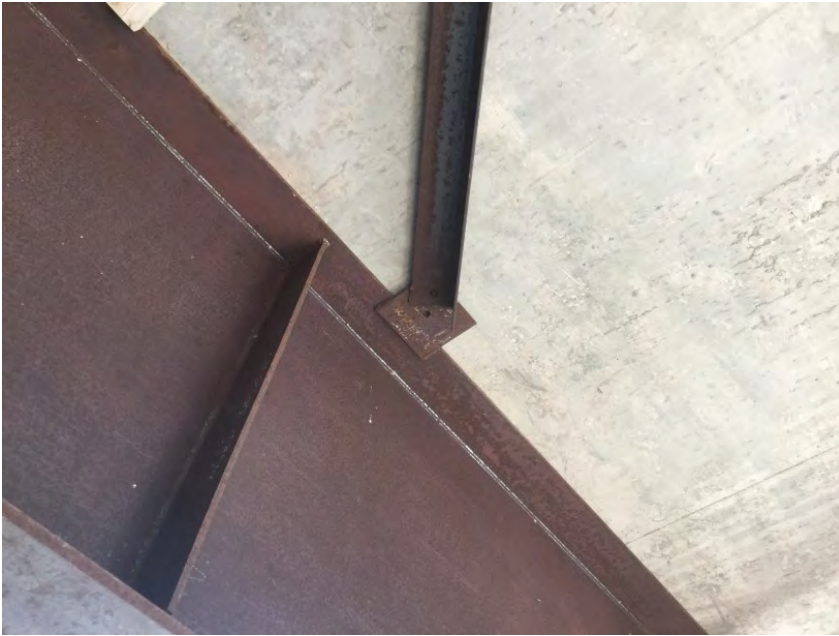
Bracing at left bank missing bolts but welded

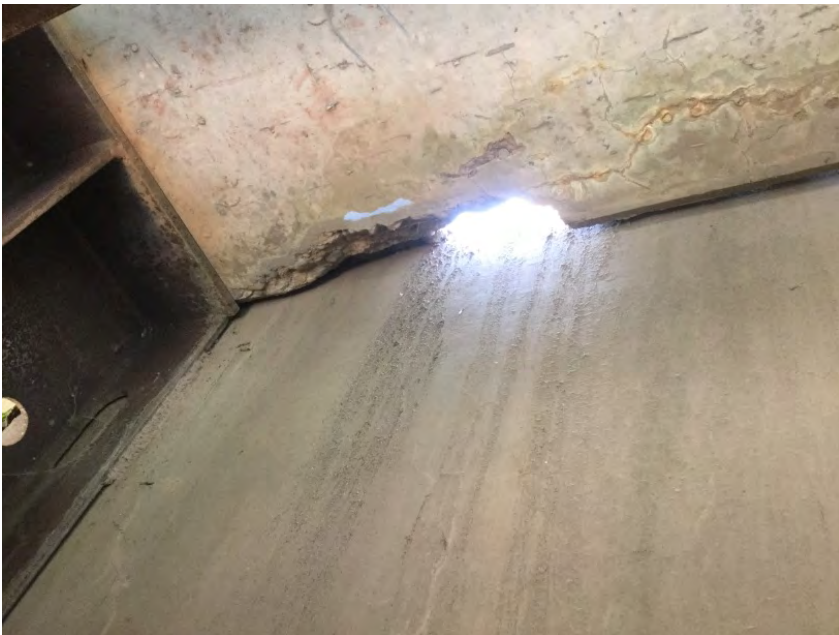
Damage to panel at left bank
