CK-2020

CHEHALIS 6km

2017 Inspection

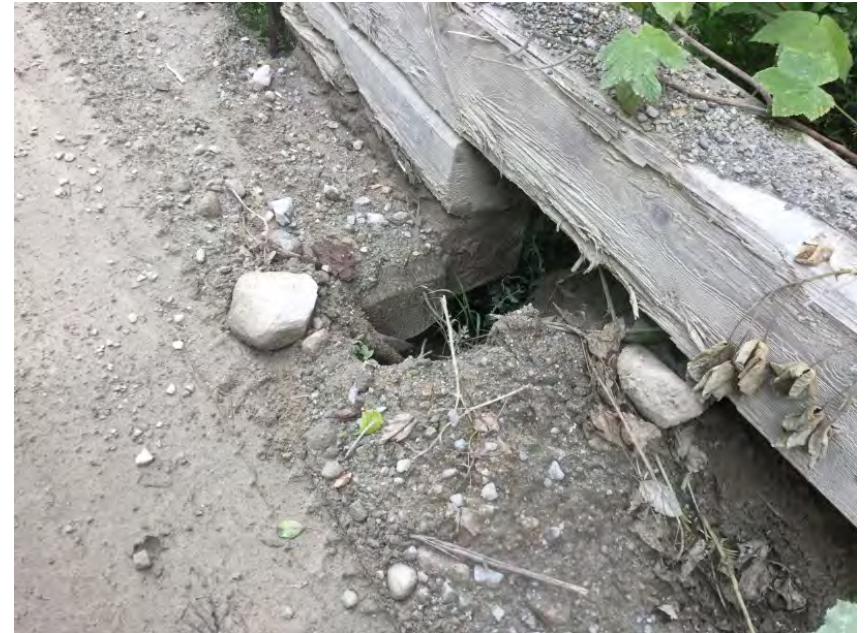
Fill Fair Failing on left upstream bank

Failing fill at left upstream

| 2 | Medium | Place fender at left upstream approach |

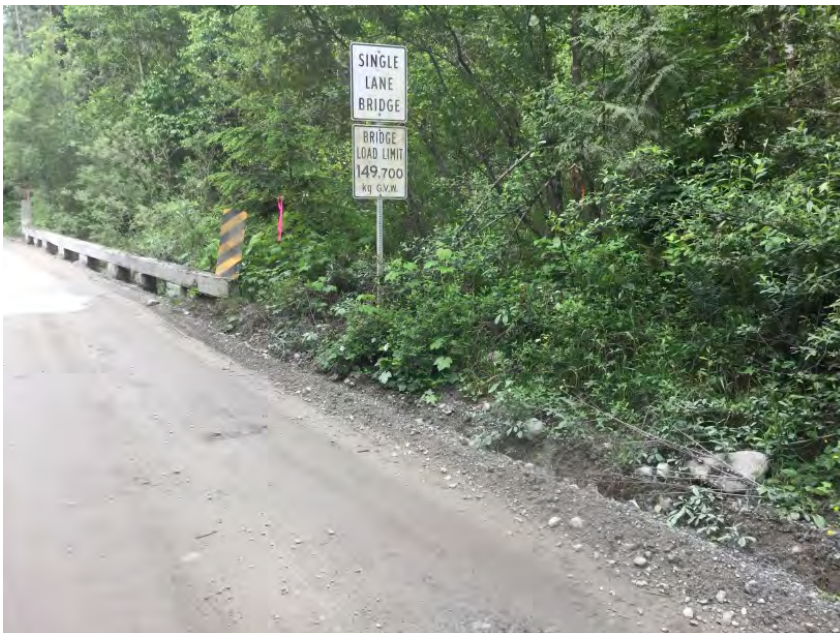
Missing left upstream fender

Replace the guardrail, risers and blocks. Place a log fender at the upstream left approach. Monitor damage to deck panels 1 and 2. Present load rating of L165 or 150 tonnes to continue.

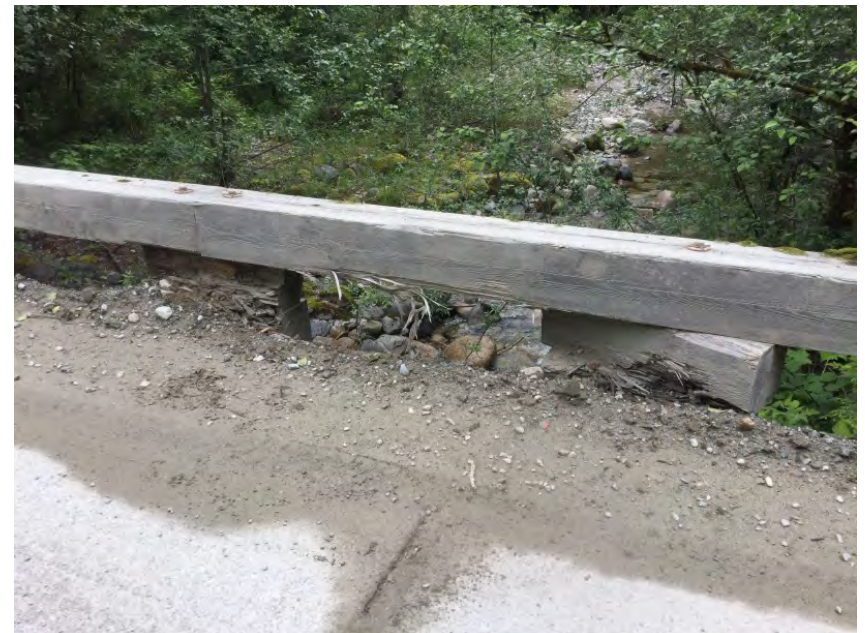
Curb Rail/Blocks/Posts Poor Rotting risers and blocks

Overall Deck Condition Poor Due to rotting risers and blocks

Rotting risers and blocks

| 1 | Medium | Replace guardrail, risers and blocks |

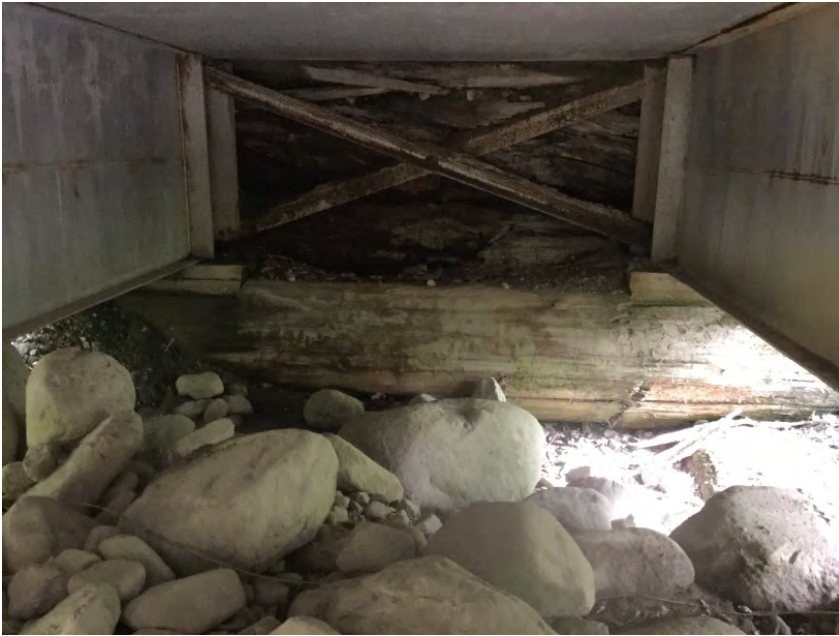
Left Bank Abutment when facing downstream

Log/Timber Cribs Fair Only on right bank, log sill left bank

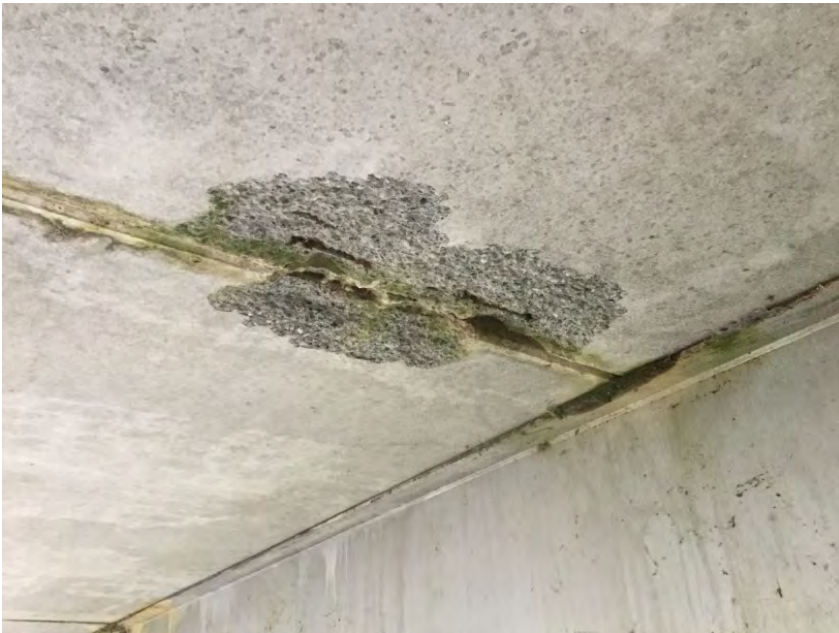
Damage to deck Panels 1 and 2 on right approach
