CK-2021

CHEHALIS 10.6km

2017 Inspection

| Crossing Name | Boulder Creek |

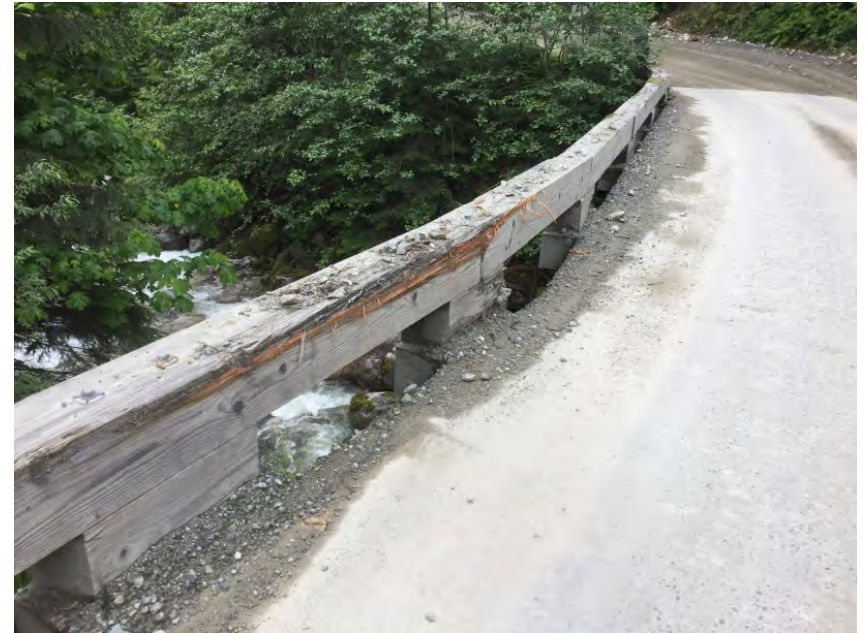
Recent damage to rail but still functional

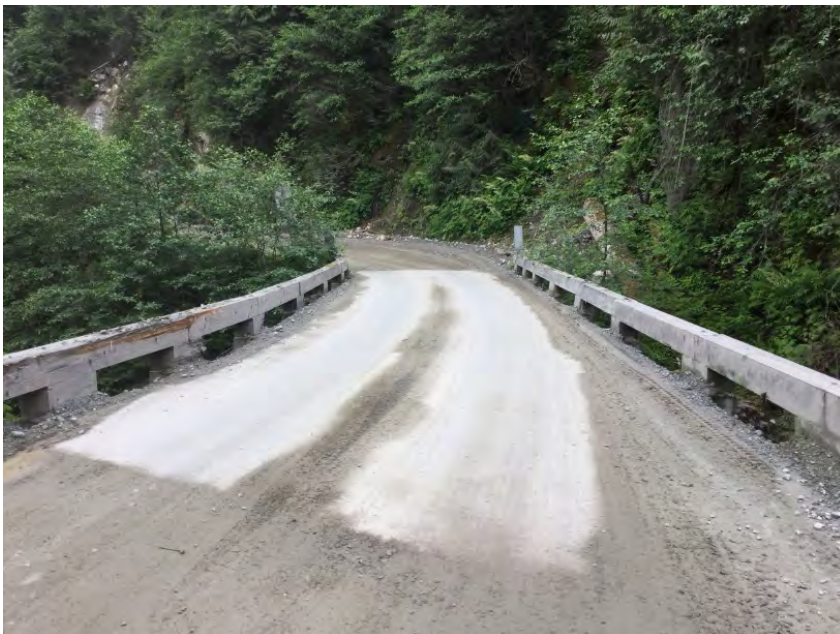
Concrete Deck      **Fair**      Some wear noted on wheel pathGrout Pockets      **Good**Deck Joints      **Fair**

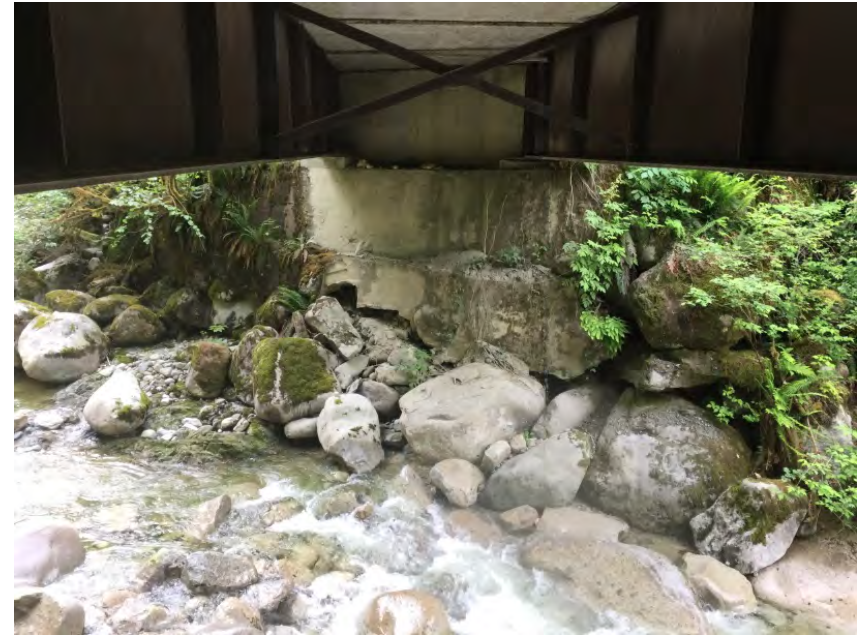
Left Bank Abutment when facing downstream

Old CIP on left bank has vertical crack extending top to bottom

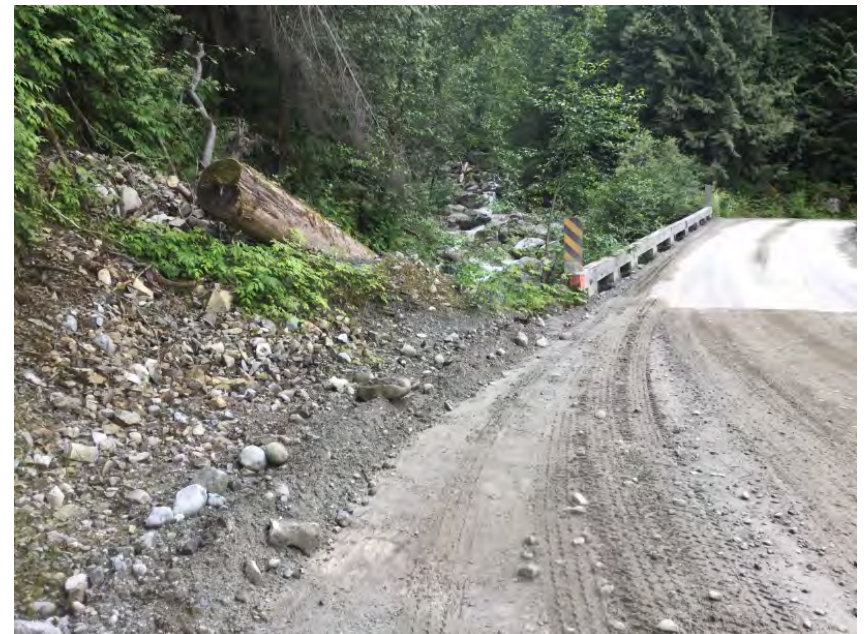
Logs and rocks - upstream right bank fender log has been pushed off the road

Missing fender at upstream right approach

| Repair Item | Priority | Repair Description |
|---|---|---|
| 2 | Medium | Replace missing fender at upstream right approach |

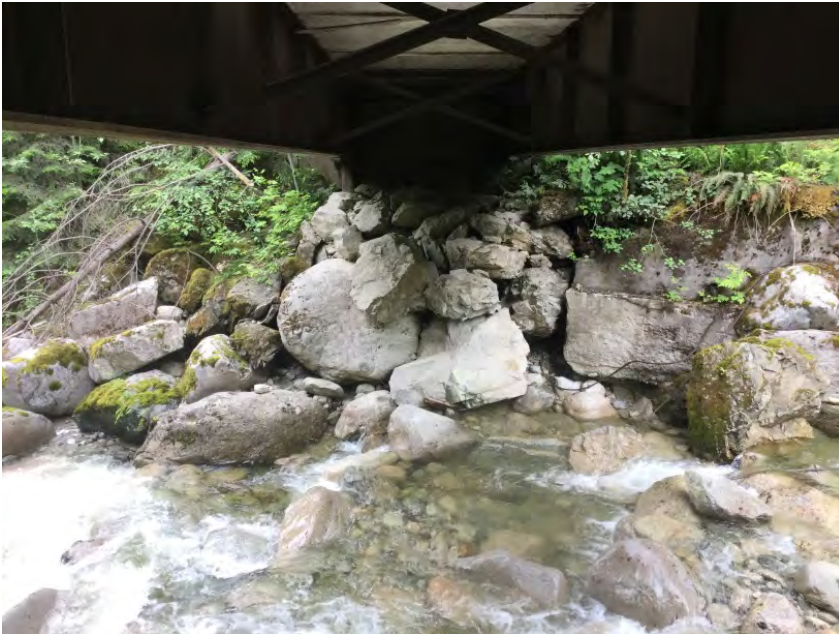
Right Bank Abutment when facing downstream

Not well graded and tied together at right bank, scour noted here aswell

| Item | Monitor Description | Frequency |
|---|---|---|
| 2 | Scour on right bank abutment | Anually |

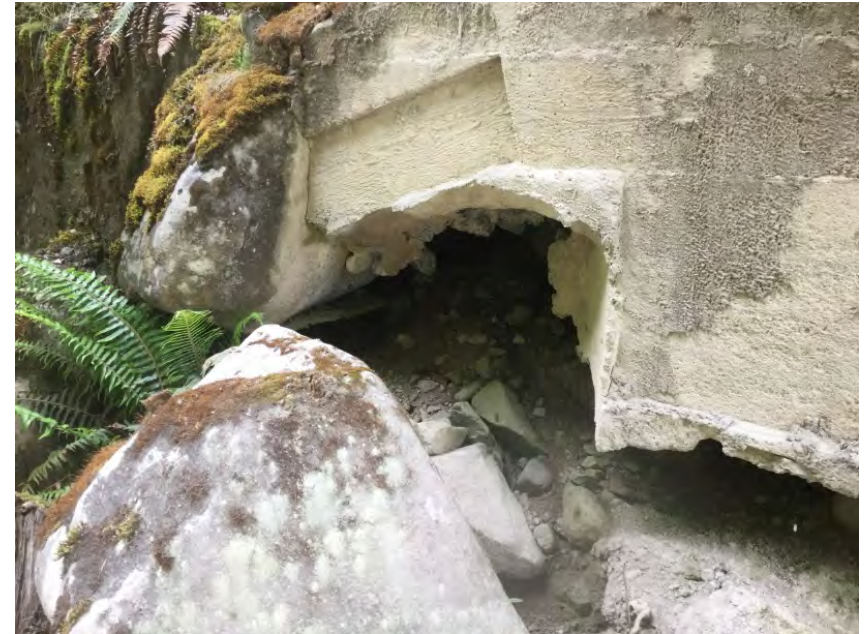
Hole in bottom of CIP, right under girder (upstream left bank)

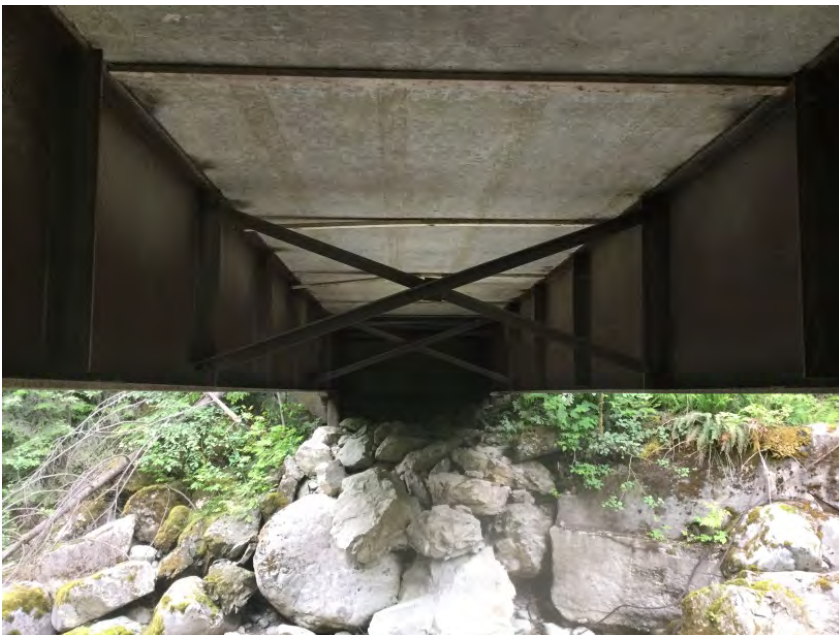
Superstructure

Light corrosion

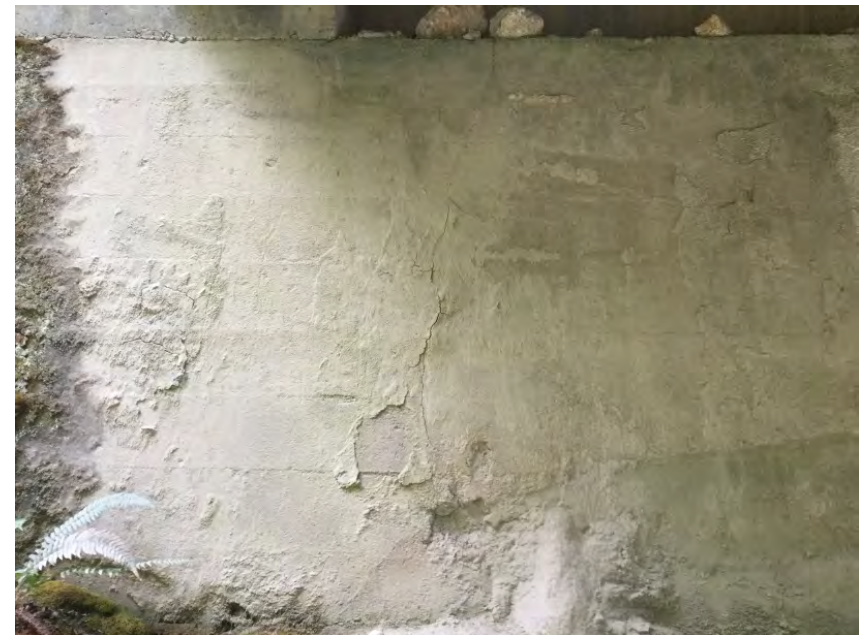
Vertical crack in CIP, under upstream girder left bank

Replace the upstream right approach fender log and missing delineator. Monitor the vertical crack noted at the left bank abutment, under the upstream girder and the riprap scour noted at the right bank abutment. Present load rating of L150 or 136 tonnes to continue.

| Item | Monitor Description | Frequency |
|---|---|---|
| 1 | Crack in left bank CIP | Anually |
