CK-2022

CHEHALIS 15.2km

2017 Inspection

Crossing Name Statlu Creek

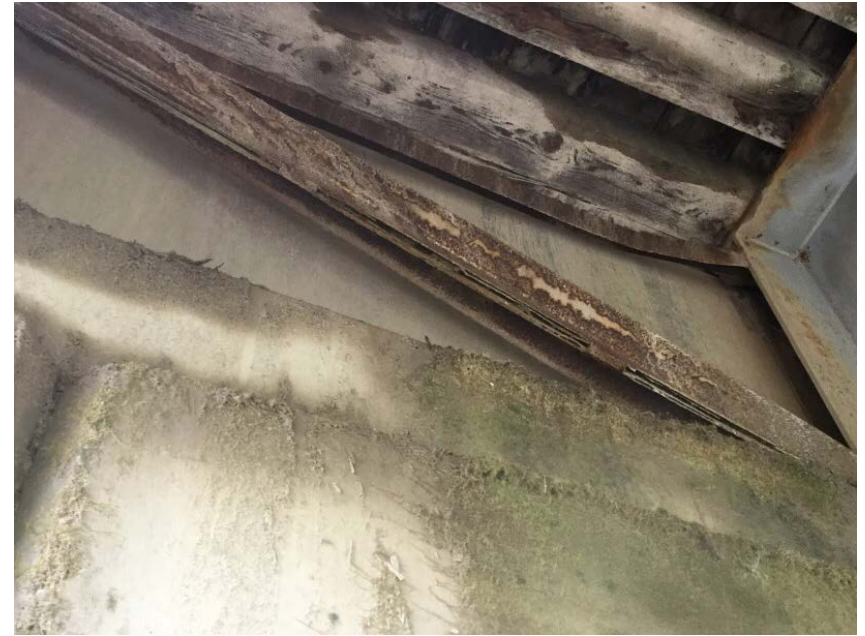
6 welded bays, heavily corroded at bearing locations

End bracing at right bearing heavily corroded

| 3 | High | Replace the end bracing sets (both ends) on the girders |

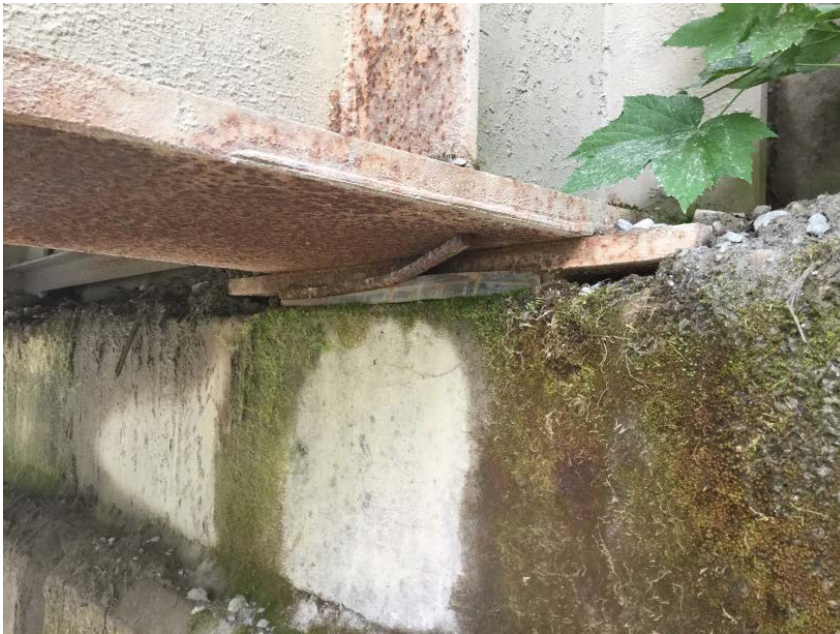
Right upstream bearing pad keeper condition

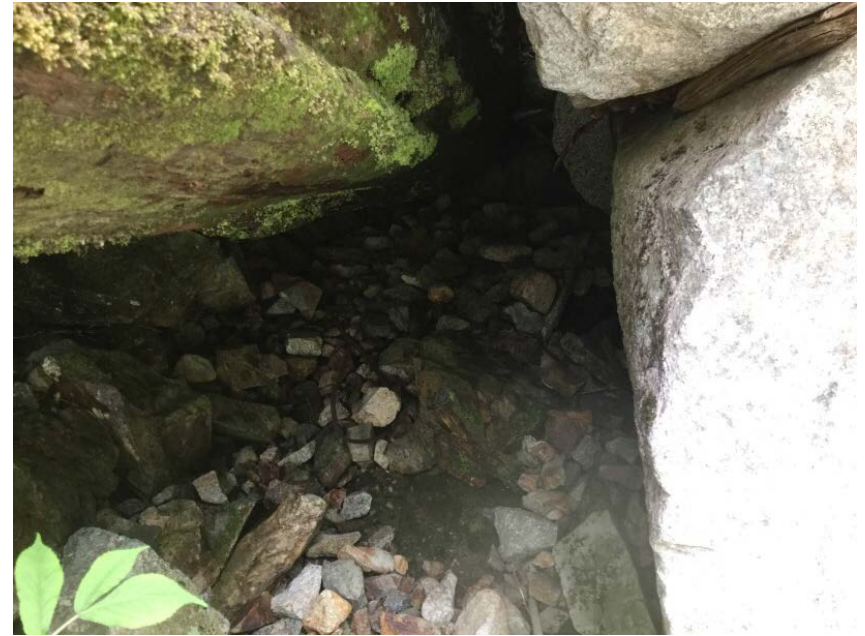
The left bank abutment cast-in-place concrete is still in fair condition; however there is scour noted under the front face and at the upstream end - this needs to be monitored. The right abutment was replaced in 2007 and is generally in fair condition; however a crack was evident on a bottom row lock block - this needs to be monitored. The end bracing on the steel girders at both abutments are in poor condition with heavy corrosion noted. The timber deck assembly was last replaced in late 2006 and is now in poor condition, especially the subdeck. Due to the poor condition of the subdeck limit loading to BCL-625 or 64 tonnes and plan to replace the entire deck assembly ASAP. While the deck is off replace both end bracing sets (at either abutment) and consider adding riprap to the upstream left abutment. If industrial users are planning to use the bridge prior to replacing the deck assembly and end bracing sets then they must implement an inspection program while in use to ensure the deck assembly is not further degrading; and those inspections must be submitted to the Chilliwack Forest District. If the deck assembly is determined to be further degraded the hauling must be stopped and the entire deck assembly replaced immediately. Contact the Chilliwack Forest District with the planned inspection program prior to use. Due to the age and condition of the abutments the above mentioned works would be considered temporary. For permanent repair options please contact the undersigned.

Riprap Fair Upstream left bank needs to be monitored as water is scouring behind the CIP

Scour noted behind upstream left abutment, extending up to 3m

| Item | Monitor Description | Frequency |
|---|---|---|
| 1 | left bank abutment condition | Routine Inspection |

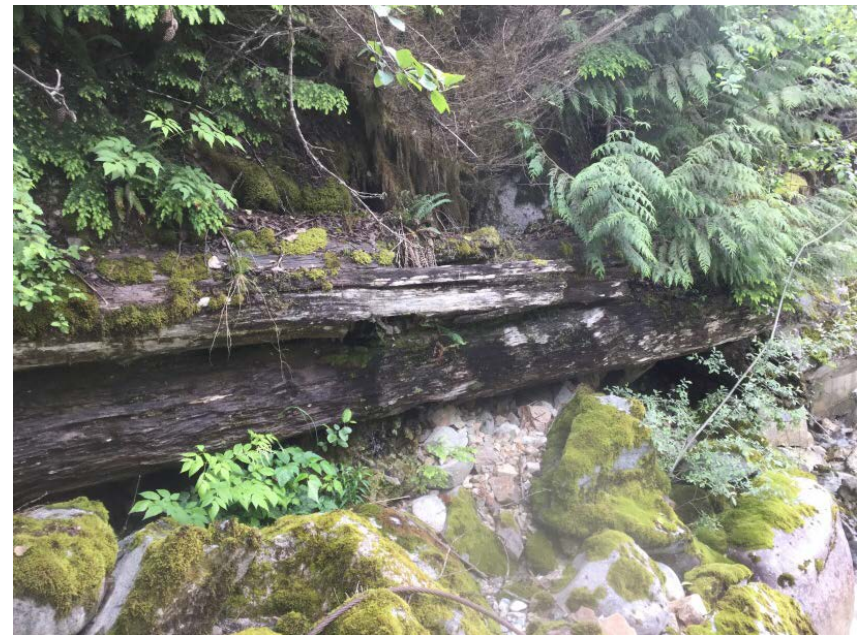
Log wingwall at left downstream location

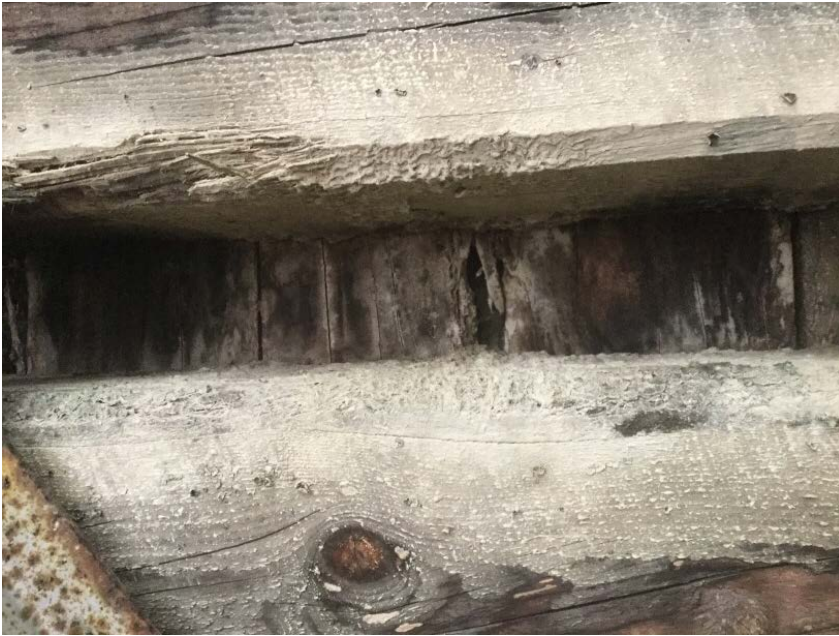
Visual signs of rot from underneath

250mm x 300mm, random tie ends were cored and pockets of rot (10-20mm) detected

Tie and subdeck condition

| 2 | High | Replace ties, subdeck, wear planks, guardrail and risers |

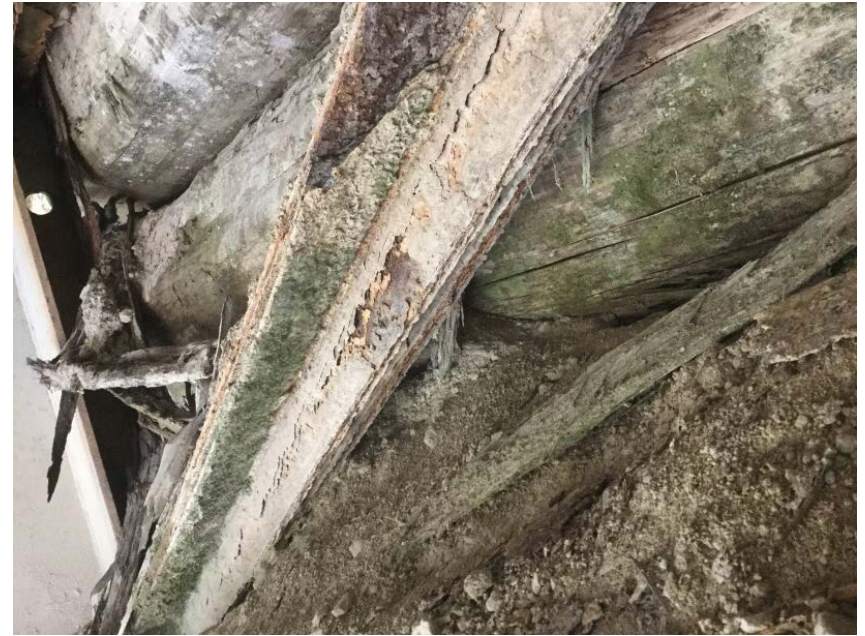
End bracing at left abutment heavily corroded

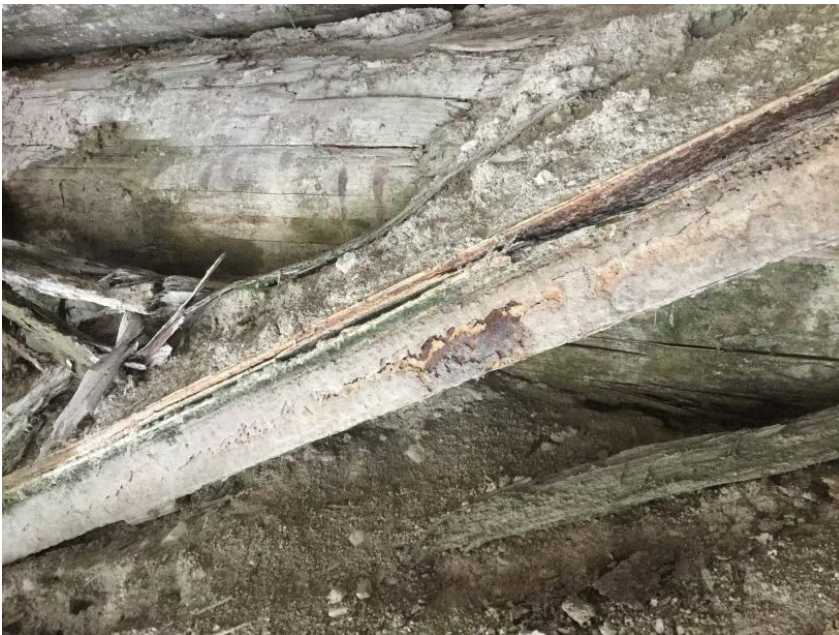
End bracing at left abutment heavily corroded

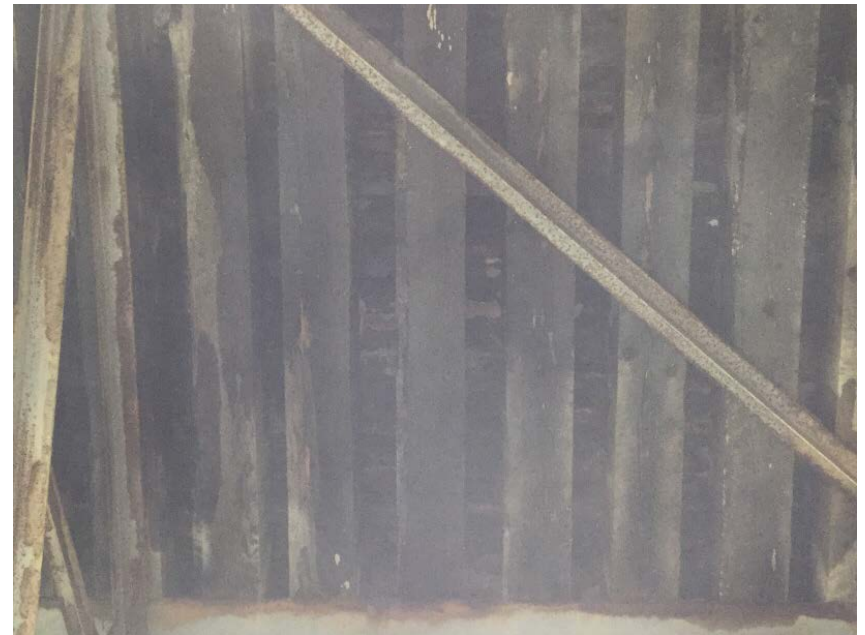
Subdeck is in poor condition

Indication of rot on subdeck

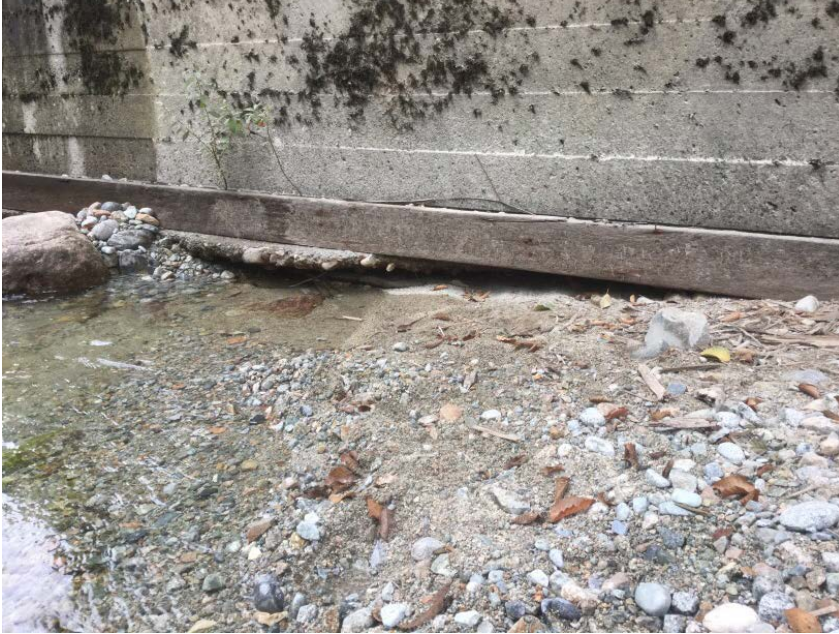
Left abutment scour, extends 700mm

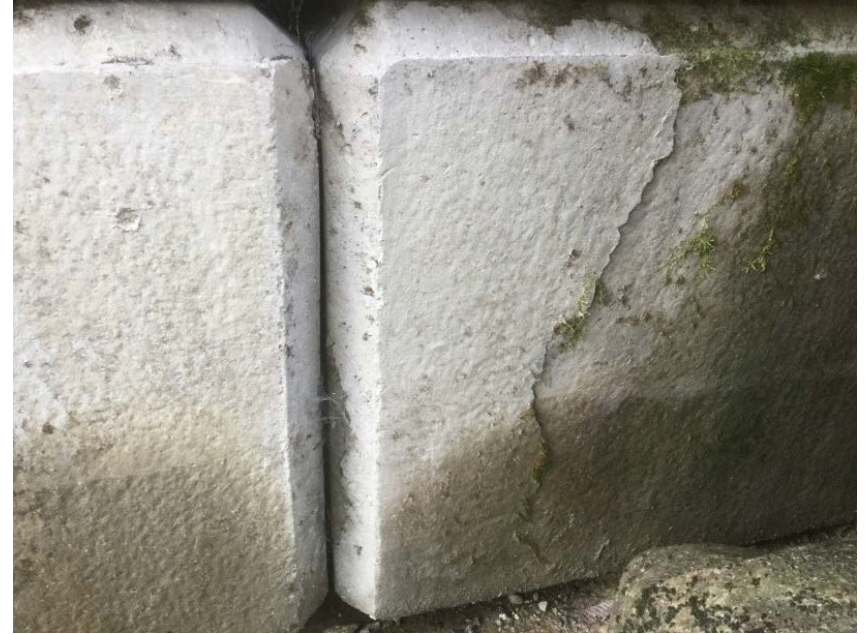
Bottom lock block at right abutment cracked

| Item | Monitor Description | Frequency |
|---|---|---|
| 2 | Lock block abutment condition | Routine Inspection |

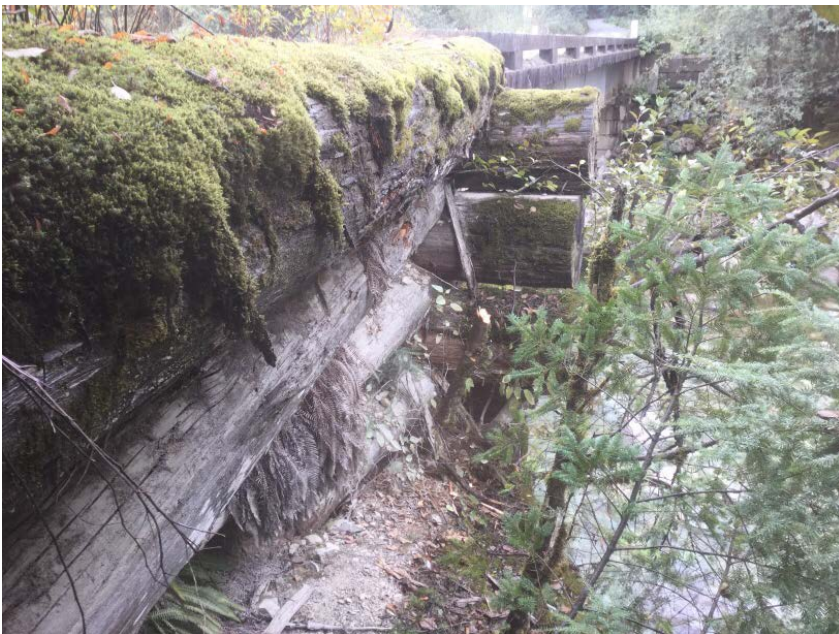
Log wingwall upstream left bank
