CK-2025

CHEHALIS 26.4km

2017 Inspection

| Crossing Name | Second Creek |

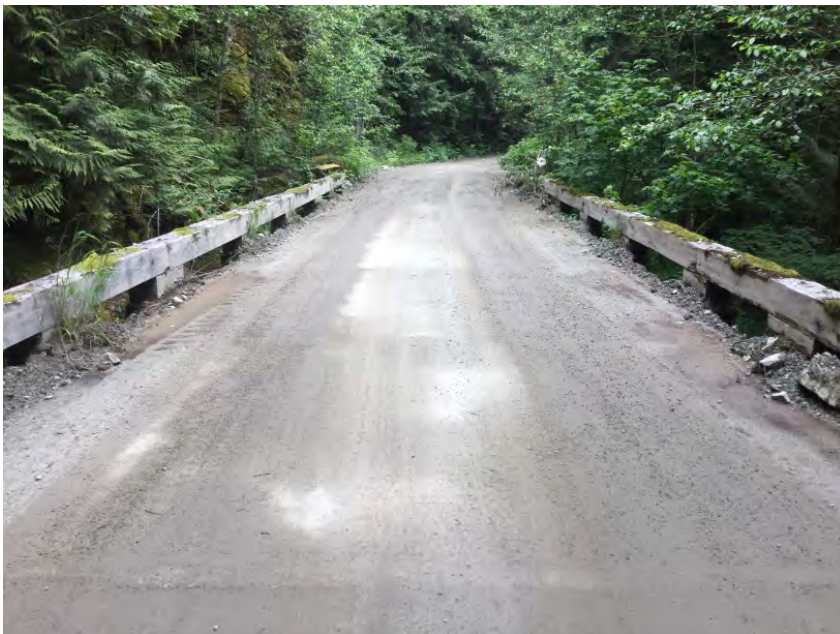
Curb Rail/Blocks/Posts      **Poor**      Rotting risers and blocks

Overall Deck Condition      **Poor**      Due to rail condition

| 1 | Medium | Replace guardrail, risers and blocks |

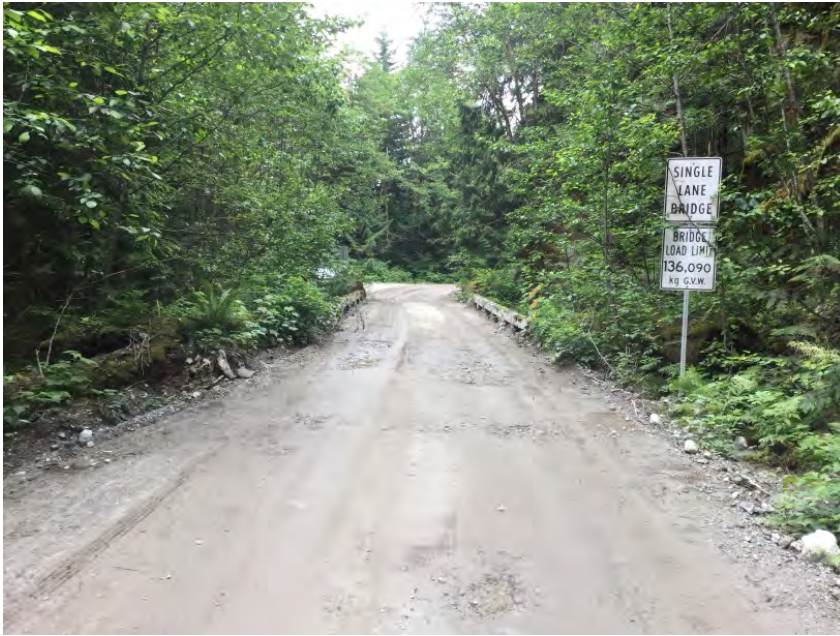
Approach from Left Bank when facing downstream

Delineator Missing  
Left ☐ 0 ☒ 1 ☐ 2

| 2 | Medium | Replace delineator and brush approaches |

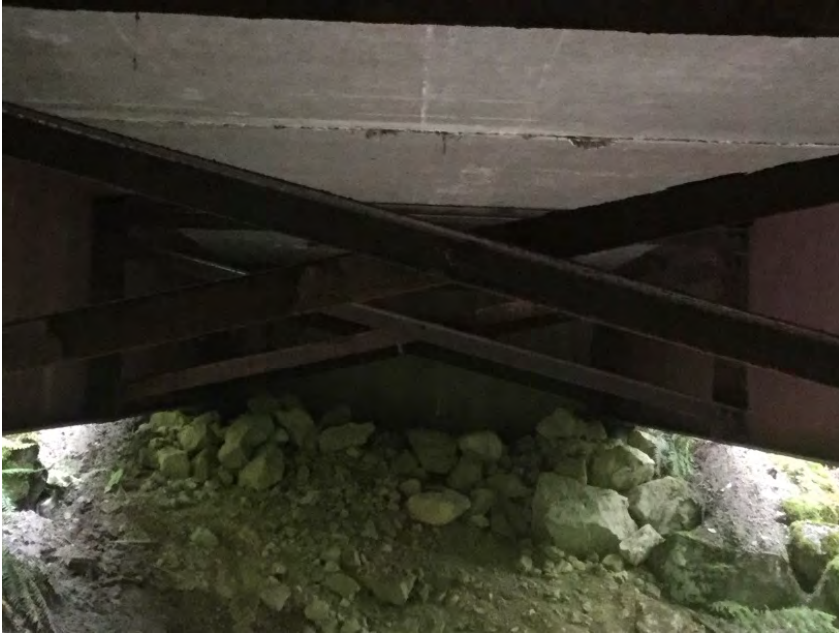
Diaphragms Fair 4 bolted bays, slight delamination occurring

Some delamination of diaphragm occurring

| 1 | steel delamination | Routine Inspection |
