CK-2033

CHEHALIS-STATLU 6km

2017 Inspection

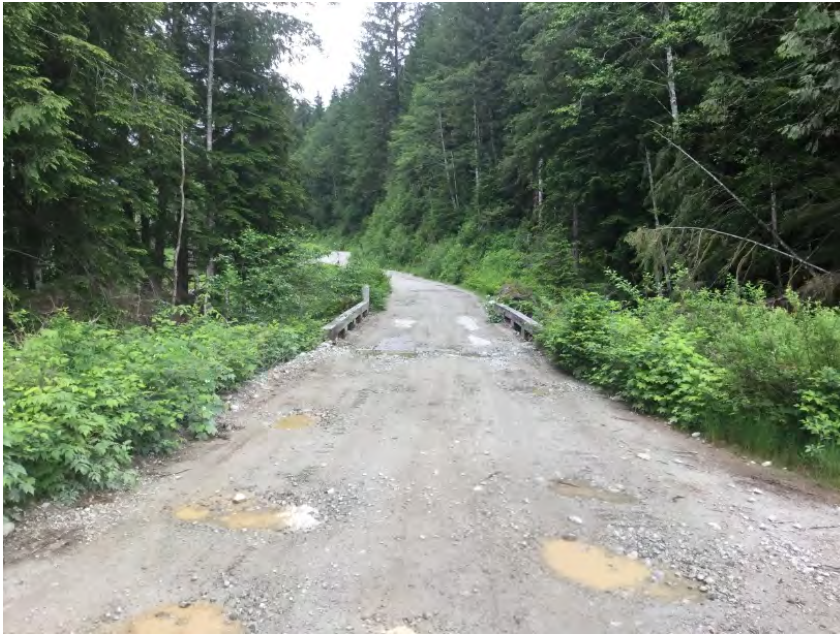
Approach from Left Bank when facing downstream

Delineator Missing  
 Left ☐ 0 ☐ 1 ☒ 2

Fender Condition Poor Missing left approach

| Repair | | Repair Description |
|---|---|---|
| 4 | Low | Replace log fenders |

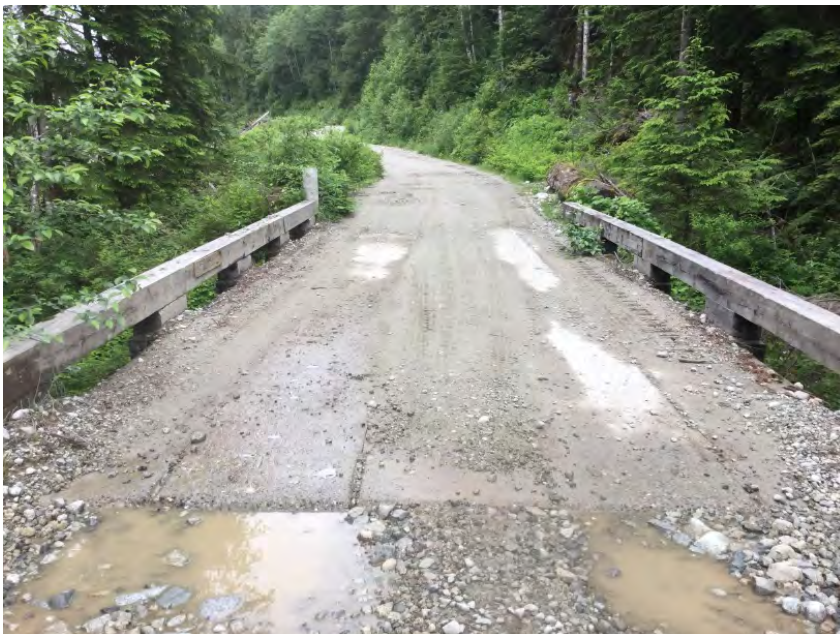
Curb Rail/Blocks/Posts Poor Rotting risers and blocks

Hardware Poor Loose rail bolts

Overall Deck Condition Poor Due to rail condition

| Repair | | Repair Description |
|---|---|---|
| 1 | Medium | Replace guardrail, risers and blocks |

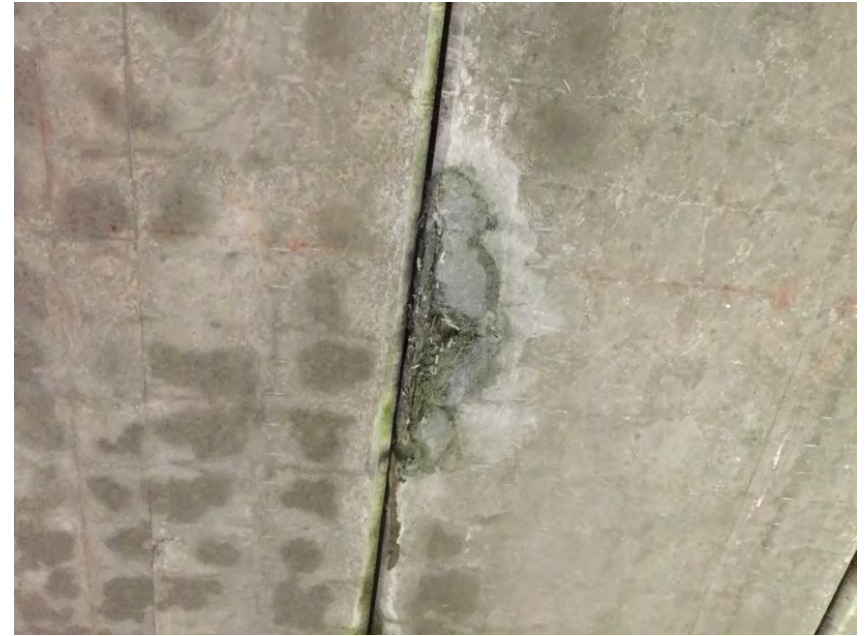
Repaired slab
