CK-2035

CHEHALIS-SOUTHSTATLU 0.1km

2017 Inspection

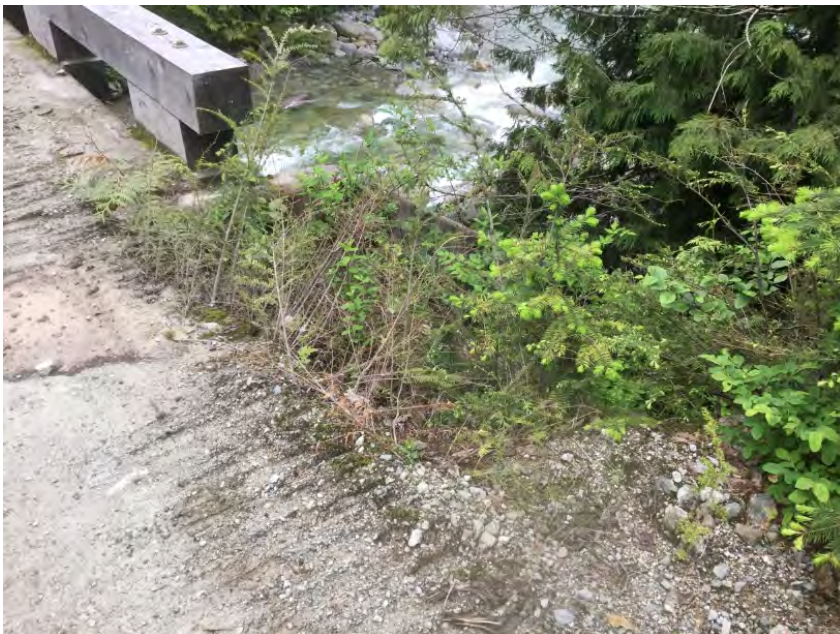
Road Surface Fair Loosing fill downstream right approach

Loosing fill at right downstream approach

Replace the eroding fill at the down stream right approach. Replace the missing fenders logs, delineators and bridge ahead signs. Present load rating of L150 or 136 tonnes to continue.

| Item | Priority | Repair Description |
|---|---|---|
| 1 | Medium | Replace eroding fill slope at down stream right approach |
