CK-2036

CHEHALIS-SOUTHSTATLU 0.2km

2017 Inspection

| Crossing Name | Statlu Creek |

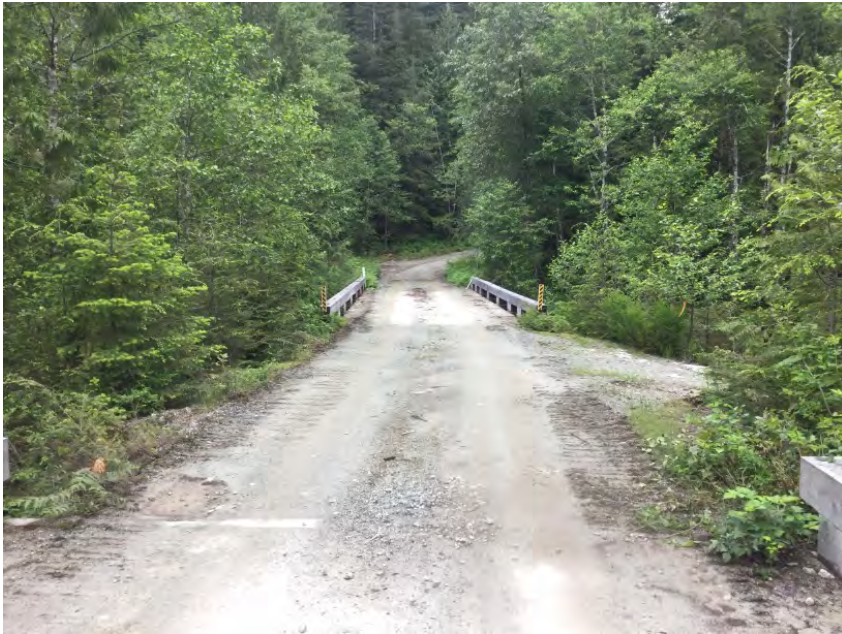
Approach from Left Bank when facing downstream

Bridge Ahead Signs  
Missing ☐ 0 ☐ 1 ☒ 2

Delineator Missing  
Left ☐ 0 ☒ 1 ☐ 2Delineator Missing  
Right ☒ 0 ☐ 1 ☐ 2

| 2 | Medium | Replace missing delineator and post bridge ahead signs |

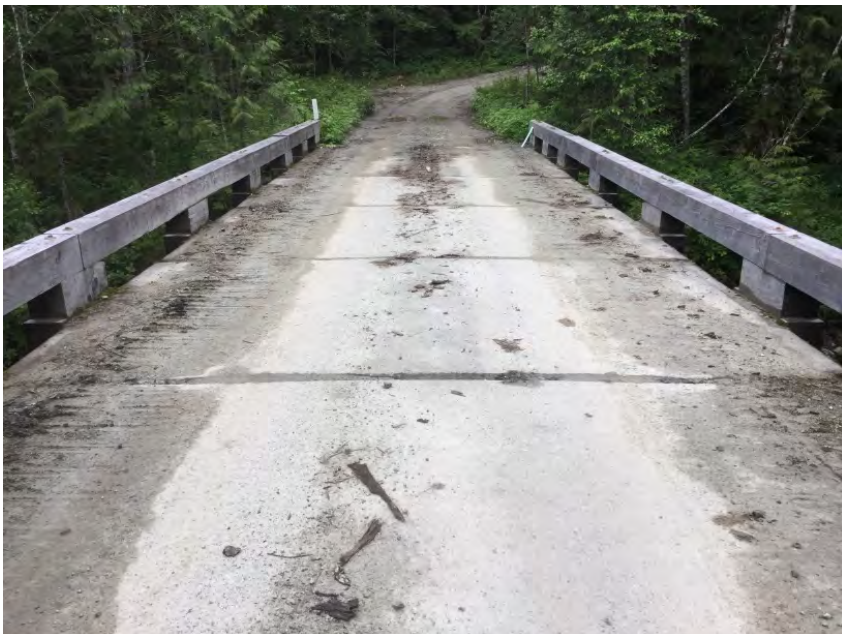
Deck Joints      **Poor**      Missing seals

Overall Deck Condition      **Poor**      Due to missing joint seals

| 1 | Medium | Replace missing deck seals |

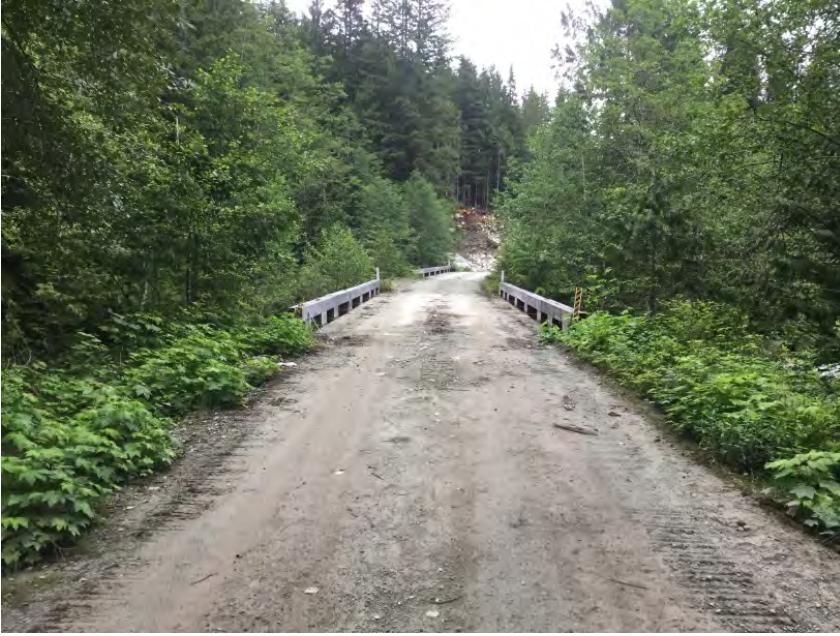
Approach from Right Bank when facing downstream

Fender Condition Poor None

| 3 | Medium | Replace missing fenders |

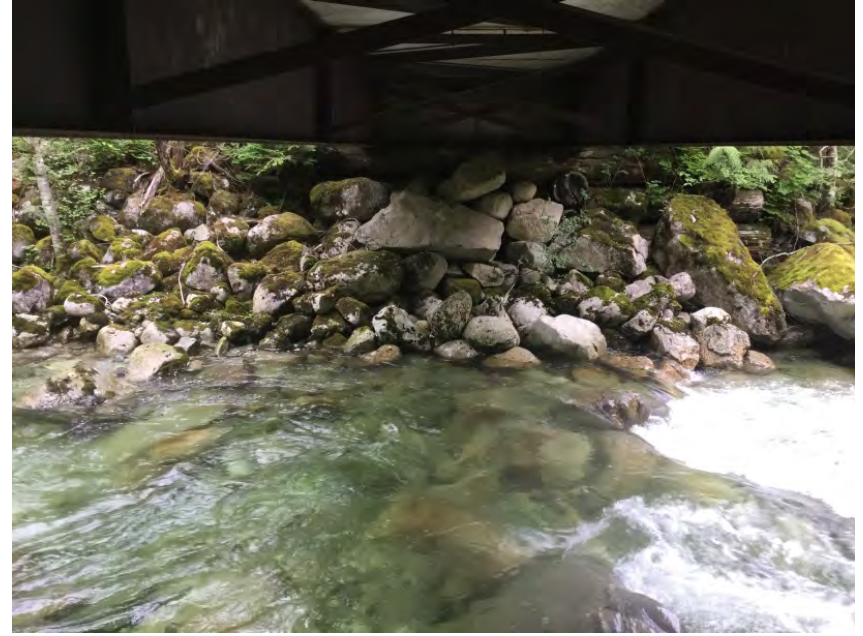
Left Bank Abutment when facing downstream

Log/Timber Cribs Fair 4x left bank, 3x right bank

Tie Backs Fair 4x and splitting but functional

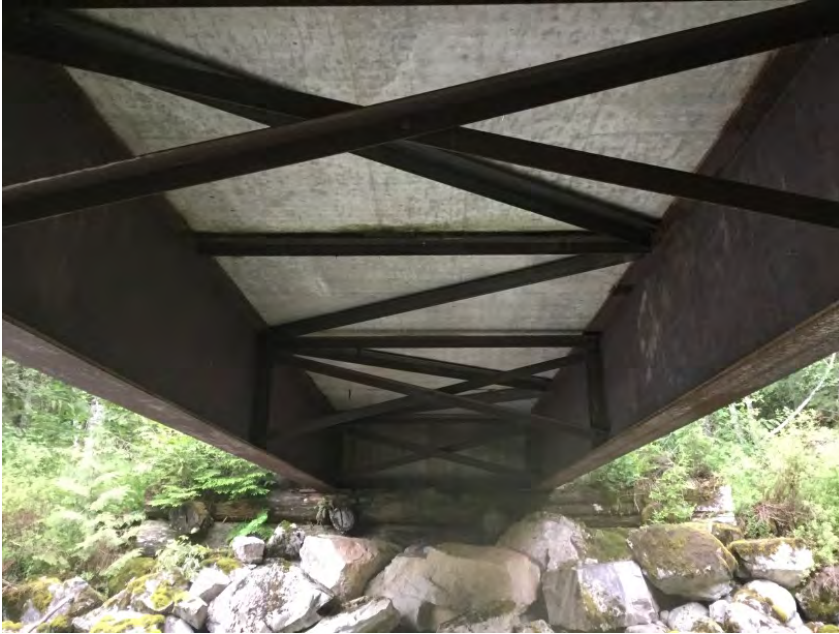
Superstructure

Girders Good

Diaphragms Good 4 bolted bays
