CK-2040

CHEHALIS-FLEETWOOD 3.1km

2017 Inspection

| Crossing Name | Lower Bentley Creek |

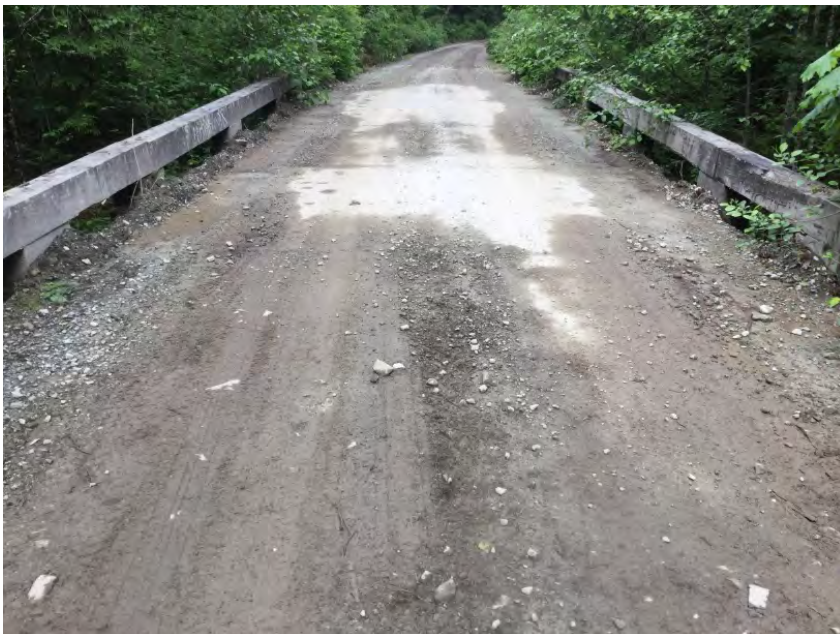
Overall Deck Condition      Fair
