CK-2042

CHEHALIS-FLEETWOOD 4.3km

2017 Inspection

| Crossing Name | Maisal Creek |

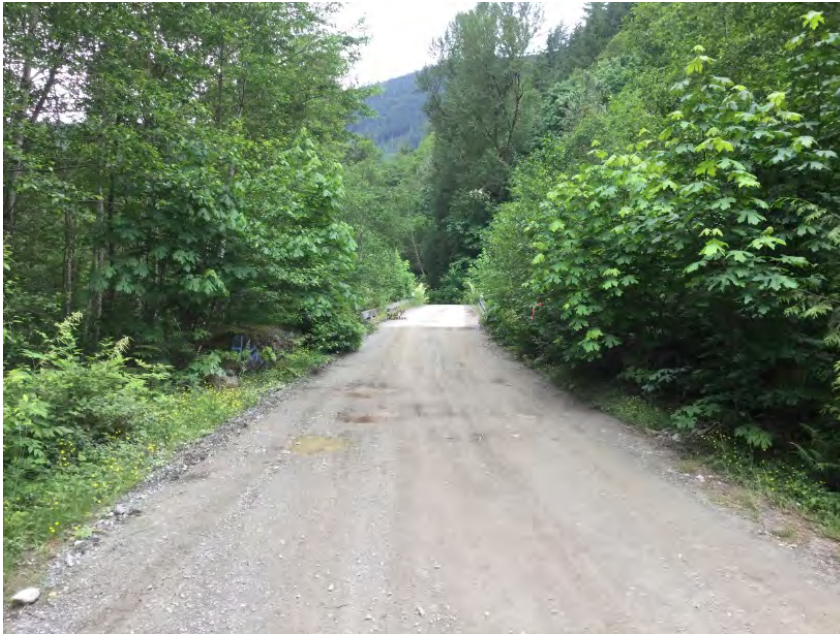
Approach from Left Bank when facing downstream

Bridge Ahead Signs  
Missing ☐ 0 ☒ 1 ☐ 2

Delineator Missing  
Left ☐ 0 ☒ 1 ☐ 2Delineator Missing  
Right ☒ 0 ☐ 1 ☐ 2

| Repair Item | Priority | Repair Description |
|---|---|---|
| 1 | Medium | Replace missing delineator and bridge ahead sign |

| 2 | Medium | Brush approaches |

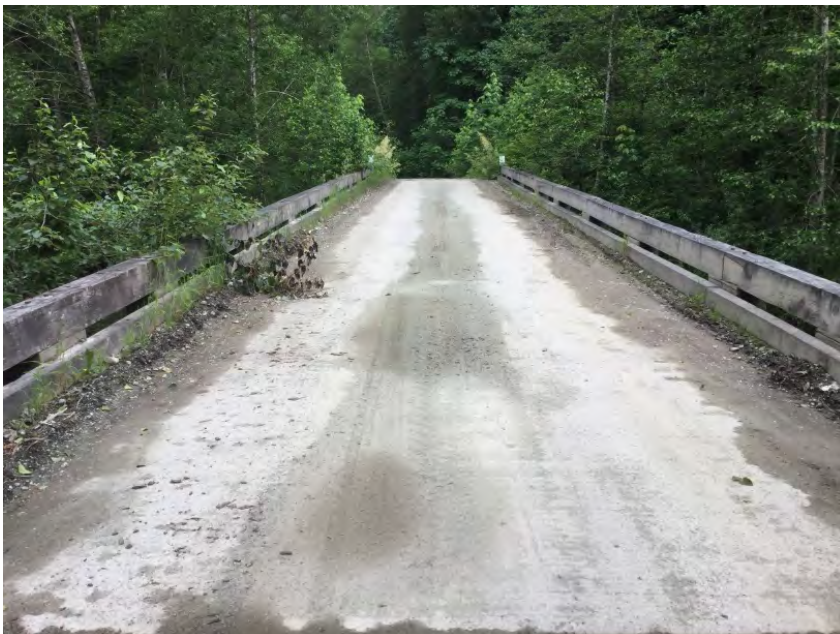
Running Surface Fair

Concrete Deck Fair Some wear on wheel path and under deck panel 1 on left approach

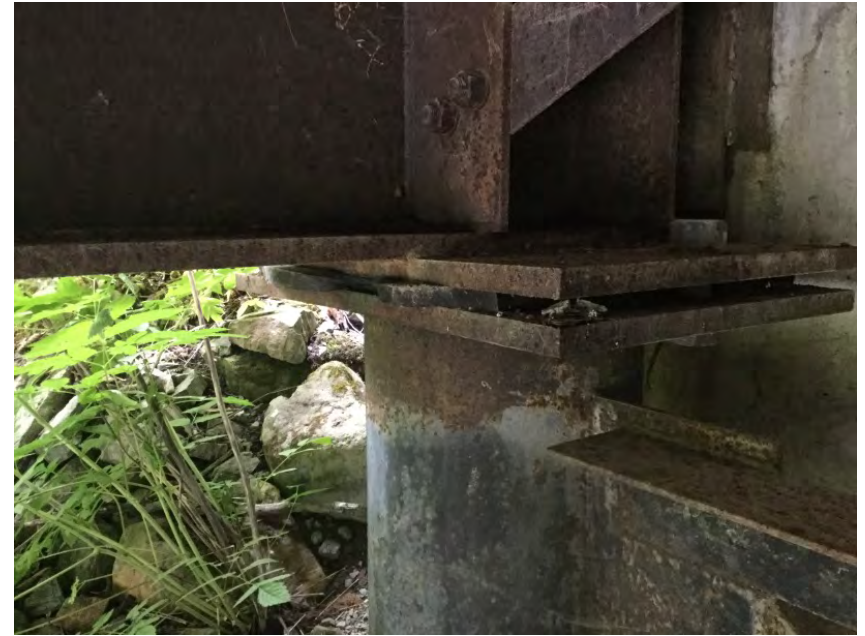
Bearings Fair

Right downstream bearing - typical all 4

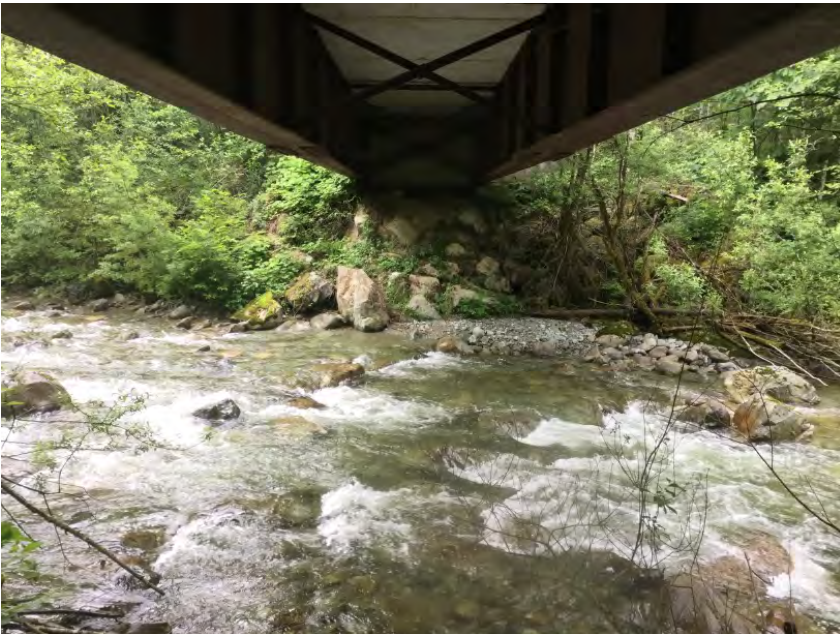
Left Bank Abutment when facing downstream

Ballast Wall Fair Some damage noted at surface

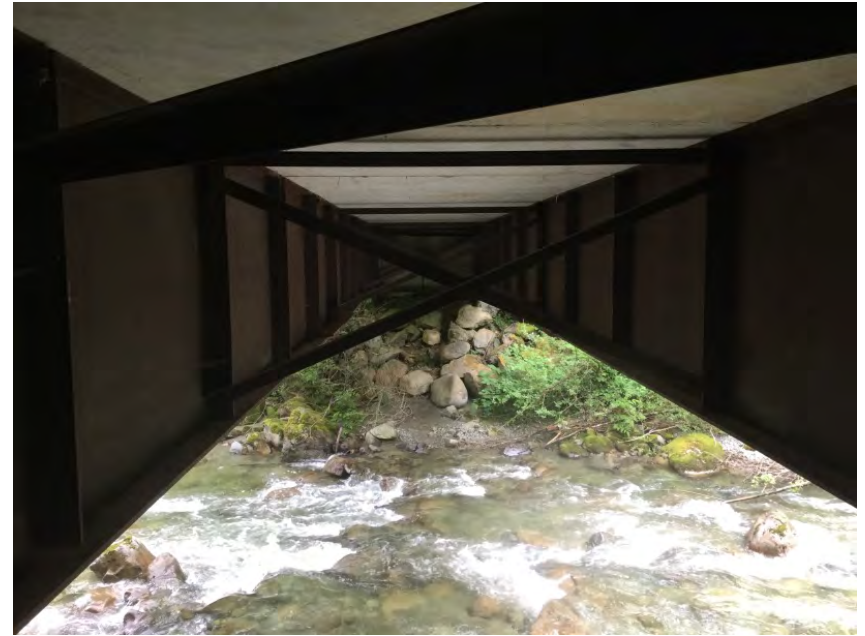
Superstructure

Girders Good

Diaphragms Good 5 bolted bays

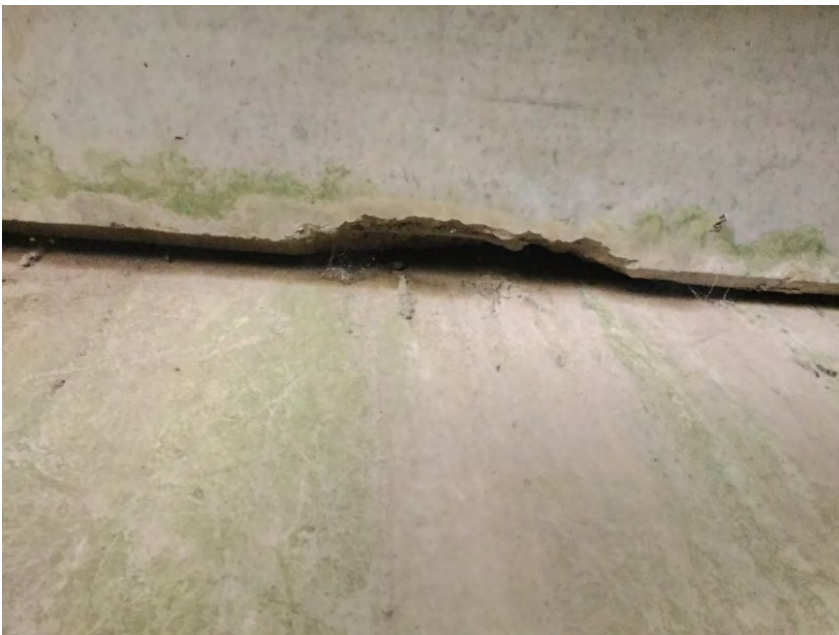
Damaged deck panel 1 on left approach
