CK-2045

CHEHALIS-MYSTERY 6.9km

2017 Inspection

| Crossing Name | Mystery creek |

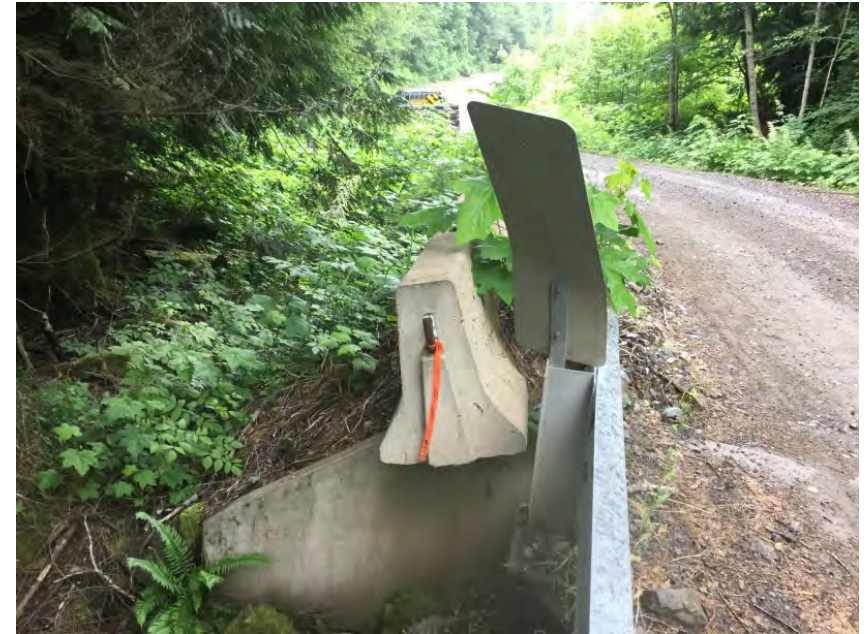
concrete no post barriers not aligned properly

Right downstream approach concrete no pos barriers could be realigned

Realign the concrete no post barriers and post bridge ahead signs. Present load rating of L75 or 68 tonnes to continue.

| Repair Item | Priority | Repair Description |
|---|---|---|
| 1 | Medium | Realign concrete no post barriers prior to hauling |

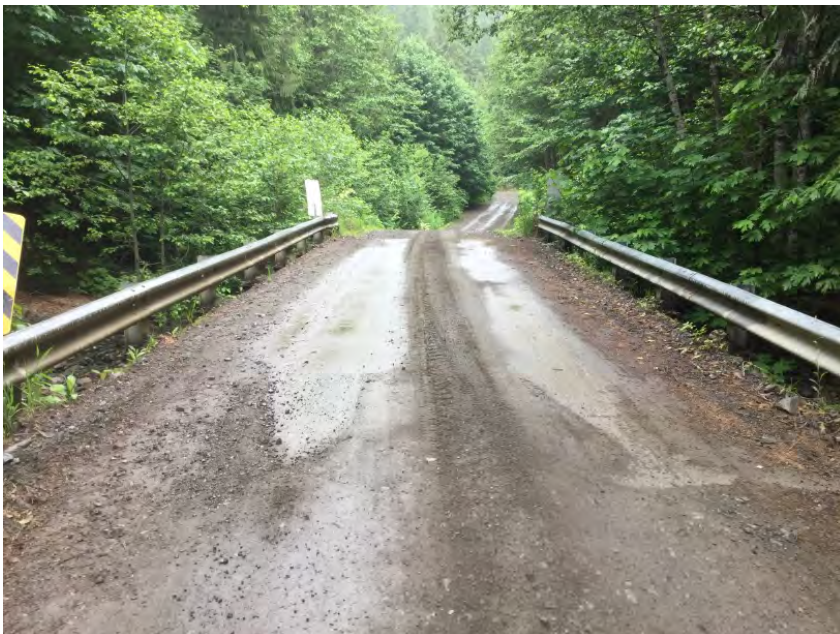
Concrete Deck      Fair      Some track damage on wheel path

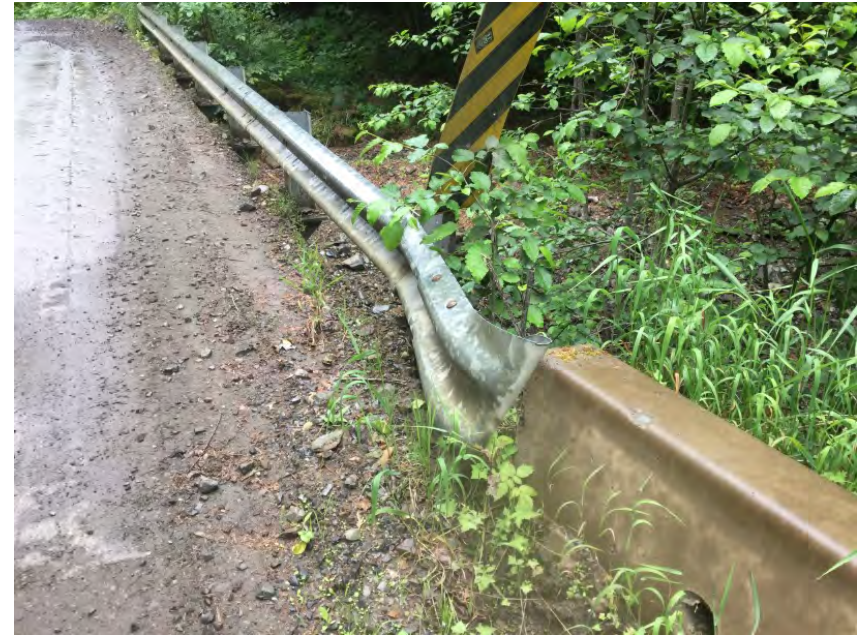
Curb Rail/Blocks/Posts      Fair      minor damage down stream right approach

Damage to right downstream guardrail - still functional

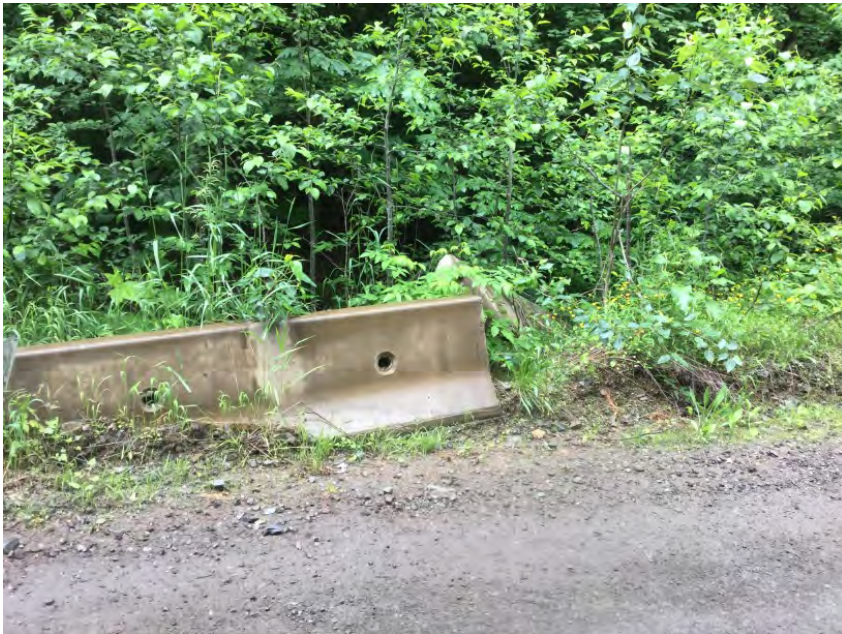
Left upstream approach concrete no post barriers should be realigned

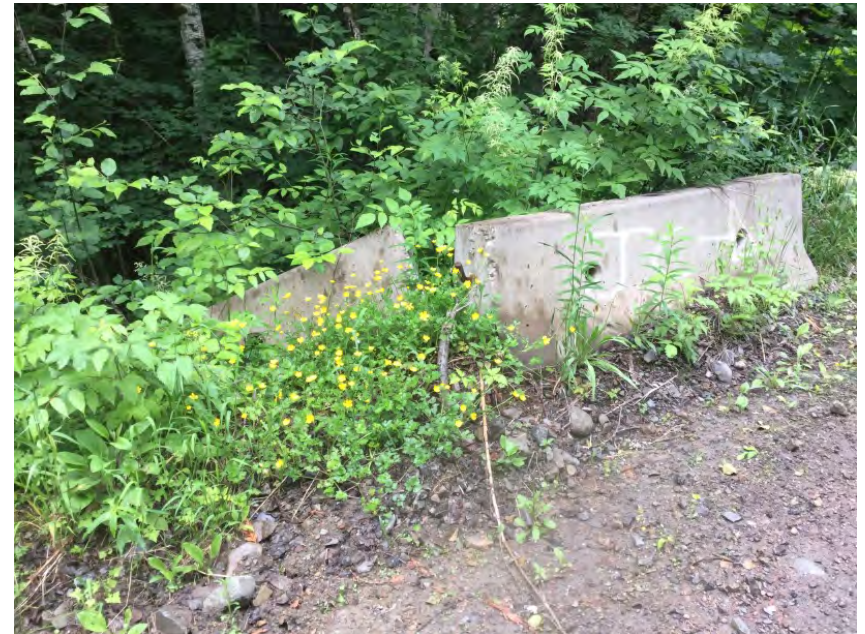
Left downstream concrete no post barriers should be realigned
