2046

CHEHALIS-MYSTERY 10.3km

2017 Inspection

| Crossing Name | mystery creek |

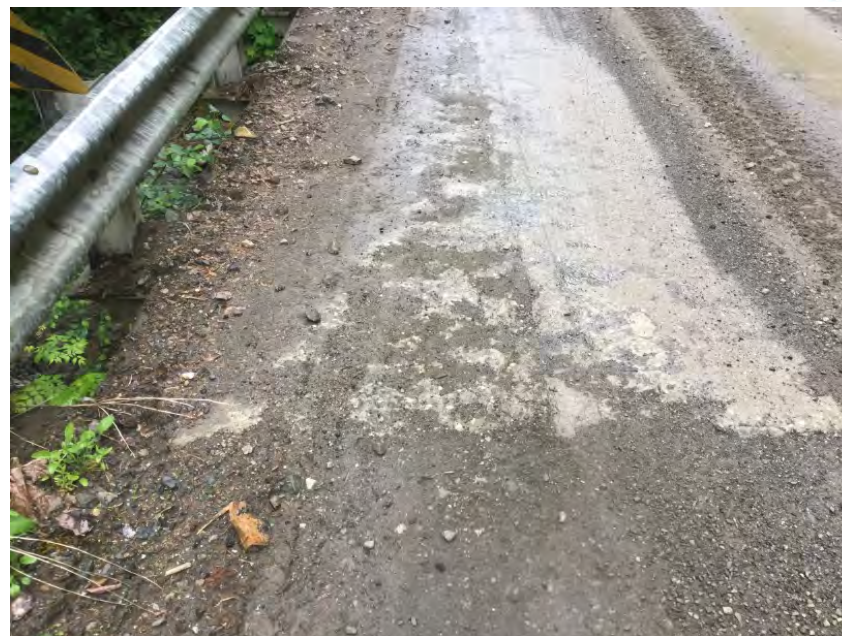
Concrete Deck      Fair      Fair to poor as damage to left bank slabs at surface

Girders Fair Damage at surface noted at left bank at slab/bank interface

Comments    Tracked machinery has damaged 3 of 4 slabs at the left bank

Significant surface damage at left approach - no sign of damage to underside of slabs

Repair damage noted to the top of the concrete slabs - consult CEG for a repair prescription prior to doing so. Repair or replace the damaged riser and replace the missing bridge ahead sign. Brush approaches. Monitor the damage and condition of the concrete slab girders. Present load rating of L75 or 68 tonnes to continue.

| Repair | | Repair Description |
|---|---|---|
| 2 | Medium | Repair damage to concrete slabs noted at left bank |

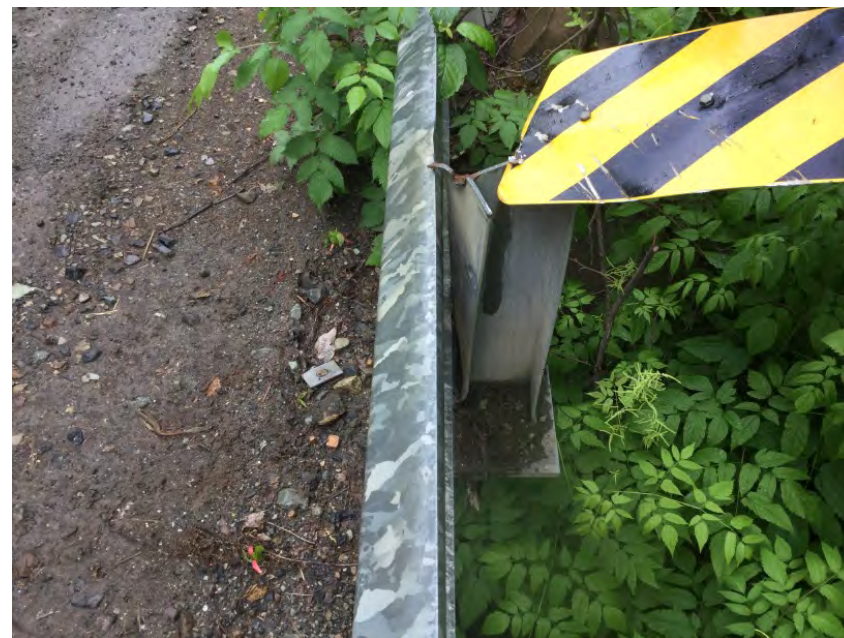
Curb Rail/Blocks/Posts      Fair      Damage to 1 riser noted - missing bolt

Damage to upstream right bank riser

| Repair | | Repair Description |
|---|---|---|
| 1 | Medium | Replace/repair damaged riser |
