CK-2048

CHILLIWACK RIVER 1km

2017 Inspection

| Structure Class | Major Culvert |

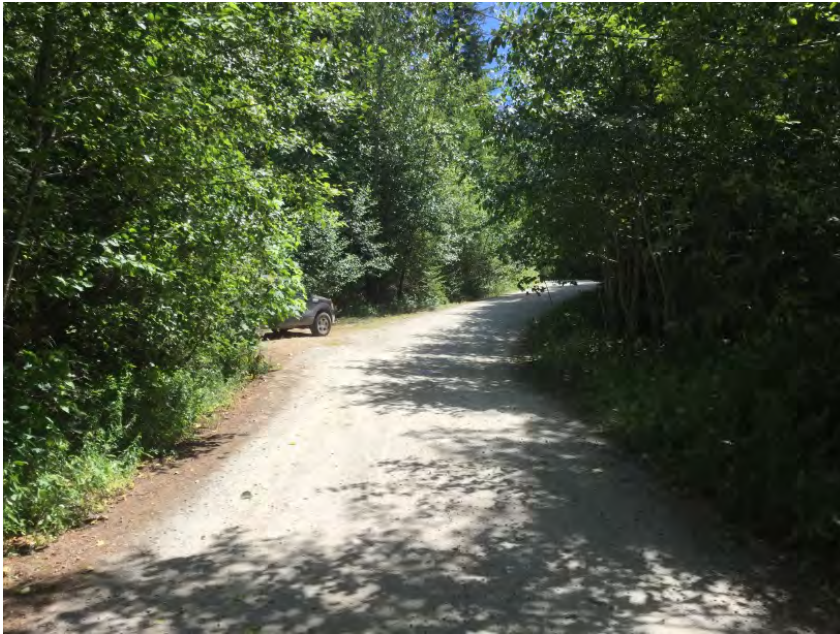
Approach from Right Bank when facing downstream

Brushing Required Y

| 2 | Low | Brush approaches |

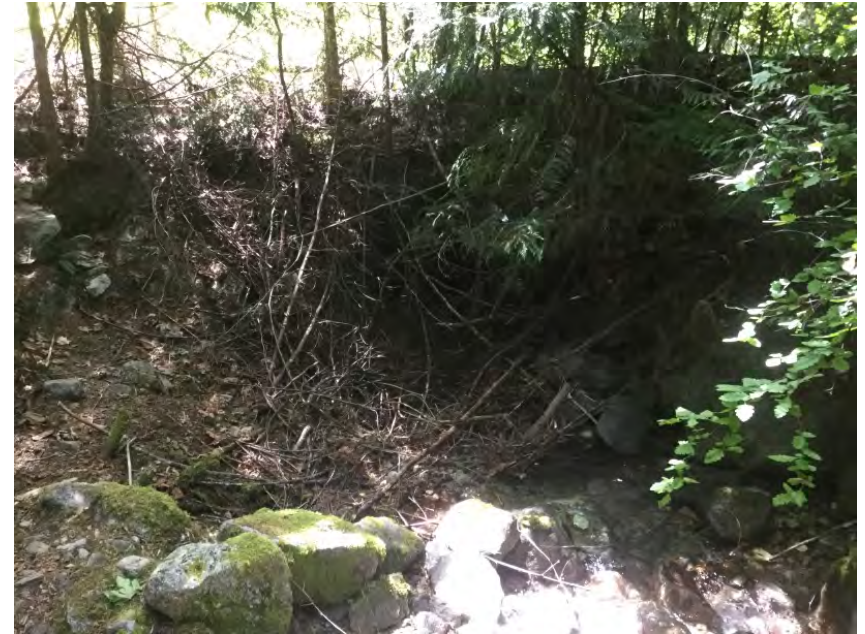
Inlet

Poor

Debris buildup

| 1 | Medium | Clean inlet |

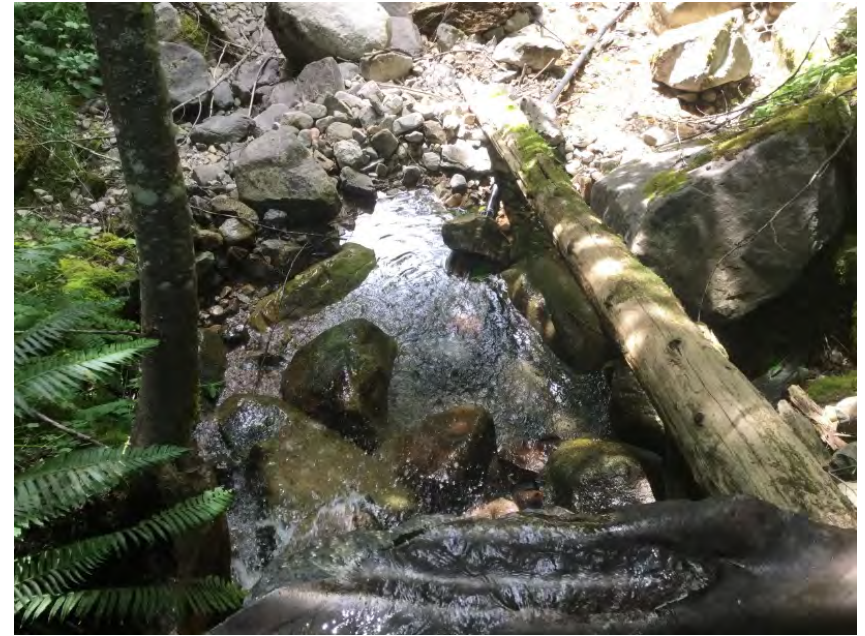
Outlet and water line

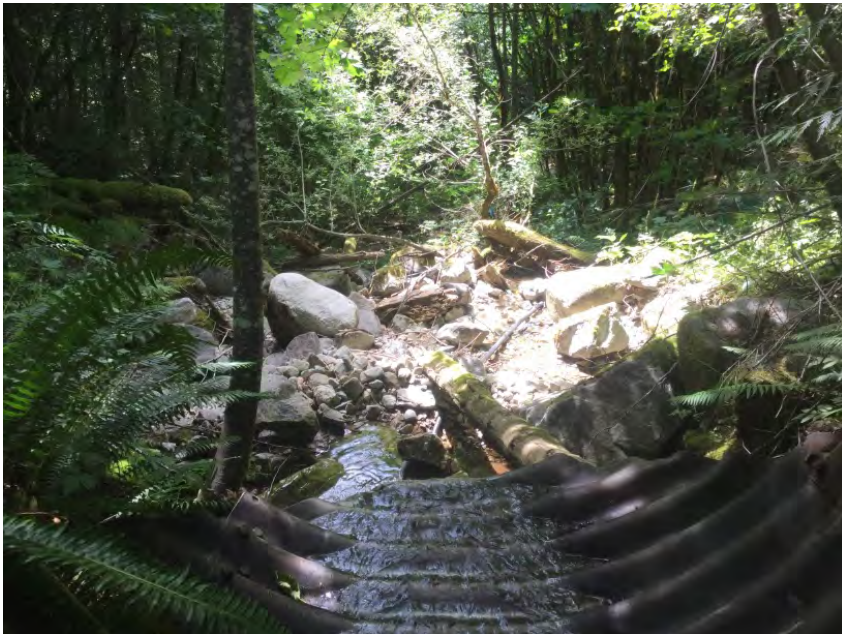
Outlet

Fair

2m drop
