CK-2068

SLESSE CREEK 6.1km

2017 Inspection

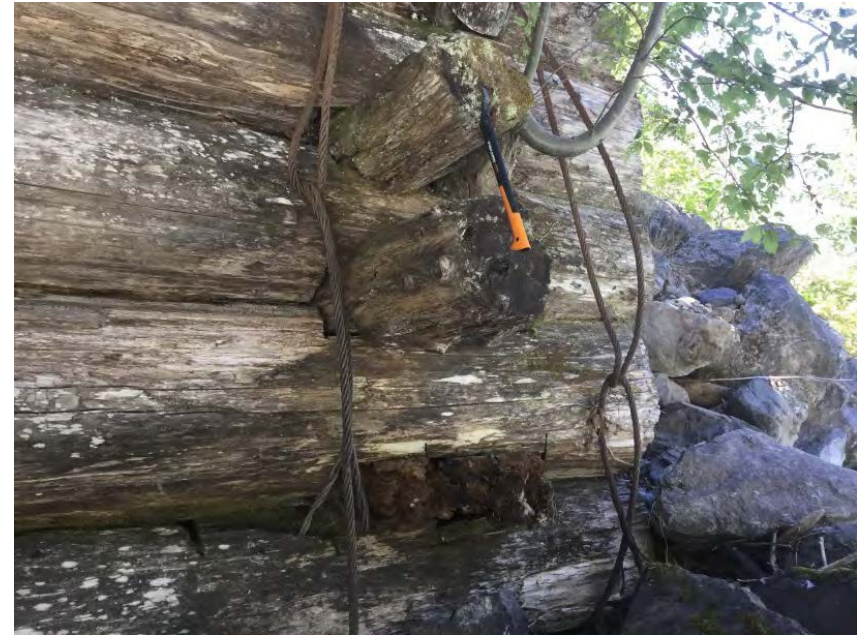
Tie Backs Poor All tie backs have extensive rot at ends and some completely sheared off at face log interface

Left bank tie back condition - Poor

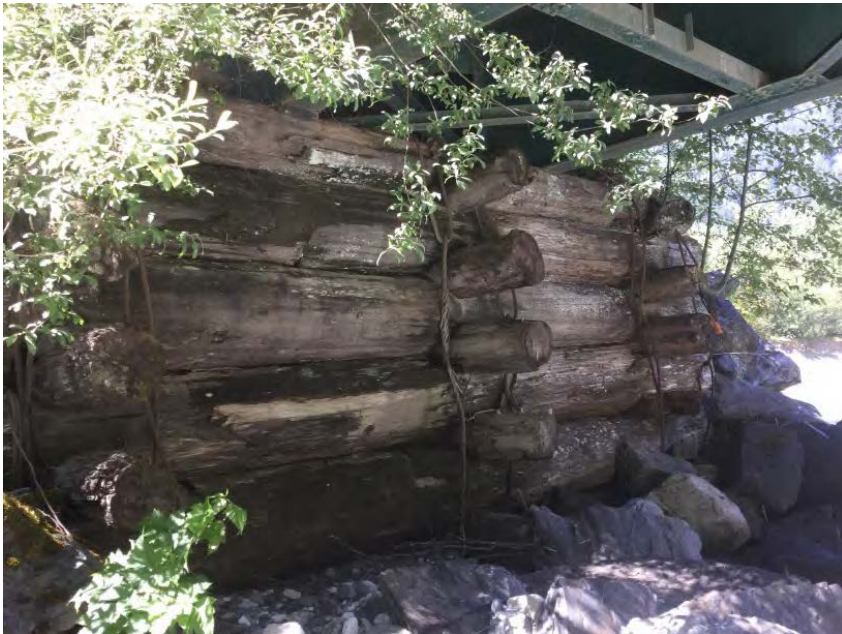
Left Bank Abutment when facing downstream

Log/Timber Cribs Poor 6 face logs (closed - face) both abutments; up to 100mm sap rot; however no crushing apparent

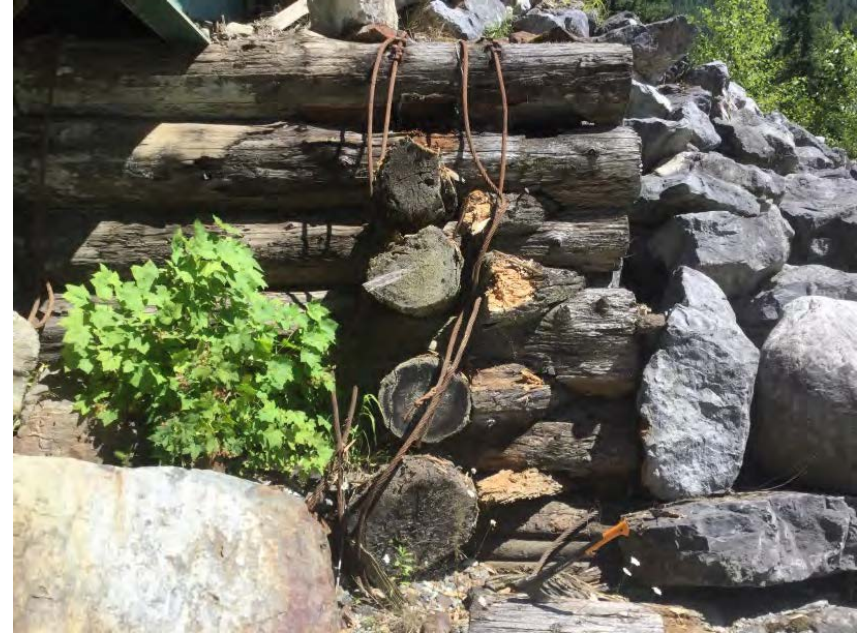
Wing Wall Poor Extensive rot

Right bank tieback condition - top upstream tieback sheared completely off, wing logs completely rotten at ends

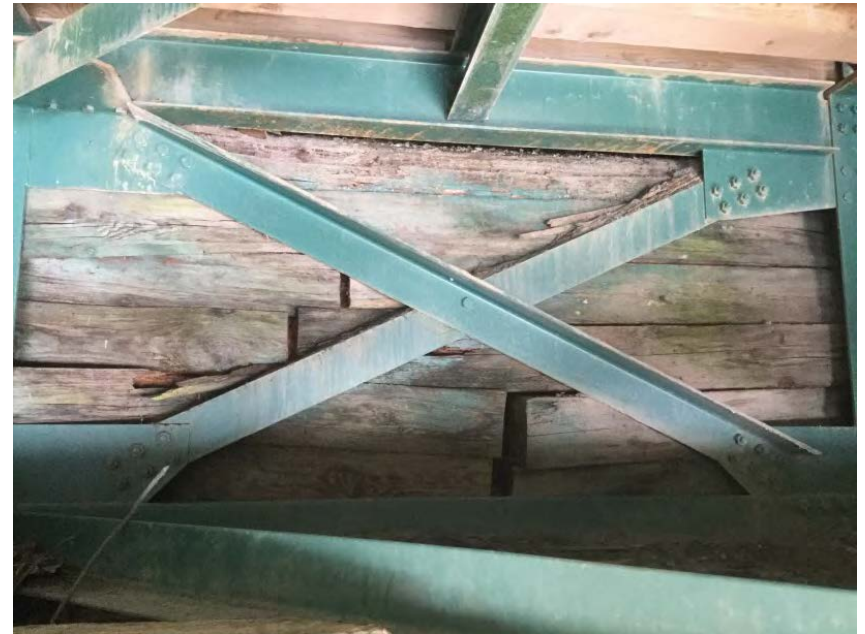
Ballast Wall Poor Extensive rot

Right bank ballast wall - extensive rot

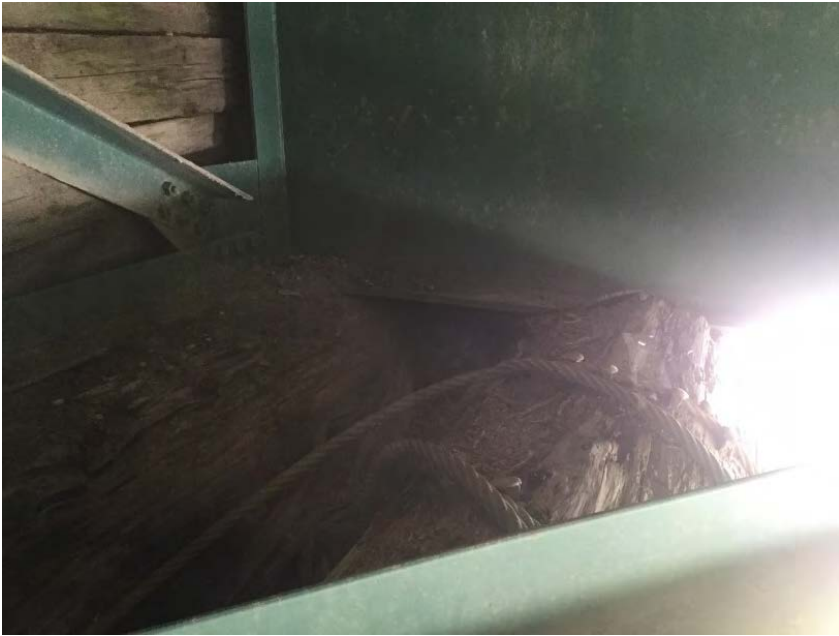
Bearings Fair girders bear at 2 different locations on right abutment - see photo

Right bank abutment bearing in 2 locations - both upstream and downstream
