CK-2086

CHILLIWACK SOUTH 4.4km

2017 Inspection

| Crossing Name | Center Creek |

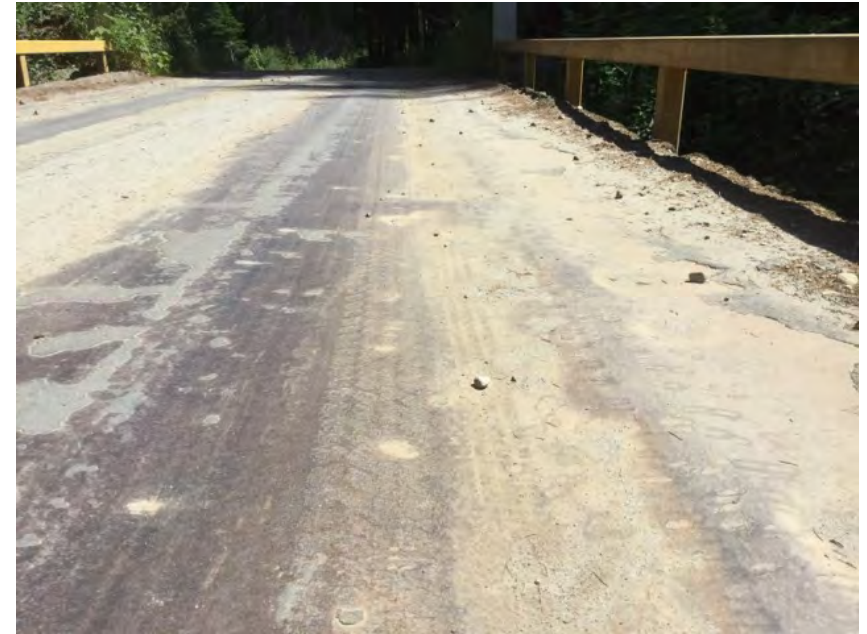
Steel Deck Plate      Fair      Some deformation on wheel path

Deck deformation on wheel path

Brush and grade approaches. Monitor steel deck deformation and loss of fill due to lack of ballast wall. Present load rating of L75 or 68 tonnes to continue.

| Item | Monitor Description | Frequency |
|---|---|---|
| 1 | Steel deck plate for further deformation | Routine Inspection |

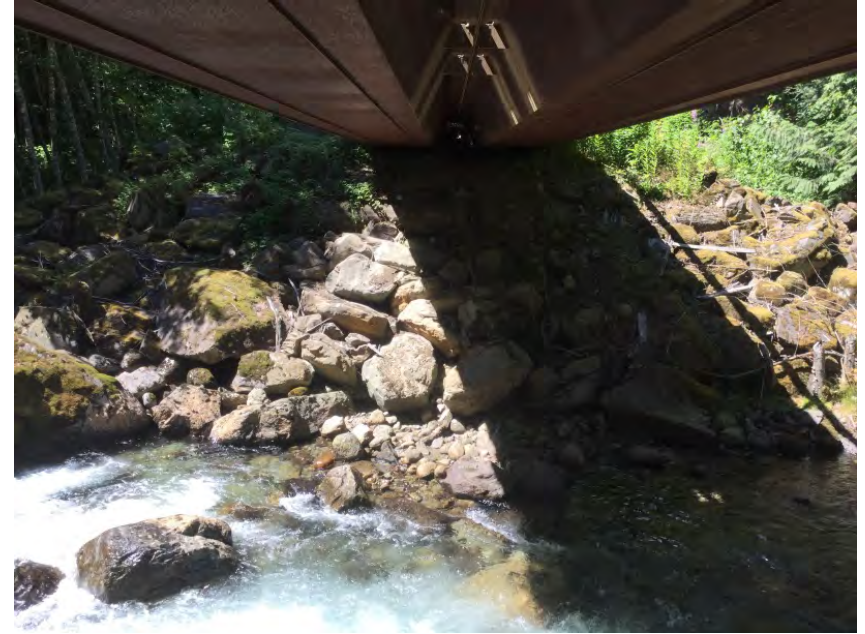
Left Bank Abutment when facing downstream

Ballast Wall Poor None

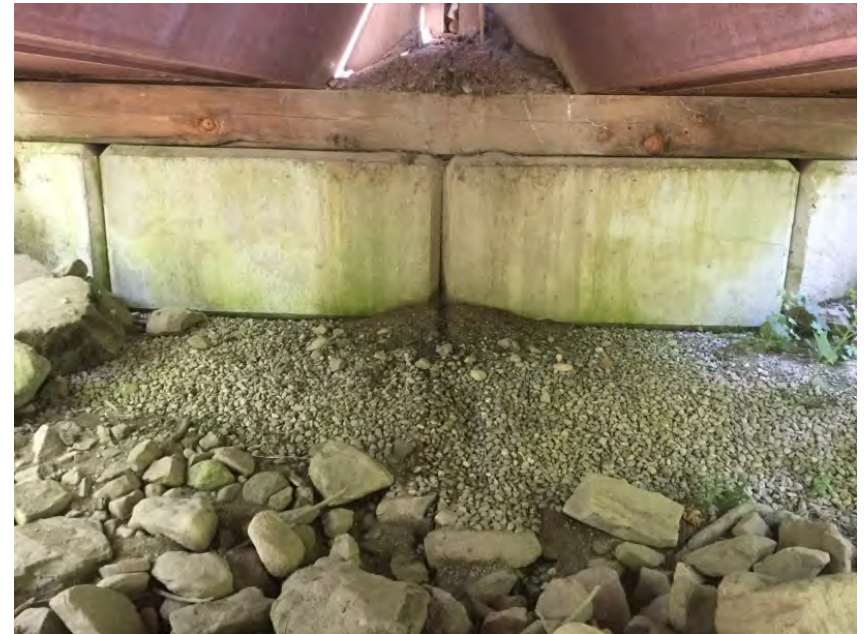
Right Bank Abutment when facing downstream

Concrete Good Lock blocks visible on right bank

Riprap Good Steep at right bank
