CK-2087

DEWDNEY CREEK 5.2km

2017 Inspection

| Crossing Name | Cedar Flat Creek |

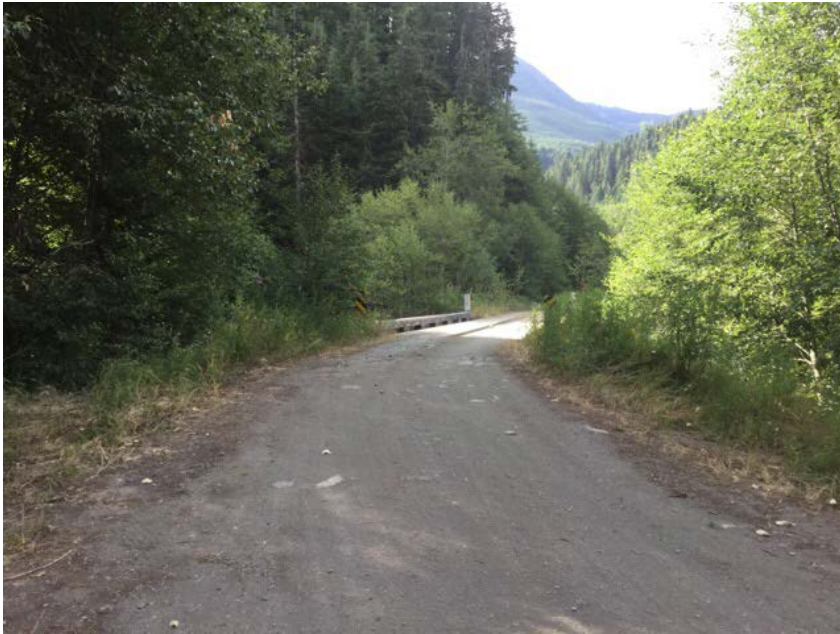
Approach from Right Bank when facing downstream

HC right approach

Bridge Ahead Signs  
Missing
☐ 0
 ☐ 1
 ☒ 2

Brushing Required Y

| 1 | Medium | Brush approaches |
| 2 | Medium | Post bridge ahead signs |

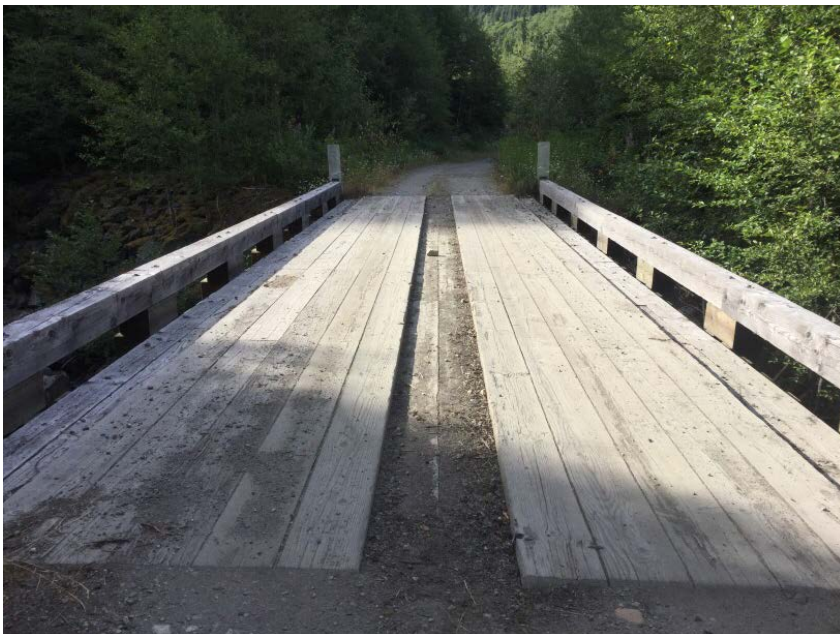
Overall Deck Condition Fair

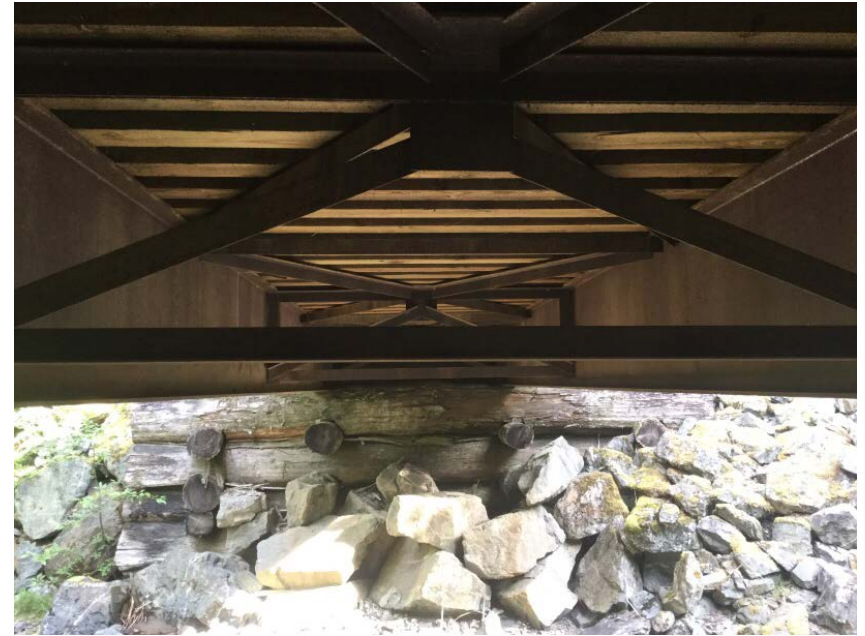
Superstructure

Girders Fair

Slight corrosion

Diaphragms Fair

4 welded bays with slight corrosion

Bracing Fair

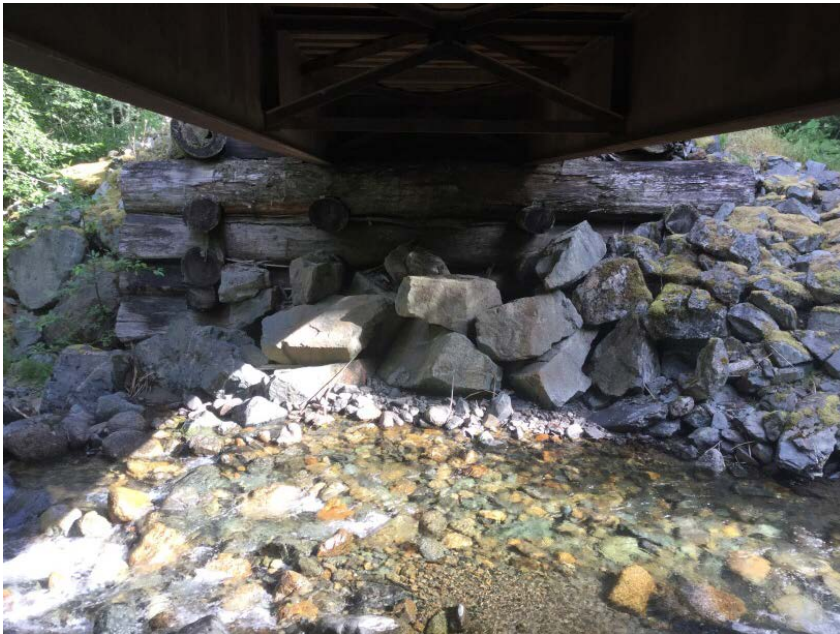
Right Bank Abutment when facing downstream

Fair

4 high on right bank, 3 high on left bank
