CK-2092

FLORENCE LAKE 4.2km

2017 Inspection

| Crossing Name | Rockwell Creek | | |

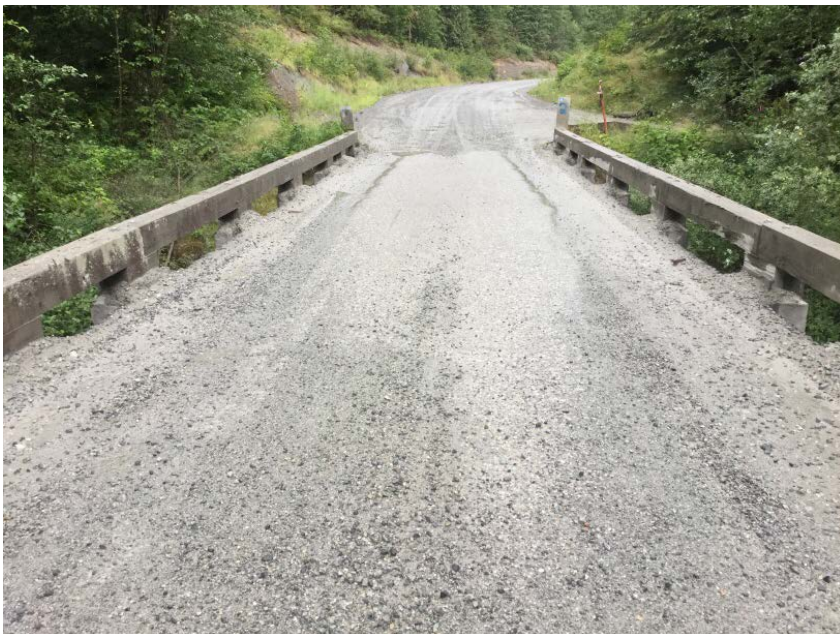
Curb Rail/Blocks/Posts Poor Side blocks up to 50% rotten

Overall Deck Condition Poor Due to rotting sideblocks and loose rail bolts

Replace guardrail, risers and blocks. Clean sediment off deck. Present load rating of L75 or 68 tonnes to continue.

| 1 | Low | Clean sediment from deck |
| 2 | Medium | Replace guardrail, risers and blocks |

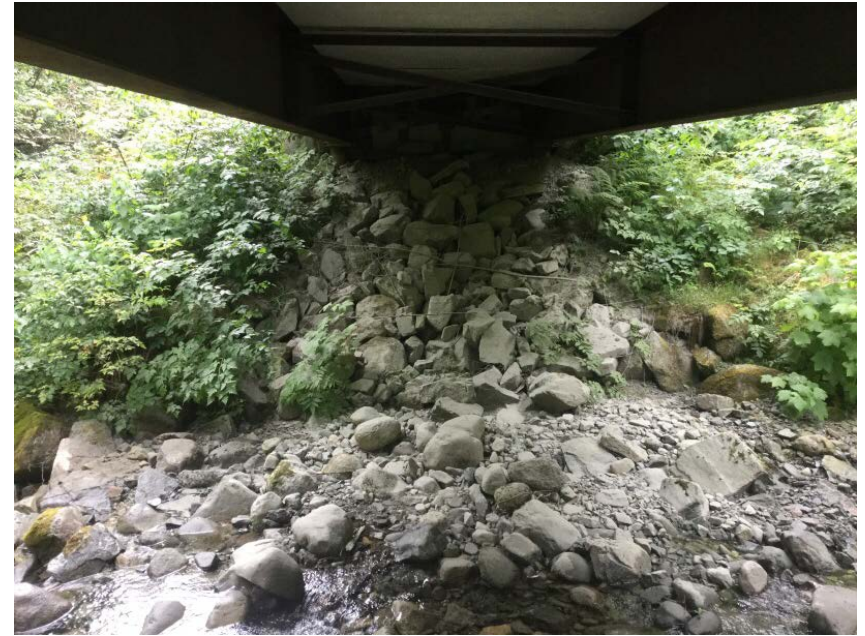
Right Bank Abutment when facing downstream

Bearings Fair Rubber bearing pads slightly bulging

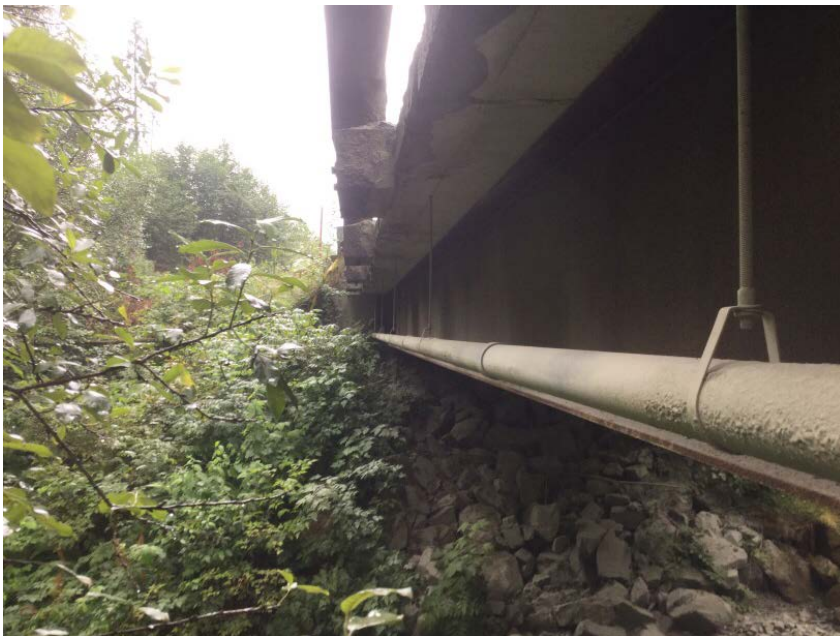
Utilities hung from deck

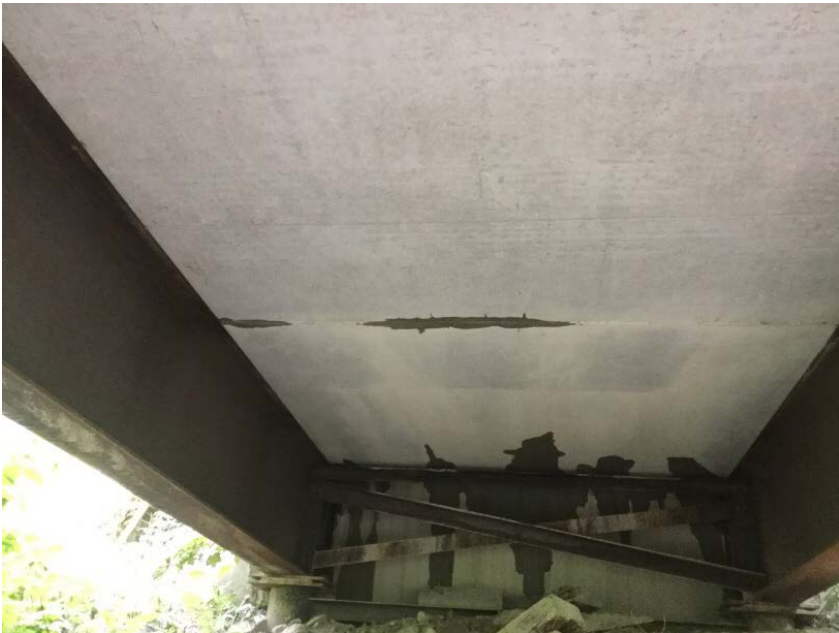
Deck Joints Fair Minor surface cracks and water getting through some joints

Water getting through deck joints but not severe

| Item | Monitor Description | Frequency |
|---|---|---|
| 1 | deck joints | Routine inspection |
