CK-2094

FLORENCE LAKE 7.8km

2017 Inspection

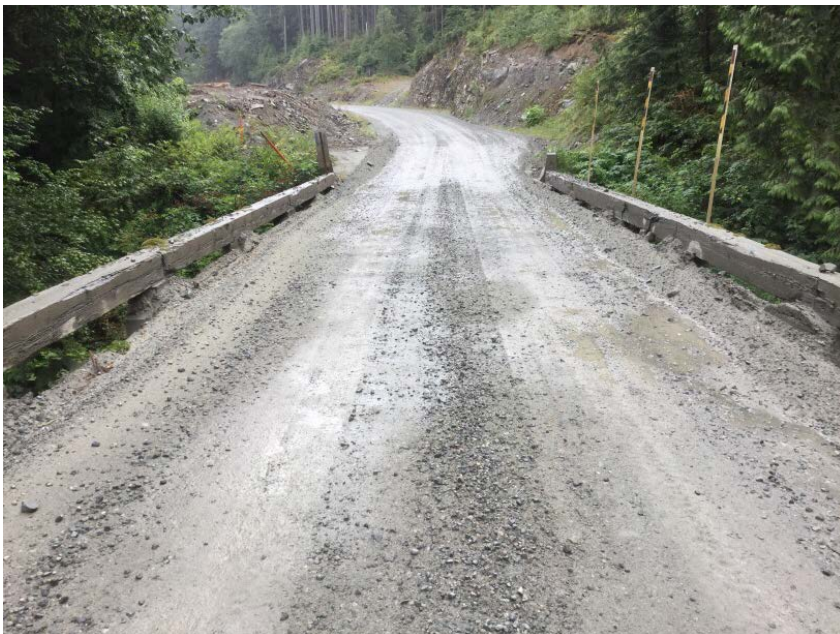
| Curb Rail/Blocks/Posts | Poor | Sideblocks are up to 50% rotten |

| Overall Deck Condition | Poor | Due to sideblock condition |

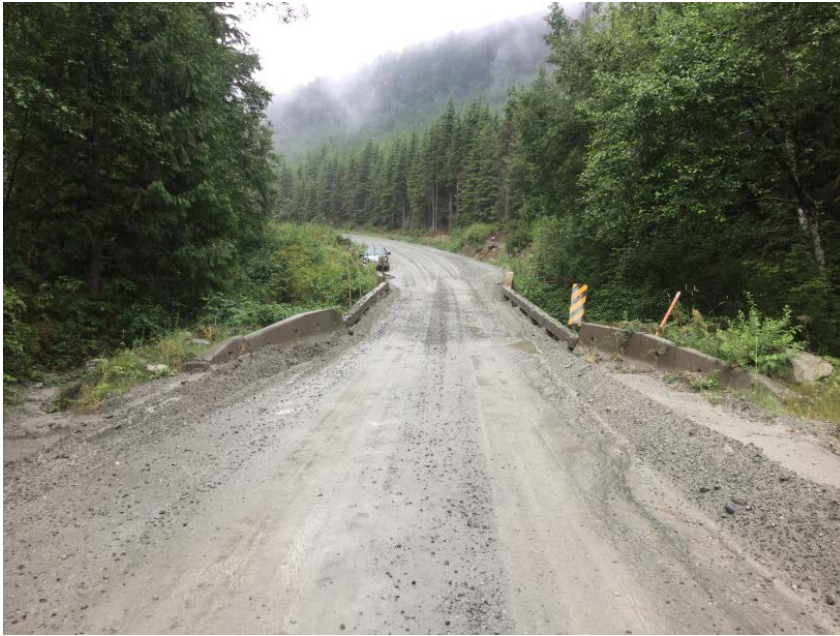
Approach from Left Bank when facing downstream

Delineator Missing  
Left ☐ 0 ☒ 1 ☐ 2

| Repair Item | Priority | Repair Description |
|---|---|---|
| 1 | Medium | Replace missing left delineator |

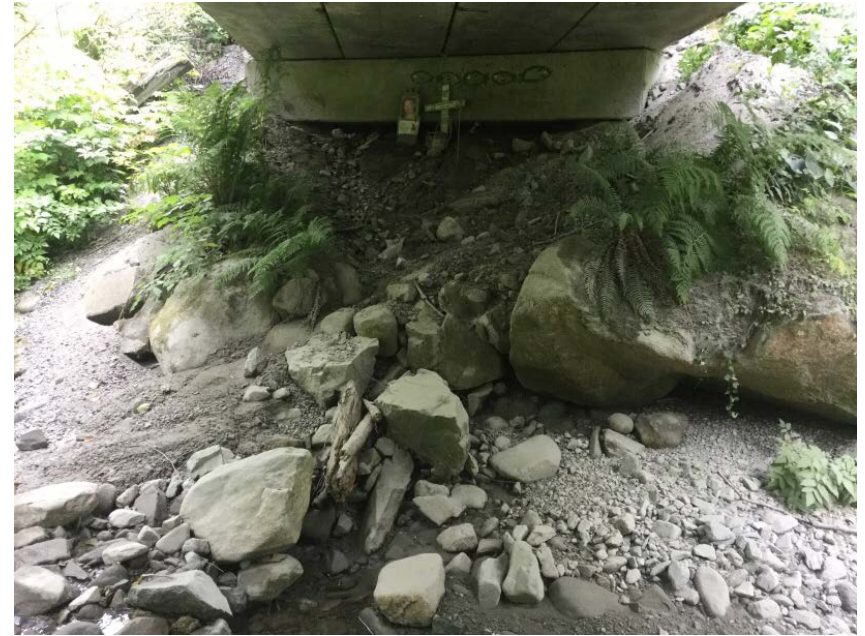
Left Bank Abutment when facing downstream

Fill Fair Loosing material under cap

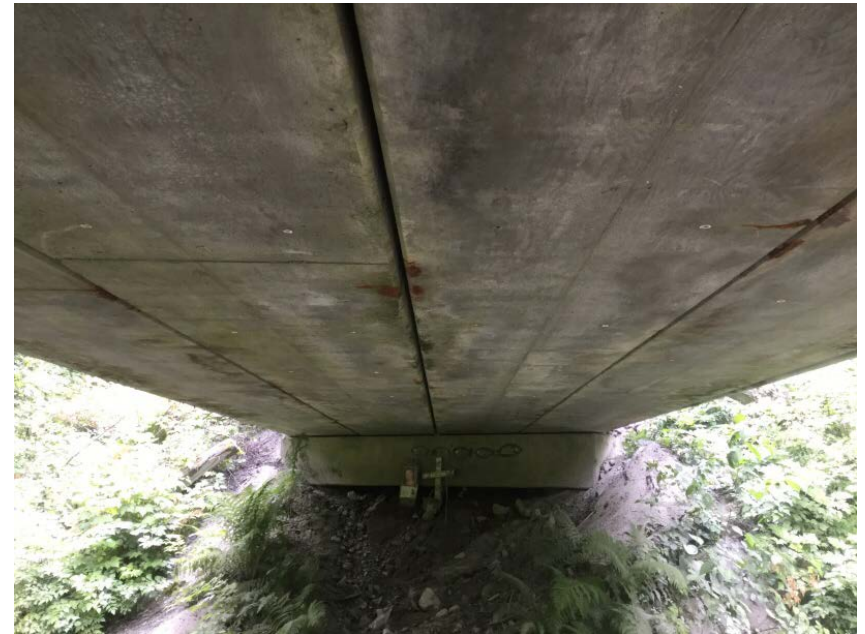
Superstructure

Girders **Good** 4 concrete slabs

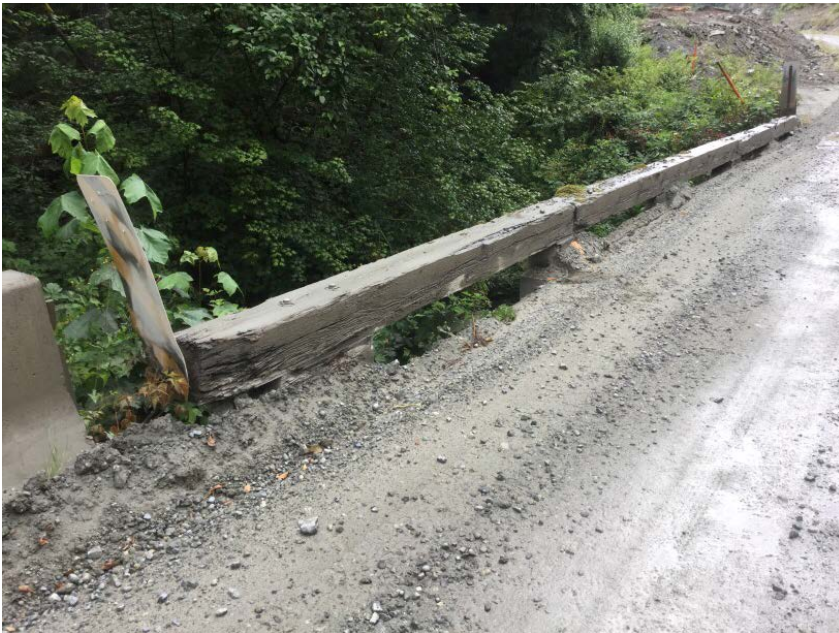
Guard Rail

Sideblocks sampled in various locations, some cored fair while others cored poor

| 2 | Medium | Replace guardrail, risers, blocks and grading strip |
