CK-2095

FLORENCE LAKE 9.4km

2017 Inspection

| Crossing Name | Kearsley Creek |

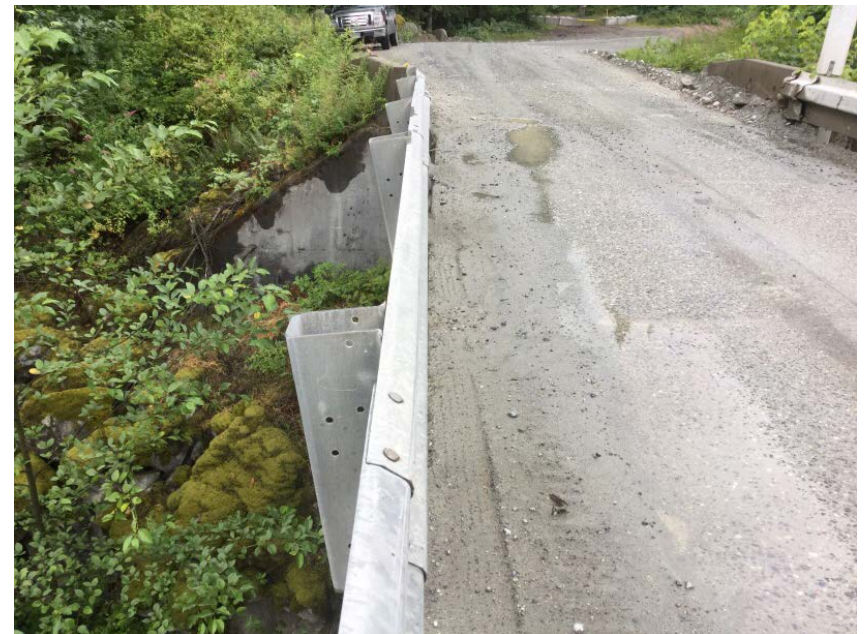
Curb Rail/Blocks/Posts      Fair      Some damage noted but still functional

Guardrail damage downstream right approach - still functional

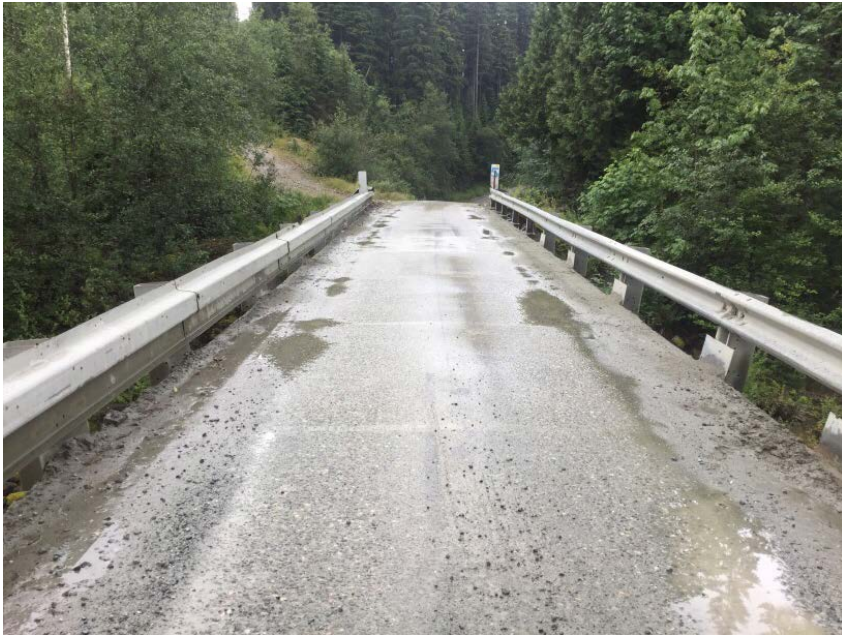
Different style of W beam rail upstream vs downstream

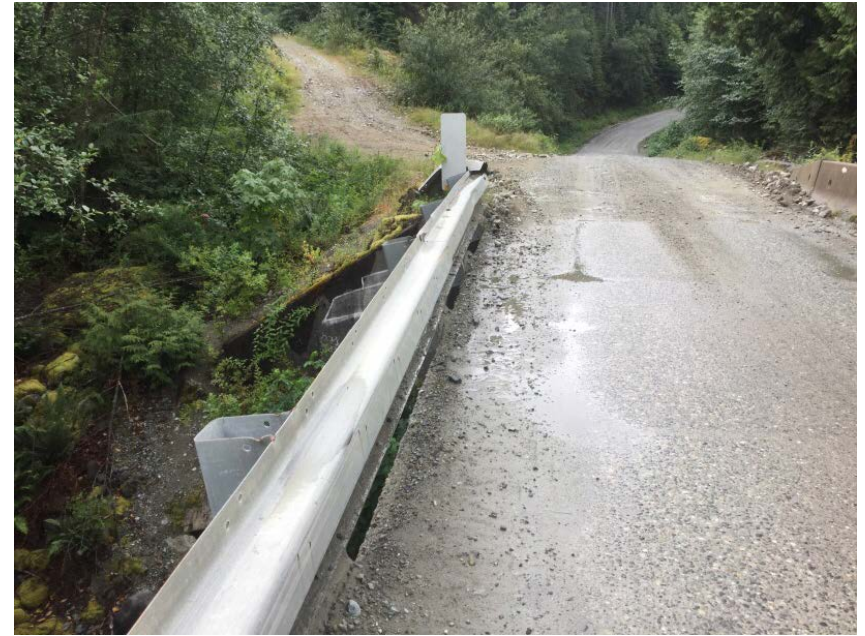
Guardrail damage upstream left approach - still functional

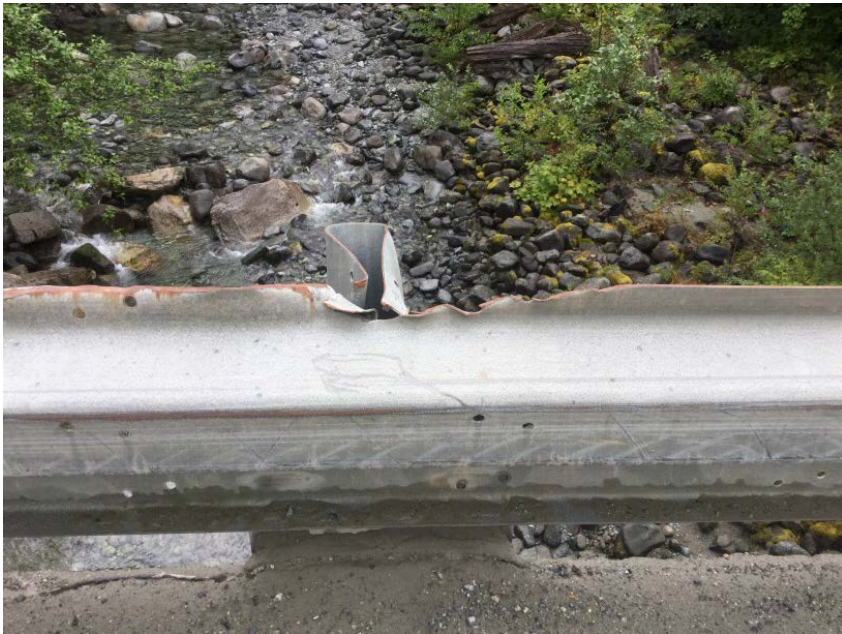
Damaged section of guardrail - still functional

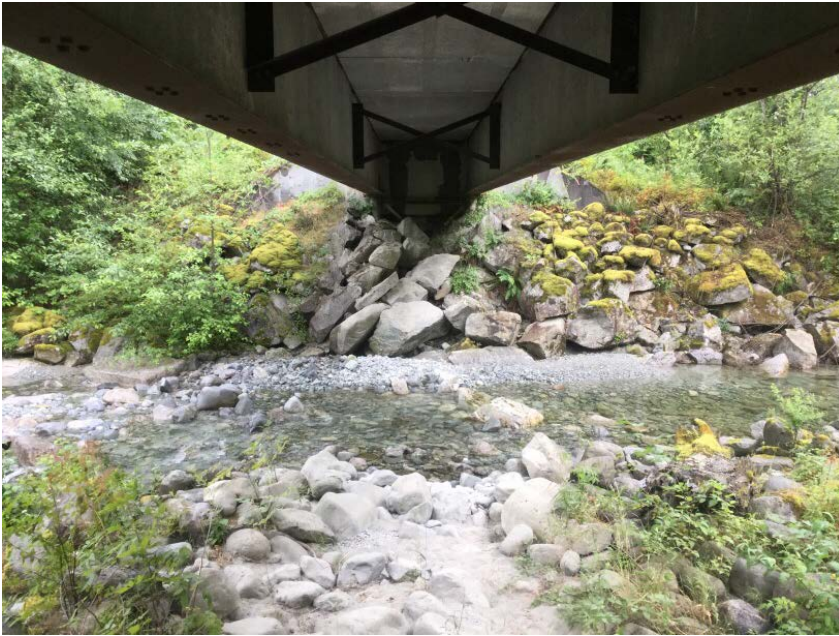
Right Bank Abutment when facing downstream

Riprap Fair Steep at right bank
