CK-2097

FLORENCE LAKE 13.6km

2017 Inspection

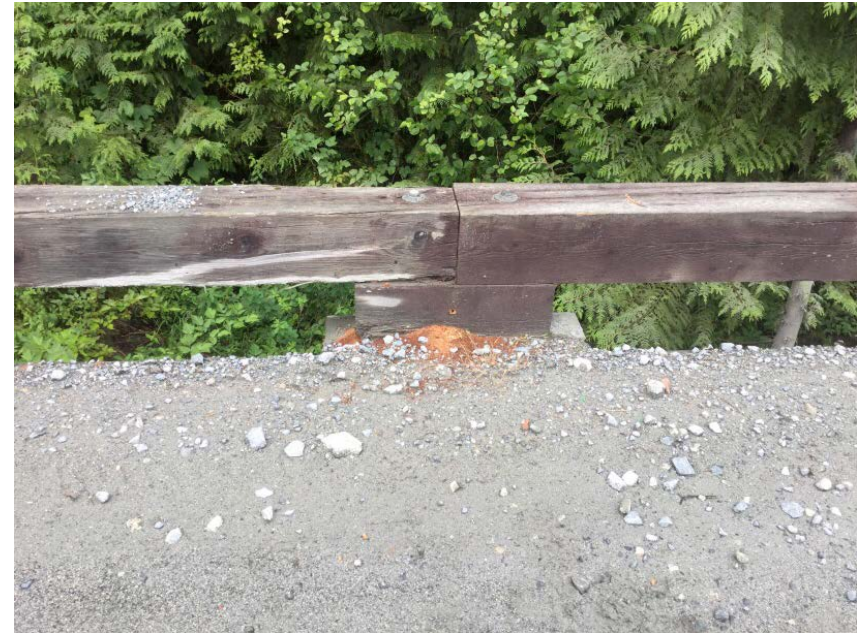
Guard Rail

| Curb Rail/Blocks/Posts | Poor | rotting risers and blocks |

| Hardware | Poor | loose rail bolts |

| Overall Deck Condition | Poor | due to rail condition |

| 2 | Medium | Replace guardrail, risers and blocks |

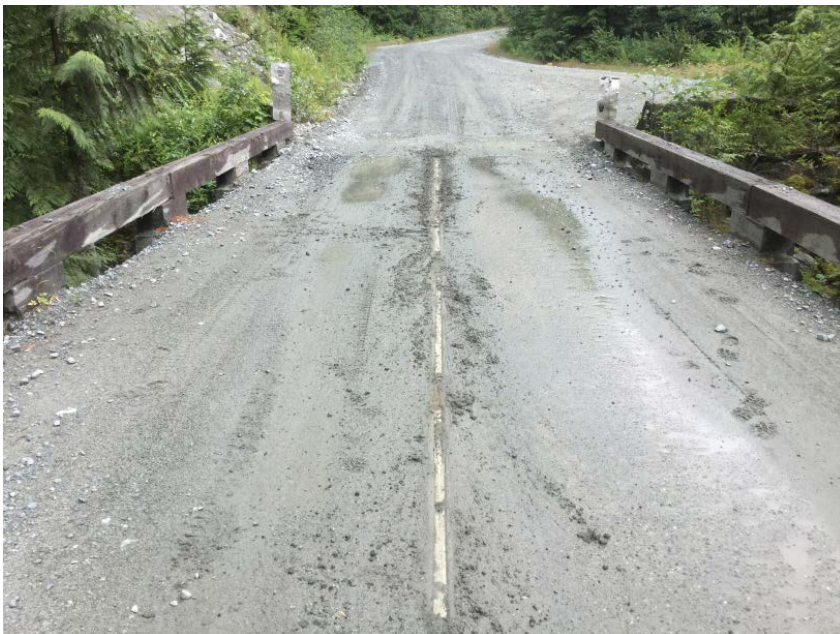
Deck

| Running Surface | Fair | sediment on deck |

| 1 | Medium | Clean sediment from deck |
