CK-2098

FLORENCE LAKE 13.6km

2017 Inspection

| Crossing Name | Sayers Creek |

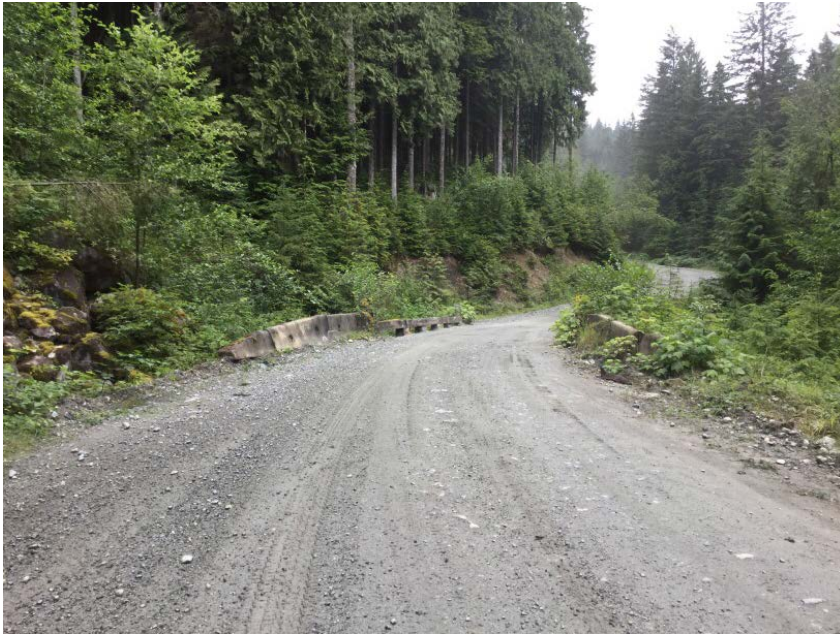
Approach from Right Bank when facing downstream

Brushing Required Y Minor

| Item | Priority | Repair Description |
|---|---|---|
| 1 | Low | Brush approaches and clean sediment from deck |

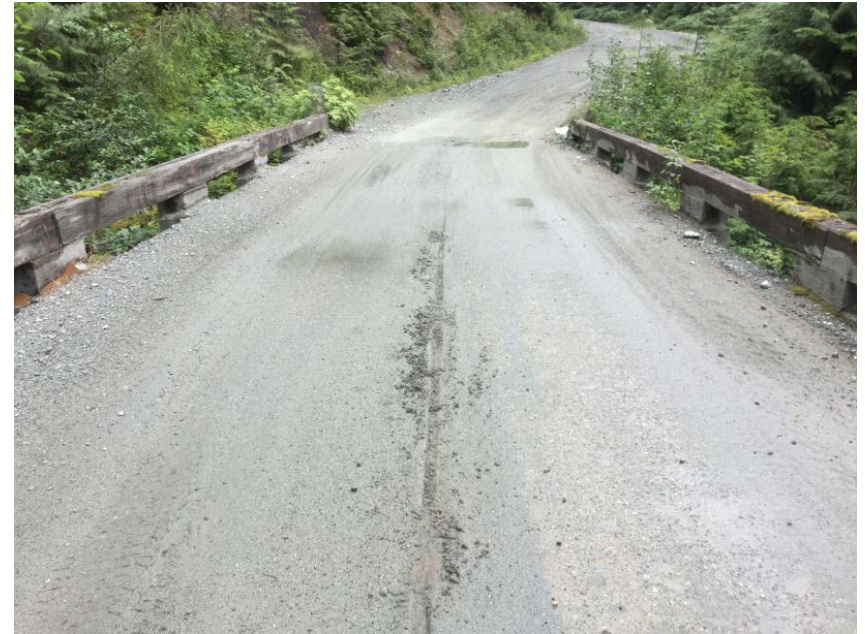
Running Surface Fair

Concrete Deck Good

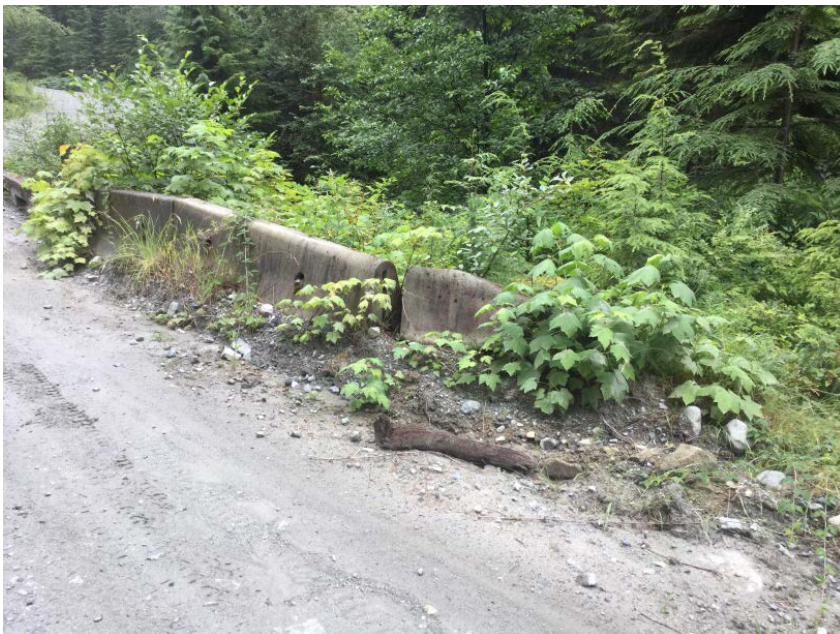
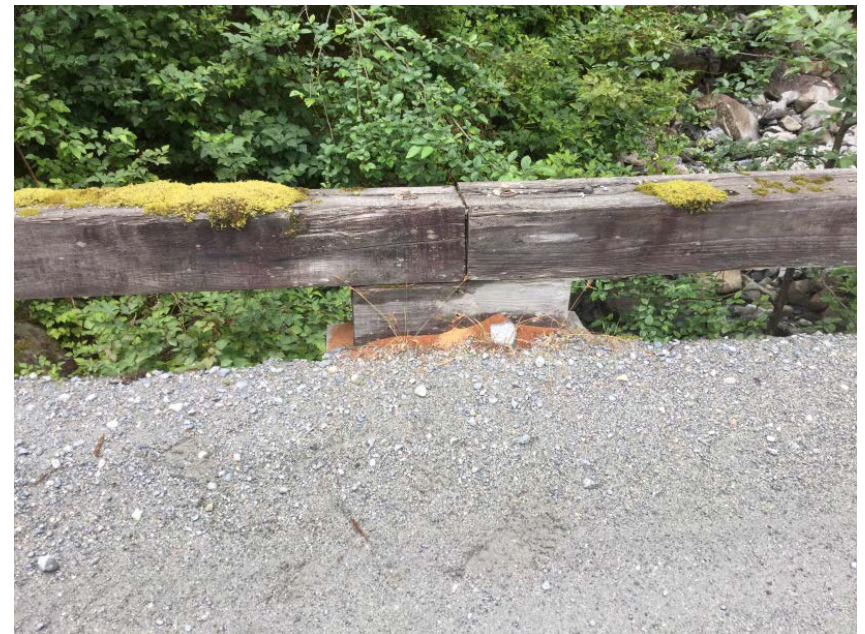
Guard Rail

Curb Rail/Blocks/Posts Poor Rotten sideblocks and risers

Hardware Poor Loose rail bolts

Overall Deck Condition Poor Due to rail condition

| Item | Priority | Repair Description |
|---|---|---|
| 2 | Medium | Replace guardrail, risers and blocks |

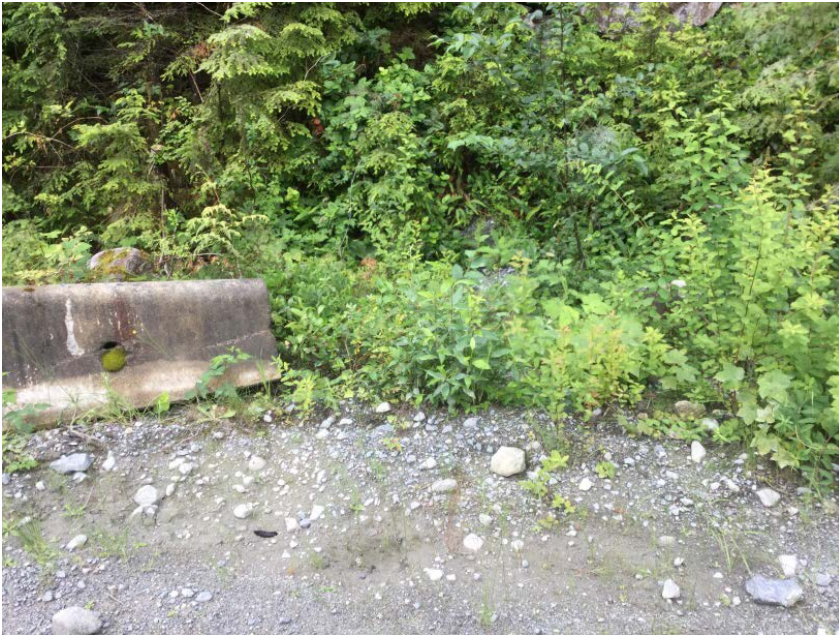
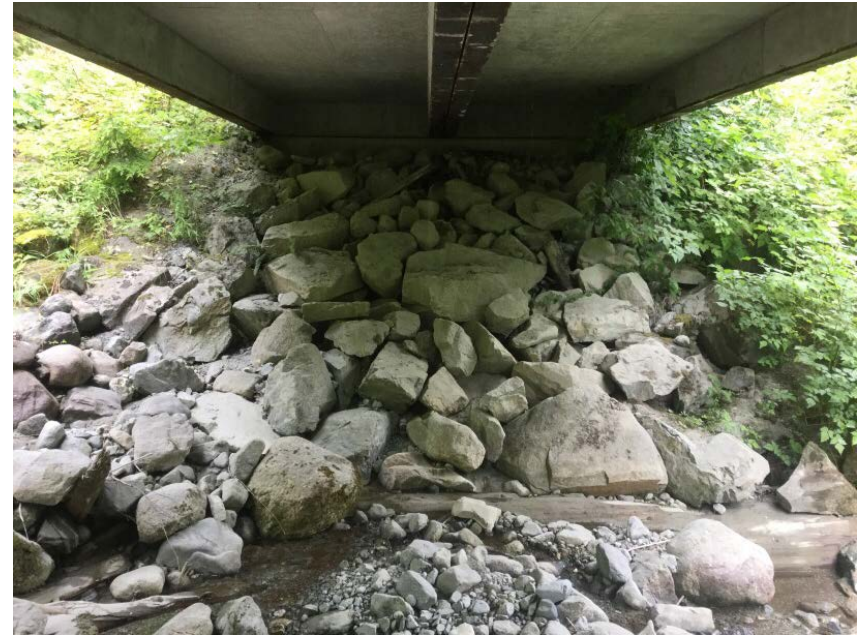
Left Bank Abutment when facing downstream

Caps or Sills Good Cap/wall combo

Ballast Wall Good
