CK-2099

FLORENCE LAKE 14.1km

2017 Inspection

| Crossing Name | Con Creek | | |

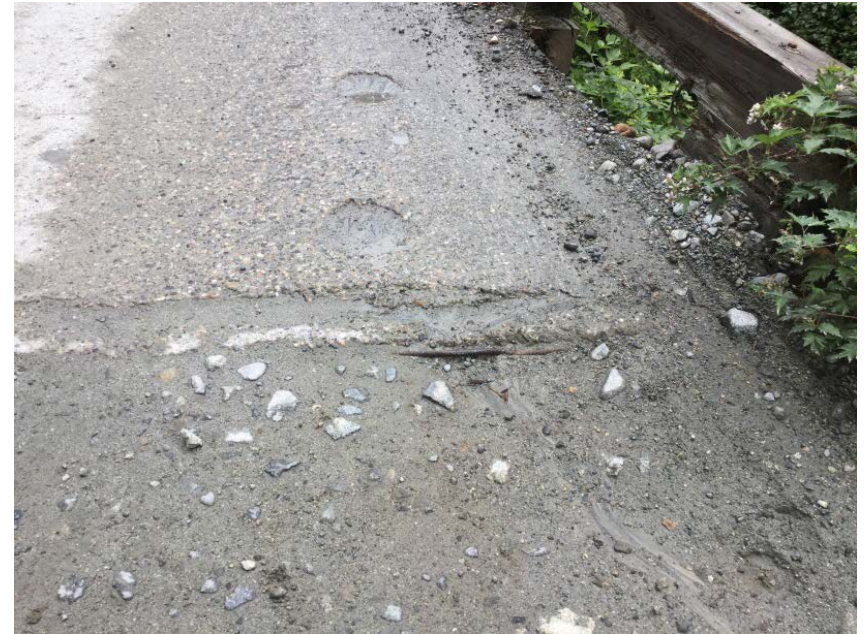
Ballast Wall Fair Damage noted at right bank

Exposed rebar on right bank ballast wall

| 2 | Medium | Repair damage to ballast wall |

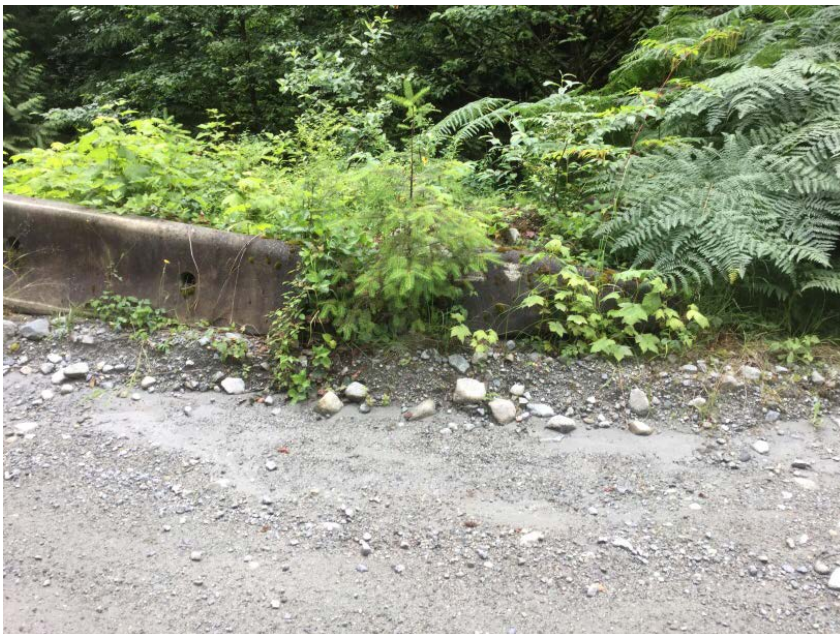
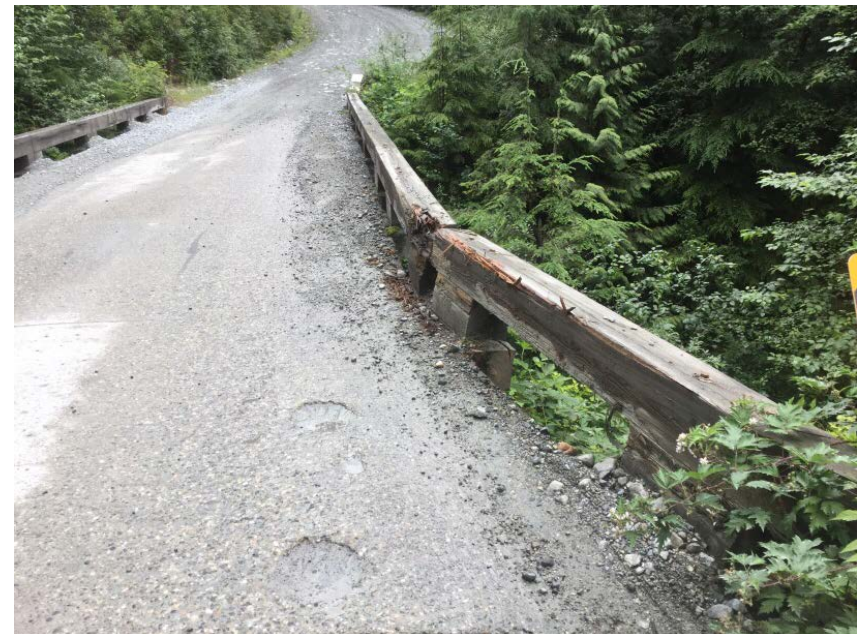
Curb Rail/Blocks/Posts      Fair      Some blocks and risers up to 30% rot

Guardrail damage downstream right bank - still functional

Overall Deck Condition      Fair      Recommend replacing the guardrail system

| 3 | Medium | Replace guardrail, risers and blocks |

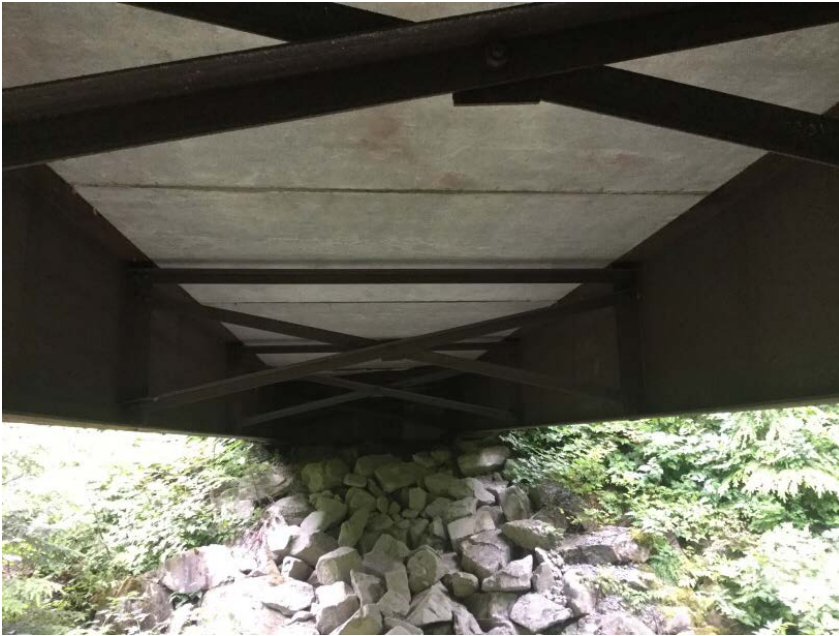
Superstructure

Diaphragms Good Slight corrosion noted

Bracing Good Slight corrosion noted
