CK-2103

GARNET CREEK 8.8km

2017 Inspection

| Crossing Name | East Fork Garnet Creek |

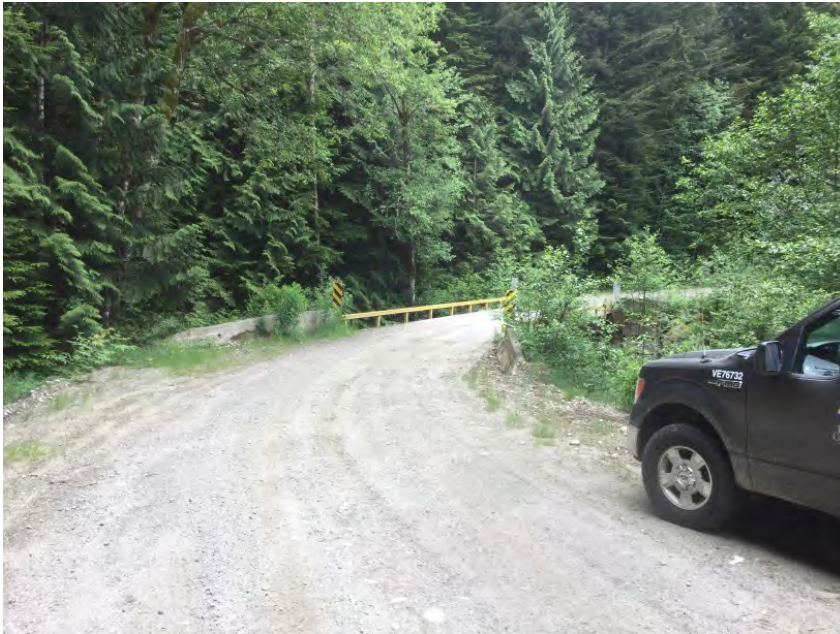
Approach from Right Bank when facing downstream

Bridge Ahead Signs  
Missing☐ 0 ☐ 1 ☒ 2

Brushing Required Y

Post bridge ahead signs and brush with activity. Present load rating of L75 or 68 tonnes to continue.

| Item | Priority | Repair Description |
|---|---|---|
| 1 | Medium | Post bridge ahead signs |

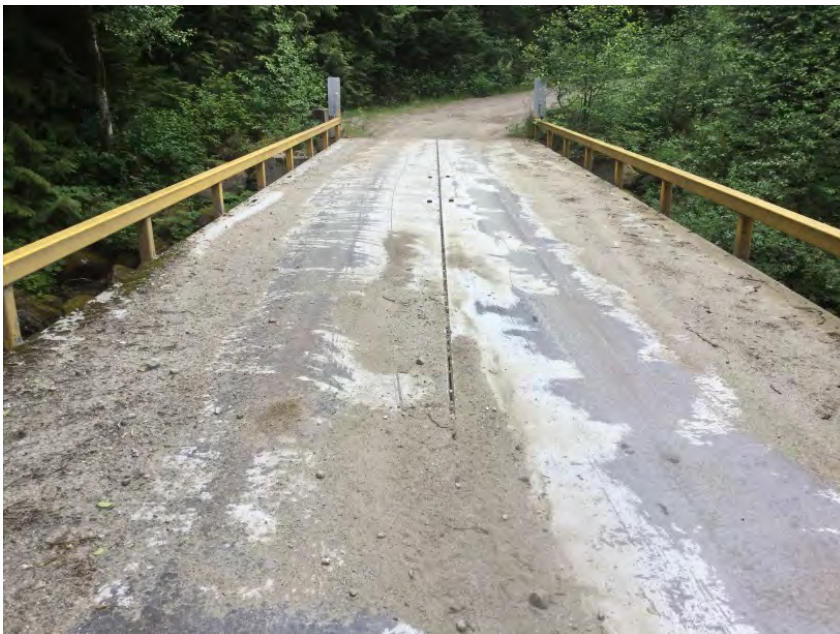
Running Surface      **Good**

Overall Deck Condition      **Good**

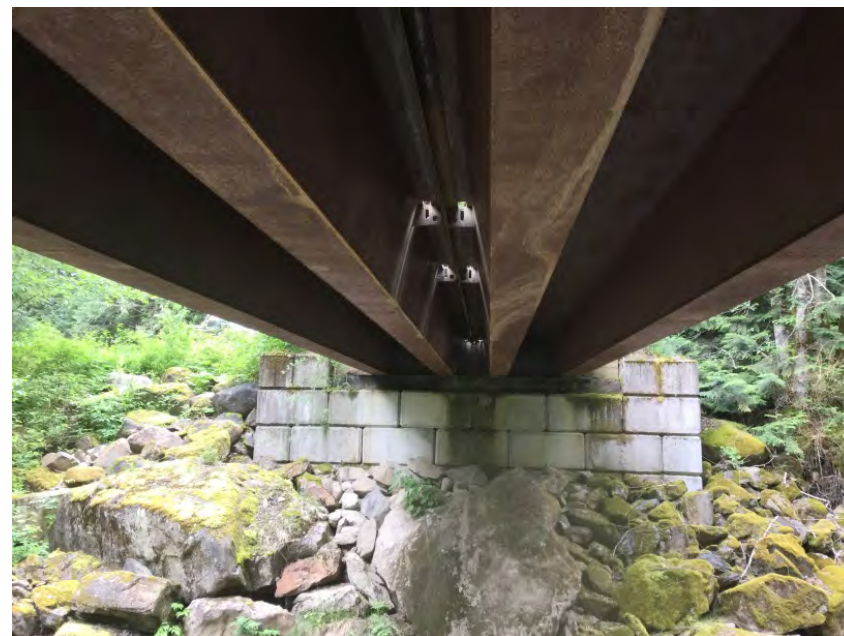
Superstructure

Girders Good

Diaphragms Unrated Inside box beams, no deformation noted

Bracing Unrated Inside box beams, no deformation noted

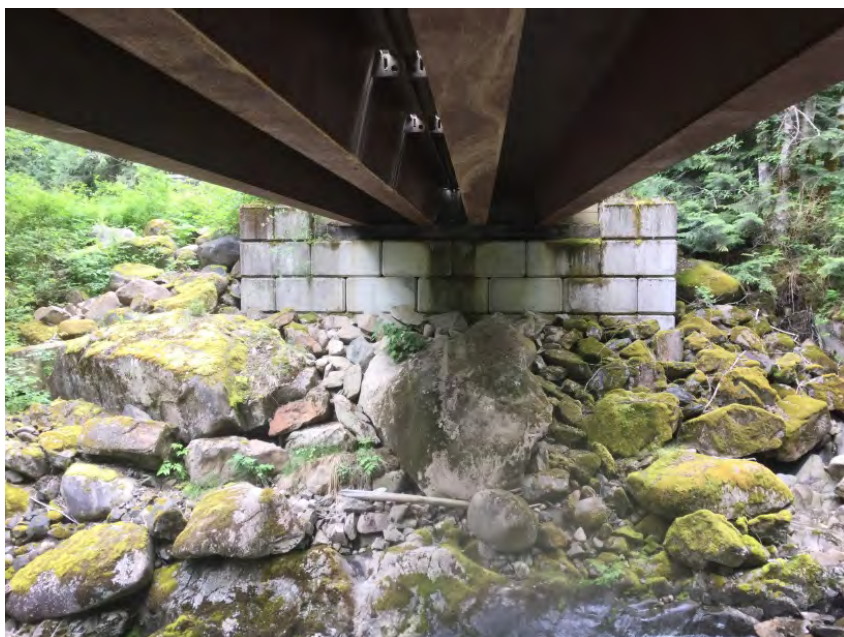
Right Bank Abutment when facing downstream

Concrete Good

4x high lock blocks

Caps or Sills Good

Ballast Wall Good

Wing Wall Good

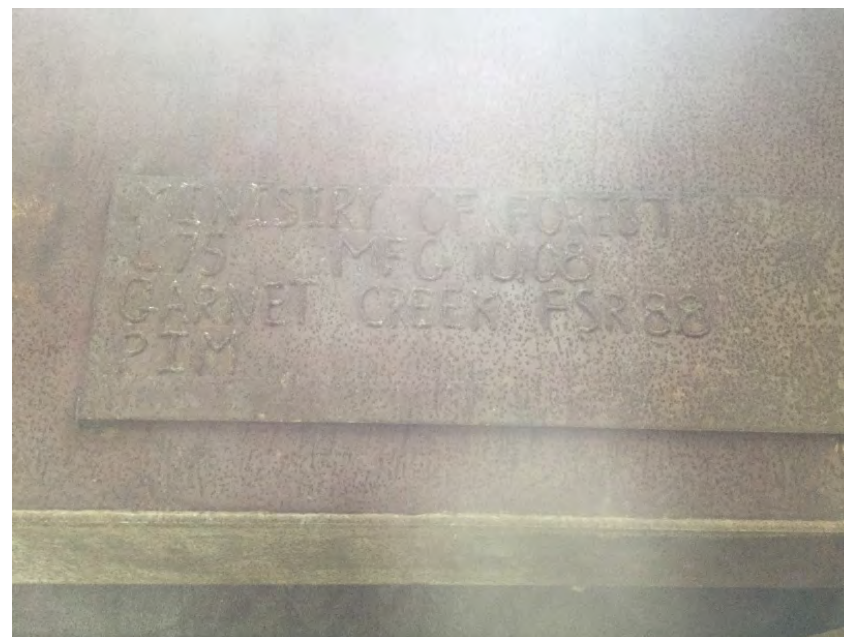
Structure ID

Serial/ID Plate MFG 10108
