CK-2104

HARRISON EAST 6.8km

2017 Inspection

| Crossing Name | Slollicum Creek | | |

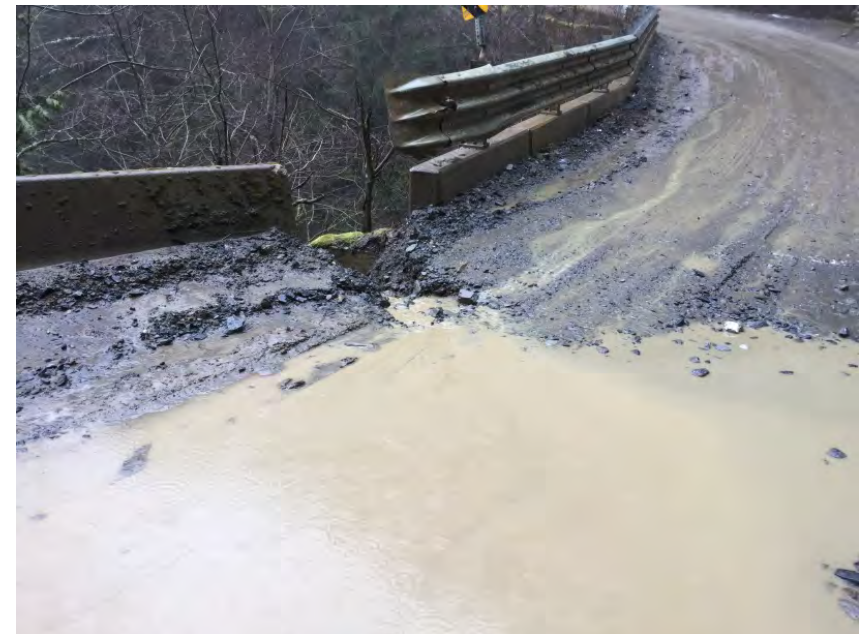
Eroding road surface at both downstream approaches

Eroding road surface at left downstream approach

Replace the eroding road fill at both downstream approaches; remove the sediment from the deck and properly assess; and replace the missing delineators. Monitor the downstream right bank wingwall as the top 2 rows of lock blocks are pushing outwards, and monitor the condition of the old log crib retaining fill, especially considering the record drawings indicate precast concrete footings as opposed to cast-in-place into bedrock. Present load rating of L100 or 91 tonnes to continue.

| Item | Priority | Repair Description |
|---|---|---|
| 1 | High | Replace eroded material at both downstream approaches |

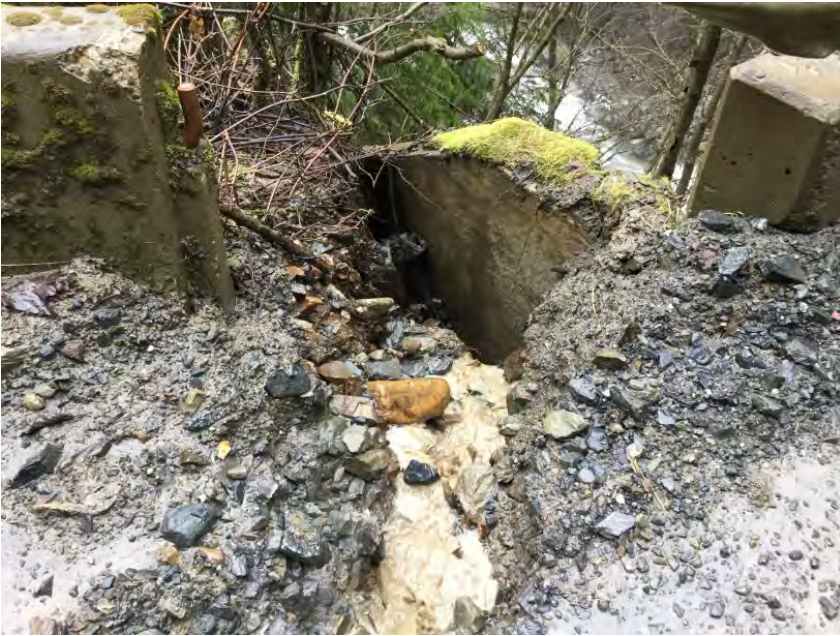
Eroding road surface and behind ballast wall on left downstream approach

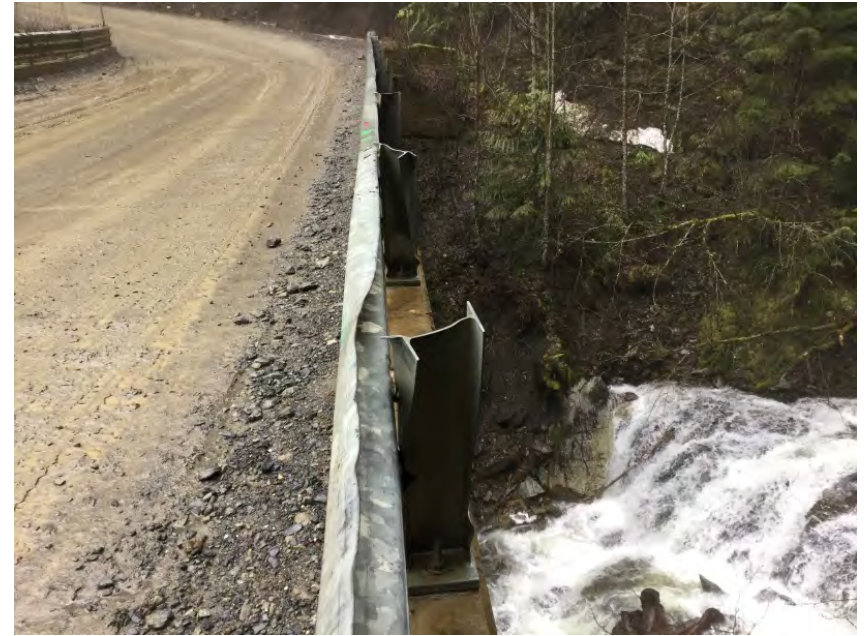
| Curb Rail/Blocks/Posts | Fair | Concrete subriser and steel riser - some damage but functional |

Damage to upstream risers - still functional

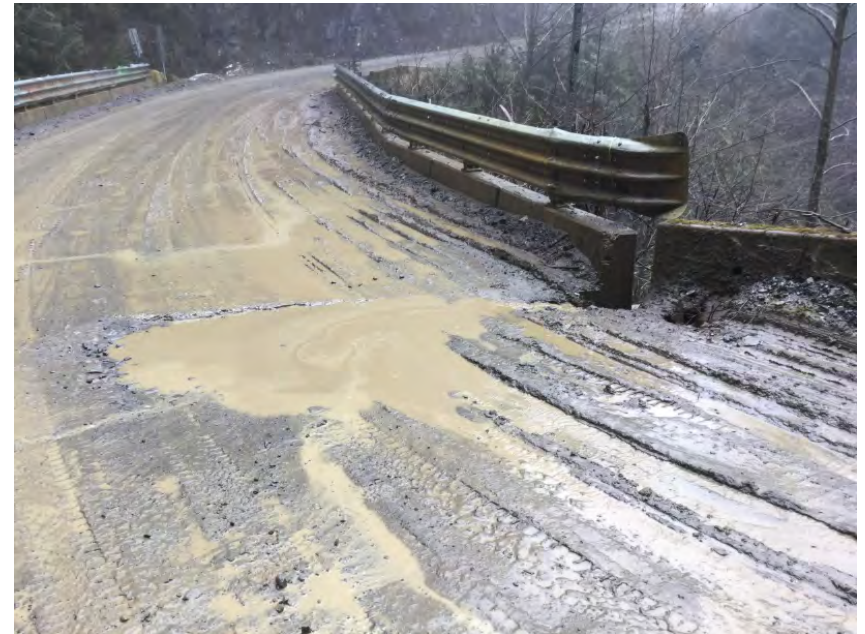
Eroding road surface right downstream approach

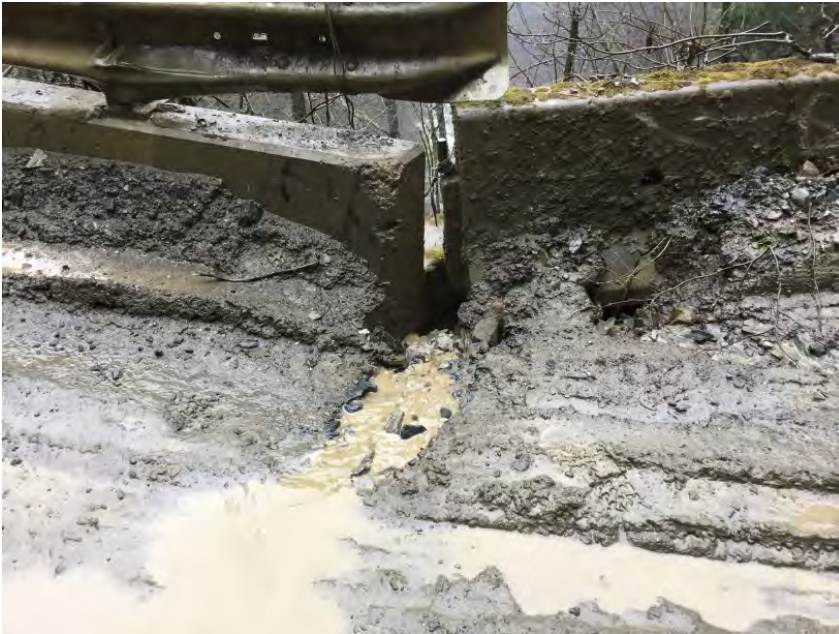
Eroding road surface and behind. ballast wall right downstream approach

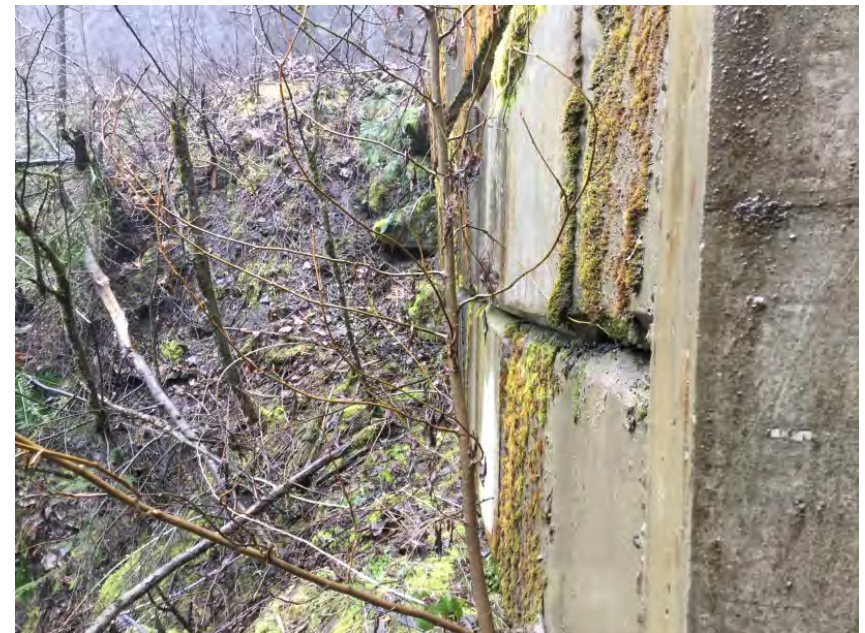
Lock blocks on downstream right approach 2nd and 3rd rows starting to push out - geogrid between each row noted

Lock blocks on DS right approach starting to push out on 2nd and 3rd rows

| Item | Monitor Description | Frequency |
|---|---|---|
| 1 | Wing wall at downstream right bank | Routine Inspection |

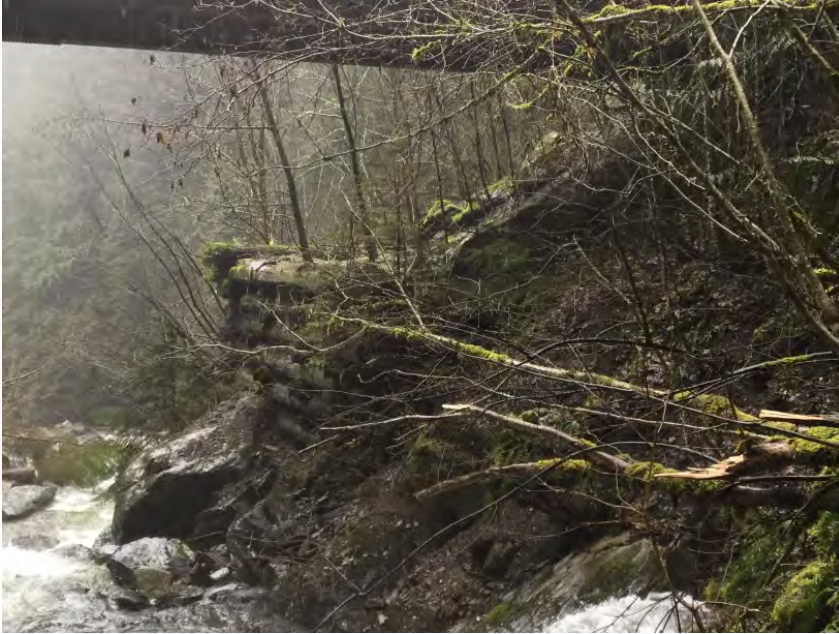
Being retained by and old log crib at both banks

Old log crib left in place right bank - for fill retention check record drawings

| Item | Monitor Description | Frequency |
|---|---|---|
| 2 | Old log cribs for failure | Routine Inspection |

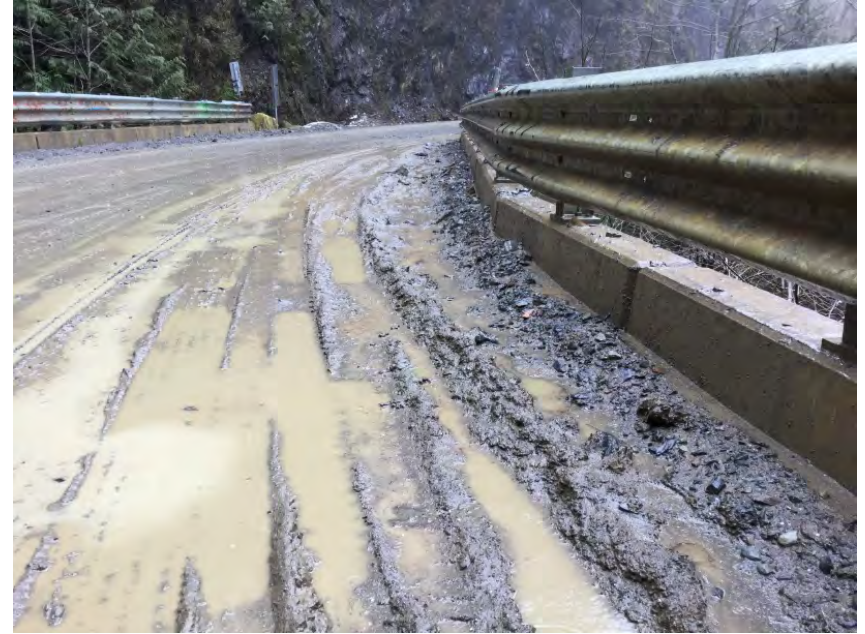
| Running Surface | Poor | Too much sediment on deck to properly assess - deck appears to be outsloped 2%, check drawings |
| Concrete Deck | Unrated | Too much sediment on deck to properly assess |

Amount of sediment on deck

| Item | Priority | Repair Description |
|---|---|---|
| 3 | High | Clean sediment off deck and assess |

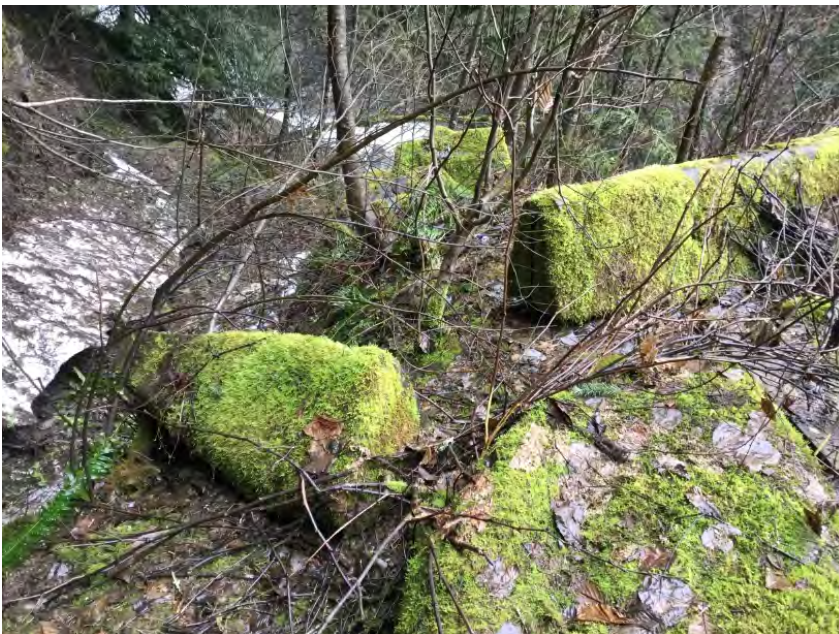
Upstream right approach detached bullnose
