CK-2112

HARRISON EAST 50.5km

2017 Inspection

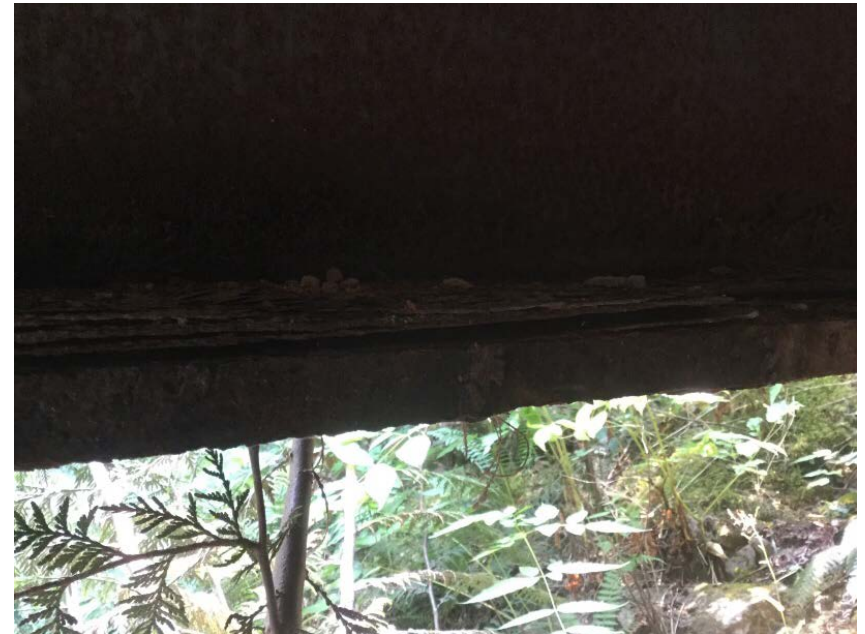
Minor steel delamination on bottom flanges

Brush and grade approaches. Monitor the corrosion noted on the superstructure. Present load rating of L150 or 136 tonnes to continue.

| Item | Monitor Description | Frequency |
|---|---|---|
| 1 | Monitor steel delamination | Routine Inspection |

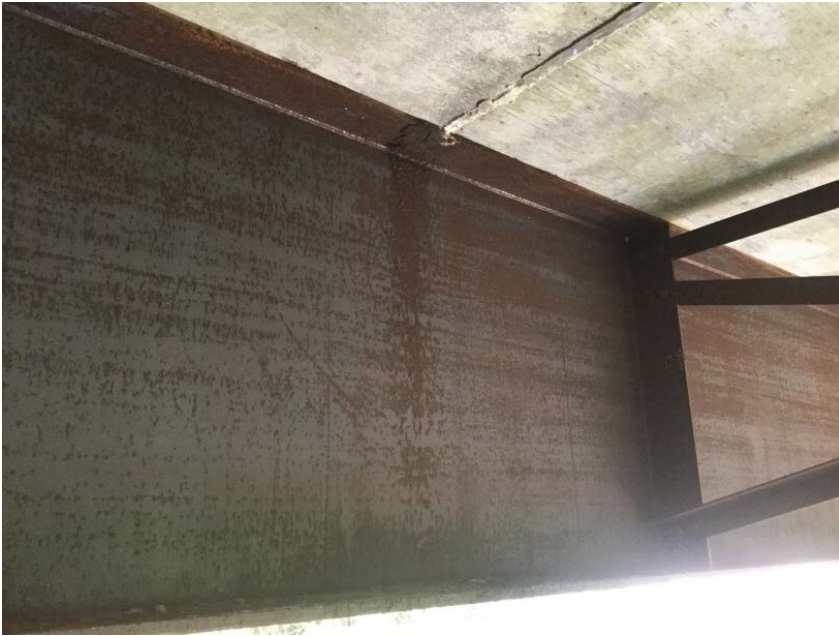
Concrete Deck      **Good**Grout Pockets      **Fair**      Some water getting through causing minor corrosion of superstructureDeck Joints      **Fair**      Some water getting through causing minor corrosion of superstructure

Water getting through some deck joints - 50% of joints but only minor corrosion

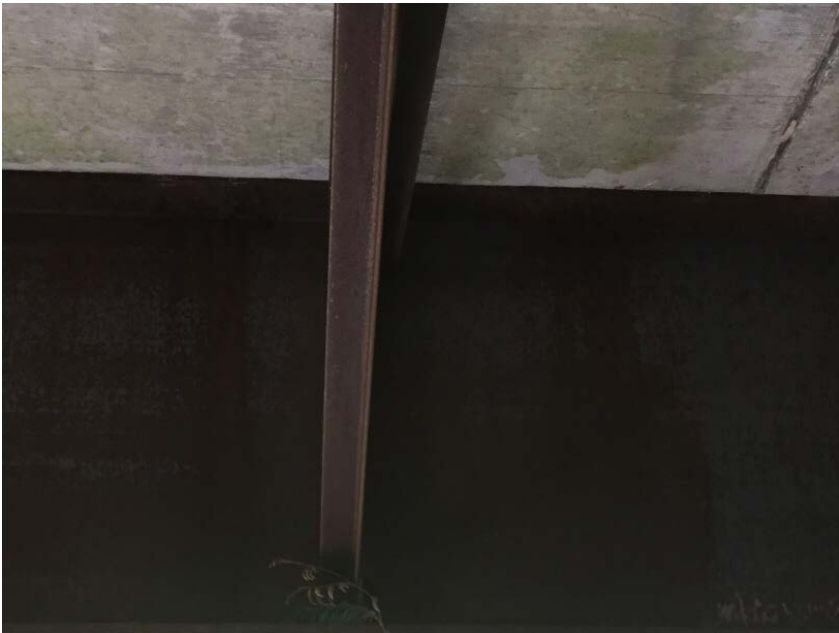
Water getting through some grout pockets - 5% of pockets

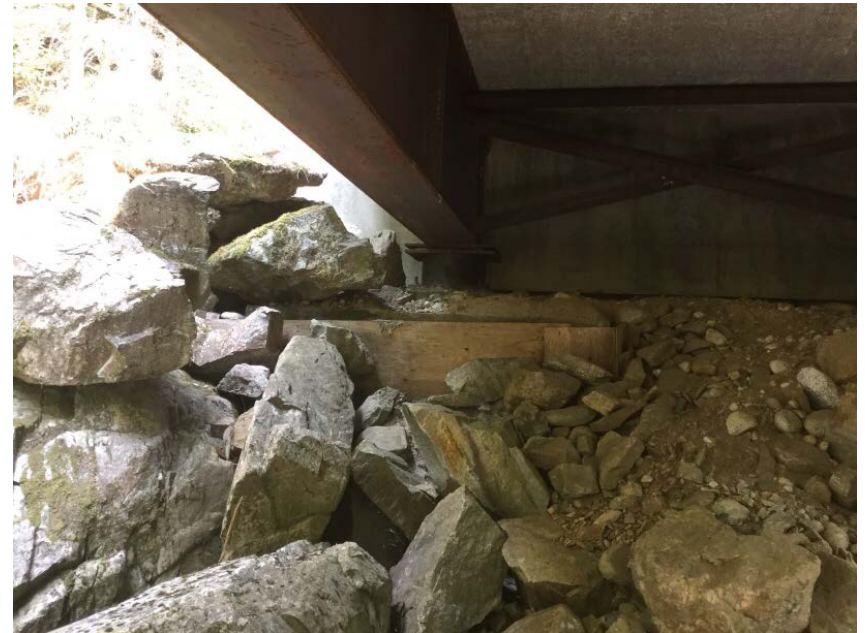
Upstream left bank footing appears to have had additional work to it and appears stable
