CK-2114

HARRISON EAST 56.5km

2017 Inspection

| Crossing Name | Gold Creek | | |

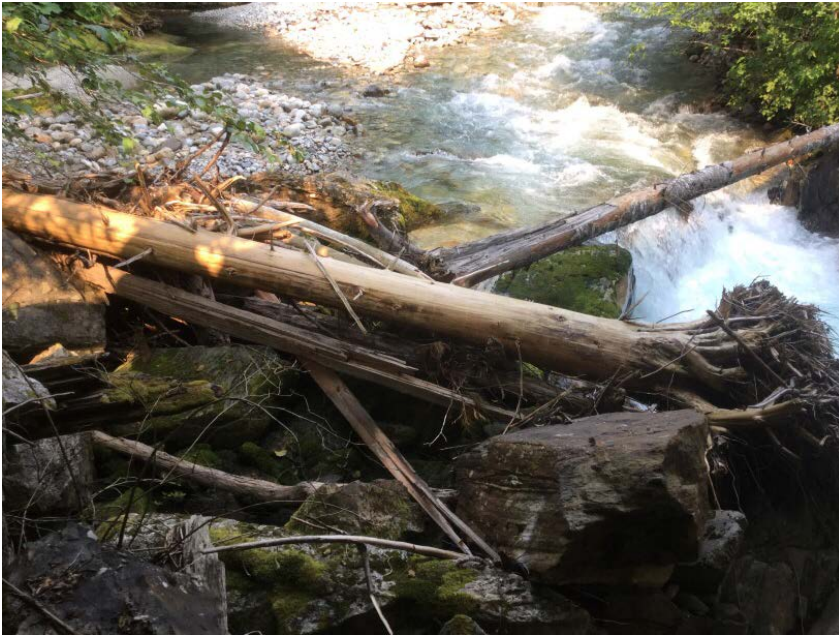
| Item | Monitor Description | Frequency |
|---|---|---|
| 1 | Debris accumulations upstream | Routine Inspection |

Debris accumulation at upstream

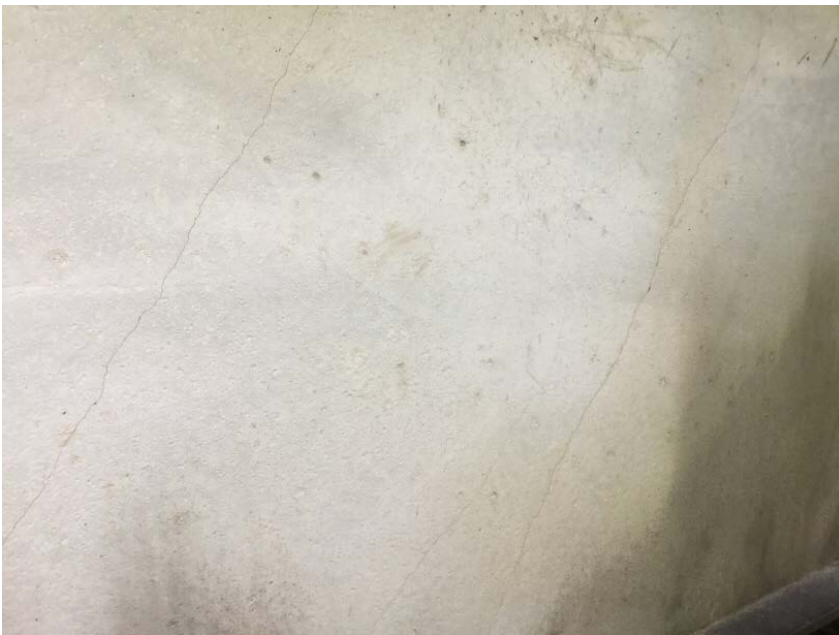
| 2 | hairline cracks in girders | Routine Inspection |

Cracking on upstream girder - minimal gap in all cracks

Brush and grade approaches; and replace the missing delineator. Monitor debris accumulations upstream of the crossing and the hairline cracks in the girders. Present load rating of L150 or 136 tonnes to continue.

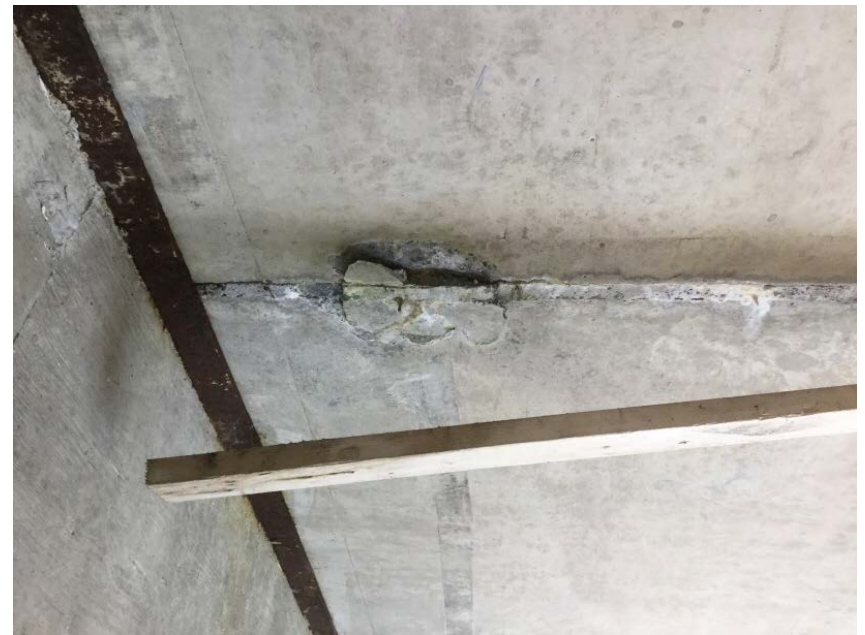
Small spall in 2 Panels - underneath
